Hare Hill Windfarm Repowering and Extension

**Environmental Impact Assessment
Report**

**Technical Appendix 9.1: Watercourse
Crossing Assessment**

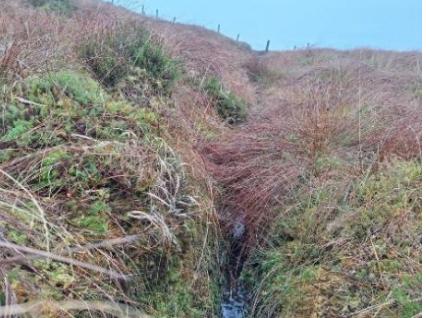
Crossing Location	WX1 (265244, 608966) Crossing Description

<ul style="list-style-type: none"> • Existing crossing: No • Channel Type: Artificial drainage channel • Gradient: Gentle • Valley form: No obvious valley sides • Bank condition: Undercut (no evidence of recent collapse) • Bed material: Vegetation, Peat • Riparian corridor: Moorland • Flow condition: Very slow <ul style="list-style-type: none"> • Water width (m): 0.11 • Water depth (m): 0.07 • Bankfull width (m): 0.32 • Bankfull height (m): 0.12 • Banktop height (m): 0.12 • Flooded Bankfull width (m): 0.44 • Flooded Bankfull height: 0.15 <p>Present on 1:50,000 scale OS map? No</p> <p>Note: None.</p> <p>EASR Auth Level: GBR</p> <p>Proposed Crossing Type: To accommodate flow, a circular culvert is proposed.</p>
<h3>Crossing Photographs</h3> <p>Upstream</p>

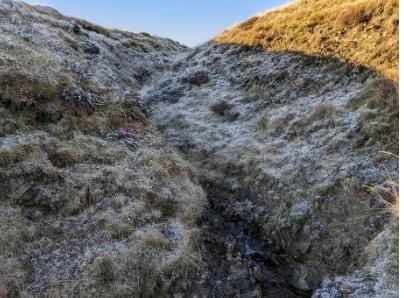
Crossing Location	WX4 (265430, 606268) Crossing Description

<p>© Crown Copyright 2025. All rights reserved. Ordnance Survey Licence 0100031673.</p>	<p>Crossing Description</p> <ul style="list-style-type: none"> • Existing crossing: No • Channel Type: Incised • Gradient: Steep • Valley form: Gorge • Bank condition: Stable • Bed material: Rounded pebbles, Coarse gravel, Boulders, Bedrock • Riparian corridor: Moorland • Flow condition: Moderate <ul style="list-style-type: none"> • Water width (m): 0.80 • Water depth (m): 0.10 • Bankfull width (m): 1.20 • Bankfull height (m): 0.30 • Banktop height (m): 3.00-4.00 • Flooded Bankfull width (m): 1.50-2.00 • Flooded Bankfull height: 1.00 <p>Present on 1:50,000 scale OS map? Yes</p> <p>Note: Substantial Gorge</p> <p>EASR Auth Level: Registration</p> <p>Proposed Crossing Type: The surveyor noted that there is a substantial gorge at this location which will require a bridge crossing or track relocation.</p>

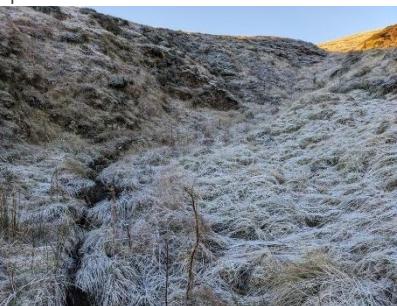
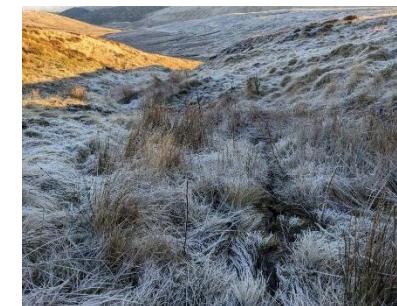
Crossing Location	WX5 (265435, 606994) Crossing Description

<p>© Crown Copyright 2025. All rights reserved. Ordnance Survey Licence 0100031673.</p>	<ul style="list-style-type: none"> • Existing crossing: No • Channel Type: Incised • Gradient: Steep • Valley form: Deep vee • Bank condition: Stable • Bed material: Coarse gravel, Vegetation • Riparian corridor: Moorland • Flow condition: Moderate <p>• Water width (m): 0.20</p> <p>• Water depth (m): 0.20</p> <p>• Bankfull width (m): 0.30</p> <p>• Bankfull height (m): 0.25</p> <p>• Banktop height (m): -</p> <p>• Flooded Bankfull width (m): 0.50-1.00</p> <p>• Flooded Bankfull height: 0.30-0.40</p> <p>Present on 1:50,000 scale OS map? No</p> <p>Note: Watercourse contained in a small gully.</p> <p>EASR Auth Level: GBR</p> <p>Proposed Crossing Type: To accommodate flow, a circular culvert is proposed.</p>
Crossing Photographs	
<p>Upstream</p>

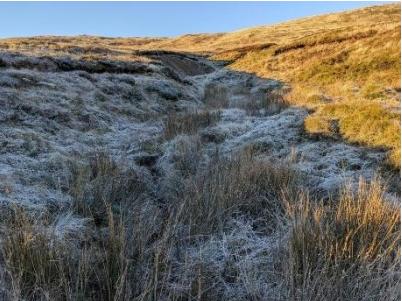
Crossing Location	WX7 (265443, 606967) Crossing Description

<p>© Crown Copyright 2025. All rights reserved. Ordnance Survey Licence 0100031673.</p>	<ul style="list-style-type: none"> • Existing crossing: No • Channel Type: Incised • Gradient: Steep • Valley form: Deep vee • Bank condition: Stable • Bed material: Coarse gravel, Vegetation • Riparian corridor: Moorland • Flow condition: Moderate • Water width (m): 0.30 • Water depth (m): 0.08 • Bankfull width (m): 0.80 • Bankfull height (m): 0.20 • Banktop height (m): - • Flooded Bankfull width (m): 1.00-2.00 • Flooded Bankfull height: 0.30 <p>Present on 1:50,000 scale OS map? No</p> <p>Note: Watercourse contained in gully, with eroded banks 25 m upstream showing evidence of frequent flooding.</p> <p>EASR Auth Level: GBR</p> <p>Proposed Crossing Type: To accommodate flow, a circular culvert is proposed.</p>
<p>Crossing Photographs</p> <p>Upstream

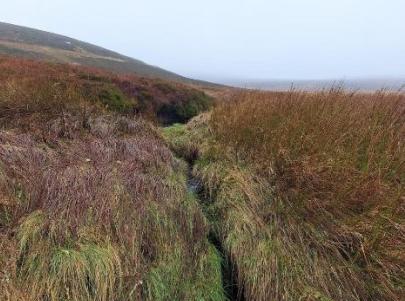
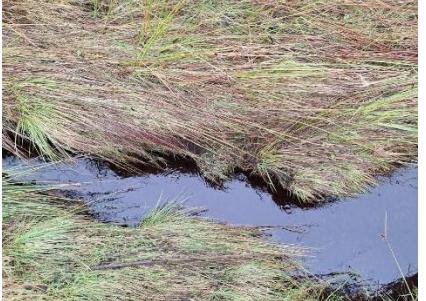
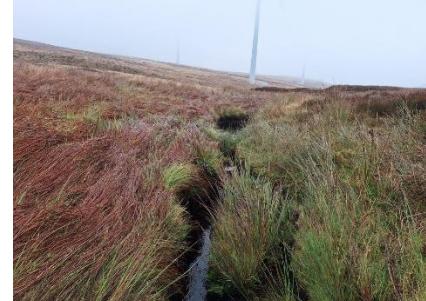
<p>© Crown Copyright 2025. All rights reserved. Ordnance Survey Licence 0100031673.</p>	<p>WX22 (266170, 608427)</p> <p>Crossing Description</p> <ul style="list-style-type: none"> • Existing Crossing: No • Channel Type: Incised, Meandering • Gradient: Gentle • Valley form: Asymmetrical • Bank condition: Undercut (no evidence of recent collapse) • Bed material: Rounded pebbles, Coarse gravel • Riparian corridor: Moorland • Flow condition: Moderate 	<ul style="list-style-type: none"> • Water width (m): 0.69 • Water depth (m): 0.19 • Bankfull width (m): 0.77 • Bankfull height (m): 0.22 • Banktop height (m): 0.22 • Flooded Bankfull width (m): 0.83 • Flooded Bankfull height: 0.26
<p>Present on 1:50,000 scale OS map? No</p> <p>Note: Faster flow upstream as the channel narrows.</p> <p>EASR Auth Level: GBR</p> <p>Proposed Crossing Type: To accommodate flow, a circular culvert is proposed</p>

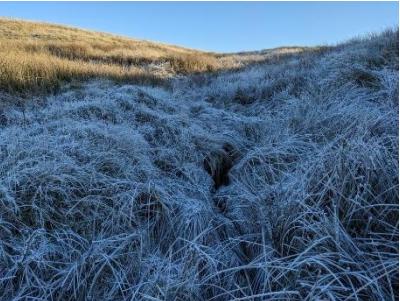
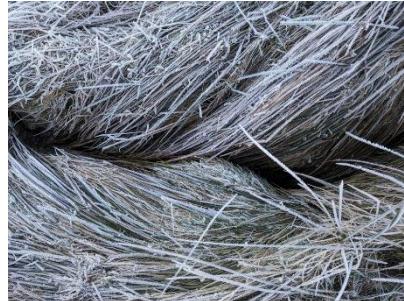
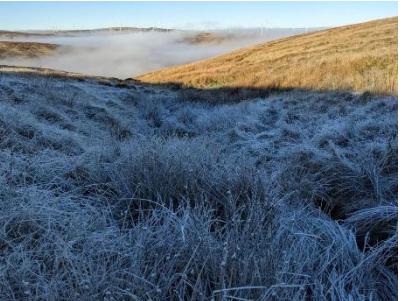
<ul style="list-style-type: none"> • Existing Crossing: No • Channel Type: Incised • Gradient: Moderate • Valley form: Shallow vee, Deep vee • Bank condition: Stable • Bed material: Boulders, Coarse gravel, Peat, Vegetation • Riparian corridor: Moorland • Flow condition: Moderate 	<ul style="list-style-type: none"> • Water width (m): 0.20 • Water depth (m): 0.10 • Bankfull width (m): 0.50 • Bankfull height (m): 0.50 • Banktop height (m): 2.00 • Flooded Bankfull width (m): 1.00-1.50 • Flooded Bankfull height: 0.70 	
<p>Present on 1:50,000 scale OS map? Yes</p> <p>Note: Water channel mostly obscured by vegetation.</p> <p>EASR Auth Level: Registration</p> <p>Proposed Crossing Type: To accommodate flow, a circular culvert is proposed.</p>			
Crossing Photographs	Upstream	Across	Downstream

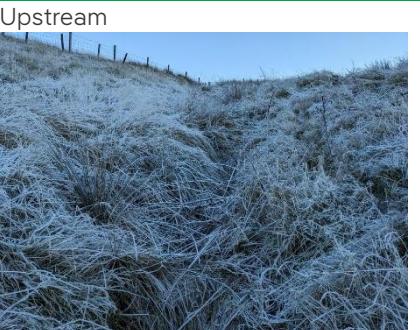
<p>WX43 (267717, 607281)</p> <ul style="list-style-type: none"> • Existing crossing: No • Channel Type: Incised • Gradient: Moderate • Valley form: Deep vee, Shallow vee • Bank condition: Stable • Bed material: Rounded pebbles, Coarse gravel, Vegetation • Riparian corridor: Moorland • Flow condition: Slow 	<ul style="list-style-type: none"> • Water width (m): 0.10 • Water depth (m): 0.05 • Bankfull width (m): 0.20 • Bankfull height (m): 0.20 • Banktop height (m): 1.50 • Flooded Bankfull width (m): 0.50-1.00 • Flooded Bankfull height: 0.60-1.00 			
<p>Present on 1:50,000 scale OS map? Yes</p> <p>Note: Watercourse mostly obscured by vegetation but could have increased flow in wet conditions.</p> <p>EASR Auth Level: Registration</p> <p>Proposed Crossing Type: To accommodate flow, a circular culvert is proposed.</p>					
Crossing Photographs	Upstream	Across
