EUCHANHEAD RENEWABLE ENERGY DEVELOPMENT

Technical Appendix 10.5: Schedule of Watercourse Crossings
Prepared for: ScottishPower Renewables

SLR Ref: 405.00481.00052
Version 3
October 2020

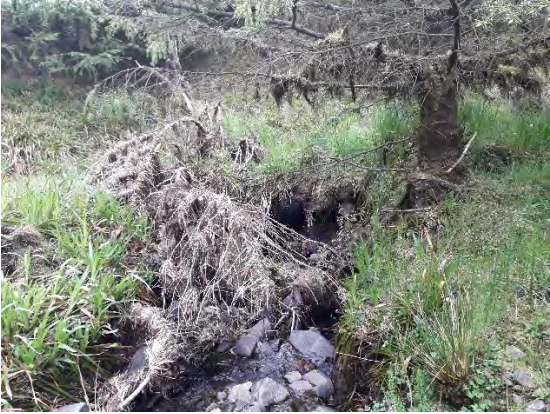
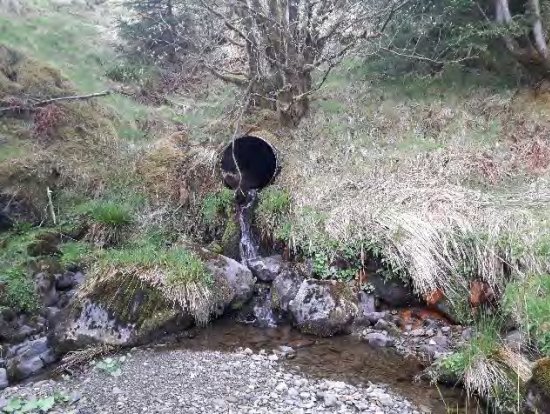
Watercourse Crossing Details	Photograph of New Watercourse Crossing Point	Photograph Looking Upstream of Watercourse Crossing	Photograph Looking Downstream of Watercourse Crossing
Watercourse Crossing: WX04 Status: Existing NGR: NS 68607 06330 Watercourse Width: 1.2 m Watercourse Depth: 0.2 m Notes: Large existing steel circular culvert which is approximately 0.9 m in diameter which is slightly corroded.	Existing

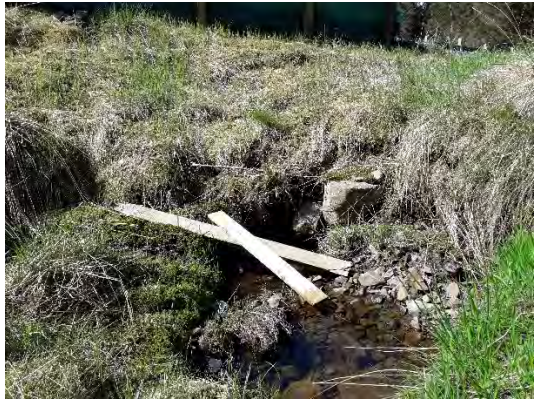
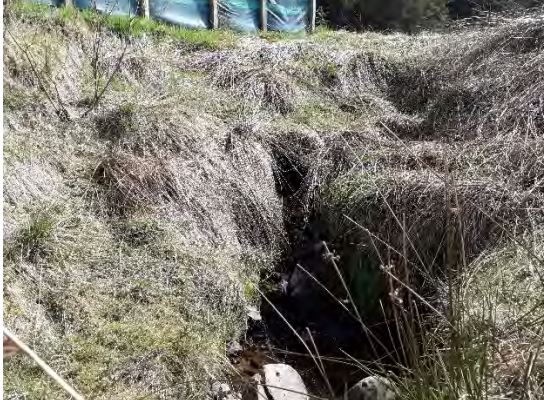
Watercourse Crossing Details	Photograph of New Watercourse Crossing Point	Photograph Looking Upstream of Watercourse Crossing	Photograph Looking Downstream of Watercourse Crossing
Watercourse Crossing: WX08 Status: Existing NGR: NS 68100 04882 Watercourse Width: 0.6 m Watercourse Depth: 0.2 m Notes: Small existing plastic circular culvert approximately 0.4 m in diameter. The culvert is very blocked on the upstream side.	Existing

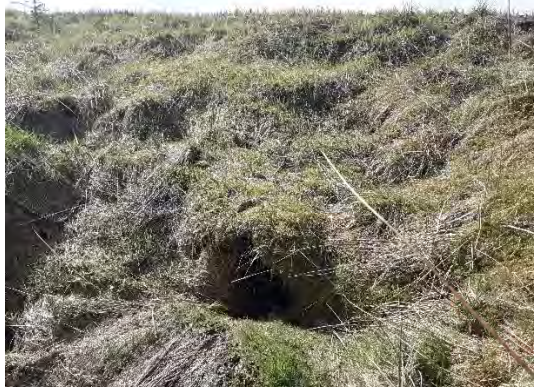
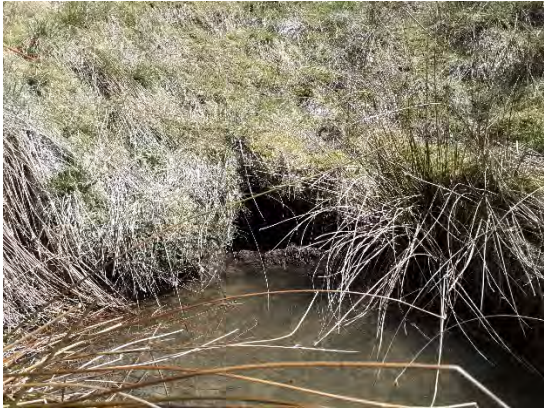
Watercourse Crossing: WX09 Status: Existing NGR: NS 67781 04399 Watercourse Width: N/A Watercourse Depth: N/A Notes: Small existing steel circular culvert which is approximately 0.4 m in diameter. The watercourse was noted as dry and overgrown.	Existing

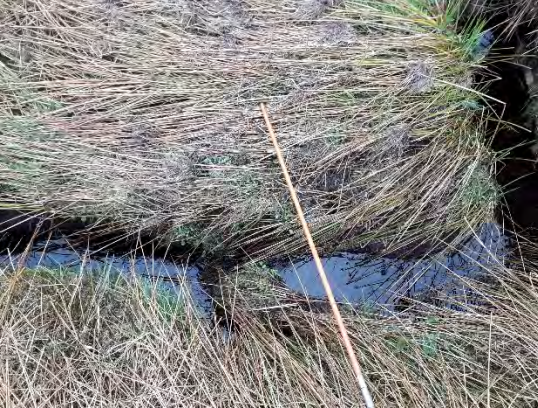
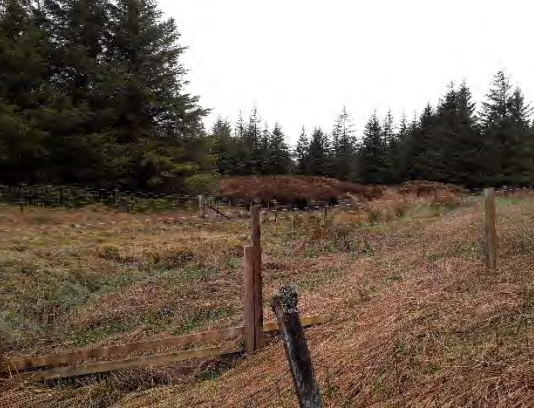
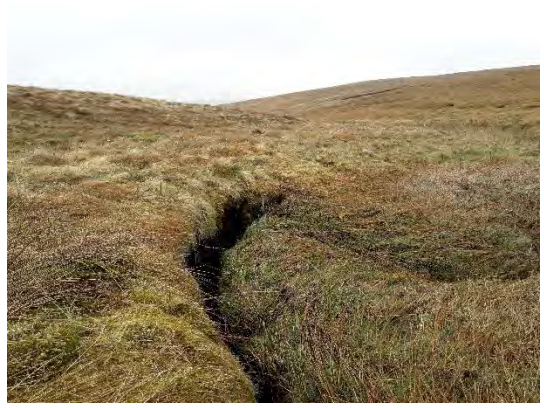
Watercourse Crossing: WX11 Status: New NGR: NS 66797 05485 Watercourse Width: 0.4 m Watercourse Depth: 0.8 m Notes: Minor watercourse located within long grasses and reeds incised into peat.

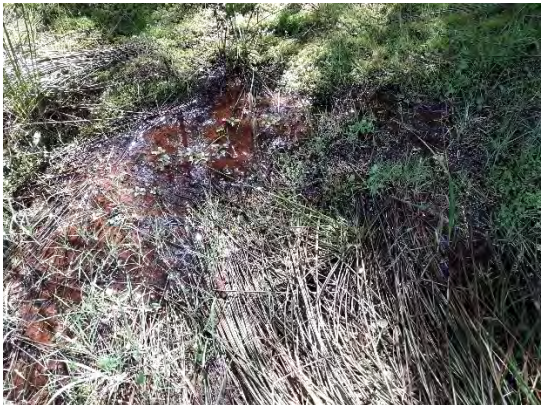
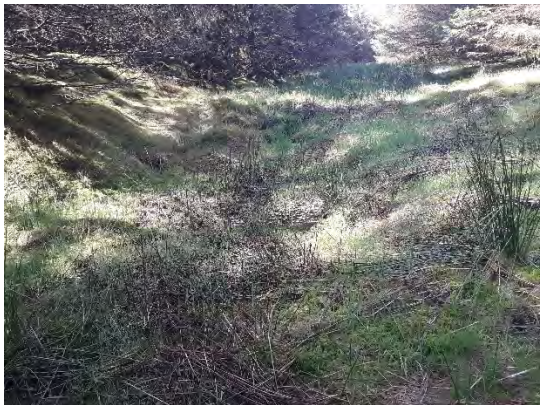
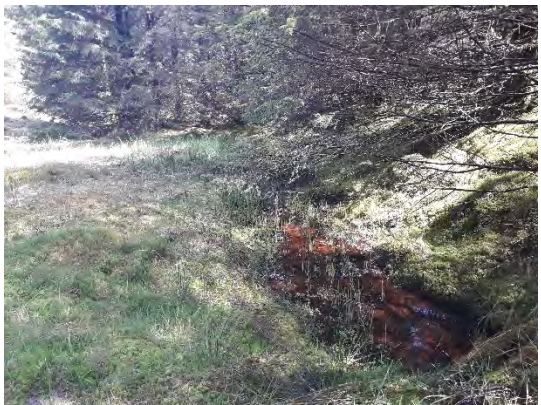
Watercourse Crossing Details	Photograph of New Watercourse Crossing Point	Photograph Looking Upstream of Watercourse Crossing	Photograph Looking Downstream of Watercourse Crossing
Watercourse Crossing: WX12 Status: New NGR: NS 66745 04766 Watercourse Width: 0.9 m Watercourse Depth: 0.05 m Notes: Minor watercourse with long grasses and reeds. It is noted the water is very shallow over a broad area and the water was observed to be silty.

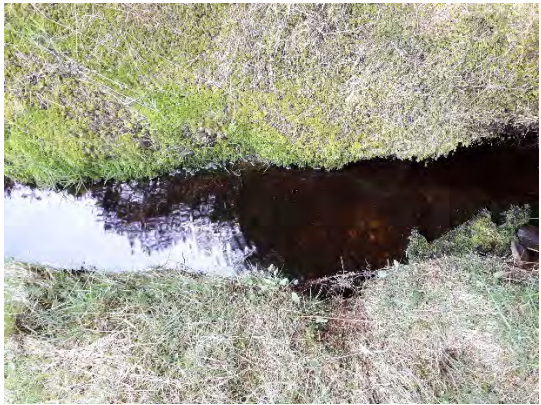
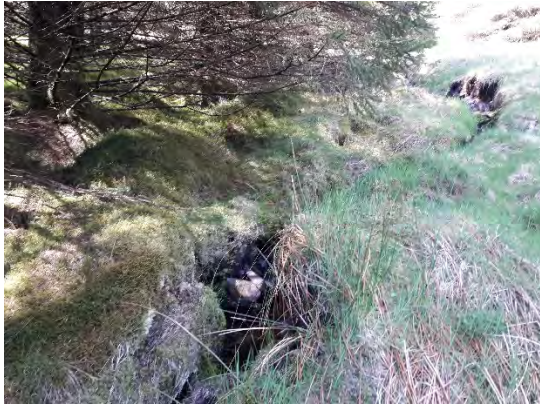
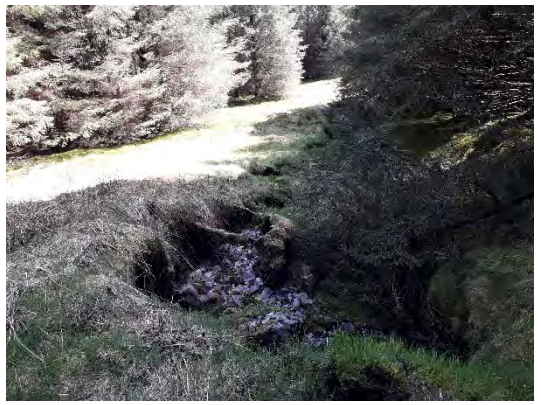
Watercourse Crossing: WX13 Status: New NGR: NS 66695 04671 Watercourse Width: 0.3 m Watercourse Depth: 0.1 m Notes: Minor watercourse within a steeply sloping channel.

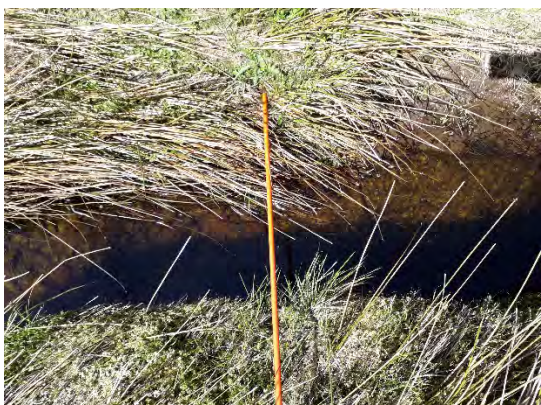
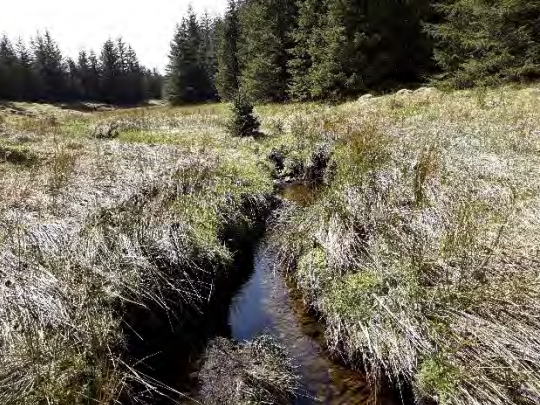
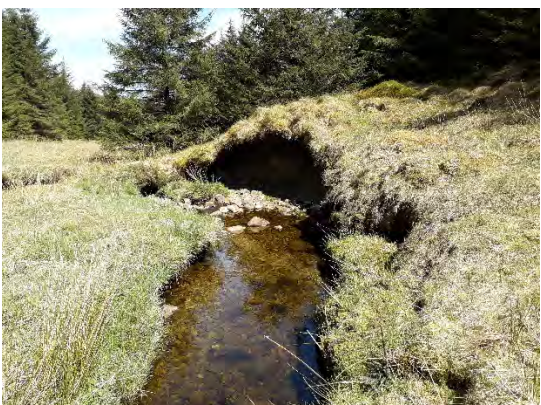
Watercourse Crossing: WX14 Status: New NGR: NS 66664 04488 Watercourse Width: 0.5 m Watercourse Depth: 0.5 m Notes: Minor meandering watercourse with long grasses. It is noted that the watercourse is slightly wider both upstream and downstream of the crossing.

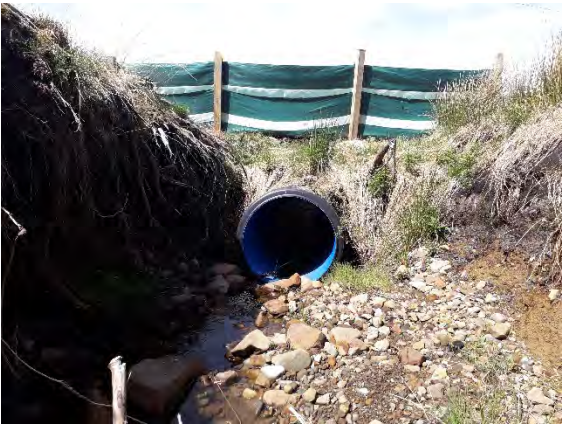
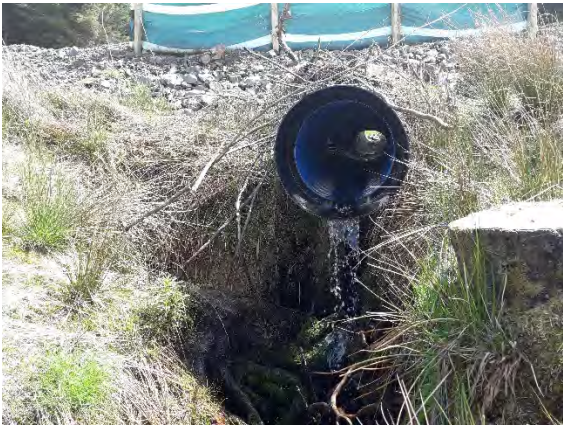
Watercourse Crossing Details	Photograph of New Watercourse Crossing Point	Photograph Looking Upstream of Watercourse Crossing	Photograph Looking Downstream of Watercourse Crossing
Watercourse Crossing: WX16 Status: Existing NGR: NS 66973 04053 Watercourse Width: 0.5 m Watercourse Depth: 0.2 m Notes: Existing plastic circular culvert to approximately 0.6 m in diameter. Silt fences are located on either side of the crossing.	Existing

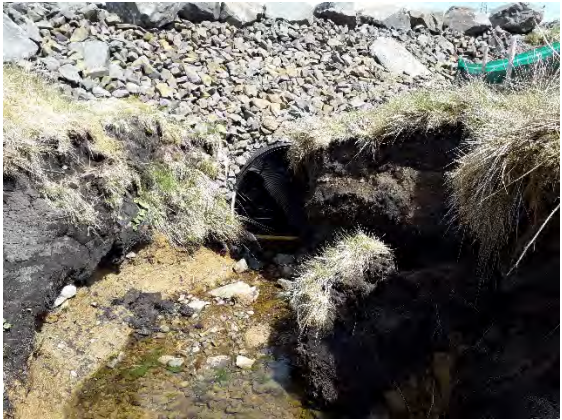
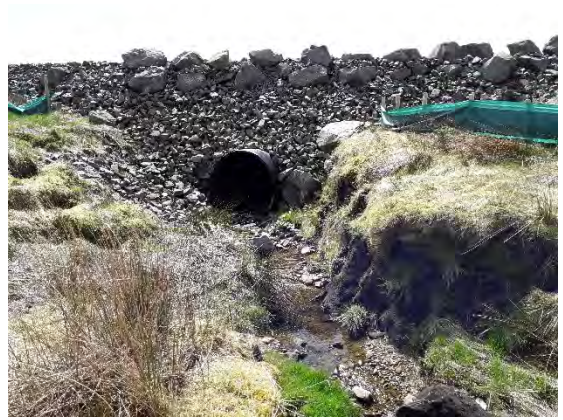
Watercourse Crossing: WX17 Status: Existing NGR: NS 66423 03721 Watercourse Width: 1.2 m Watercourse Depth: 0.2 m Notes: Large existing plastic circular culvert approximately 1.2 m in diameter. Evidence of some boulder migration into the culvert itself but a steady low flow was still observed. Silt traps are located on either side of the crossing location.	Existing

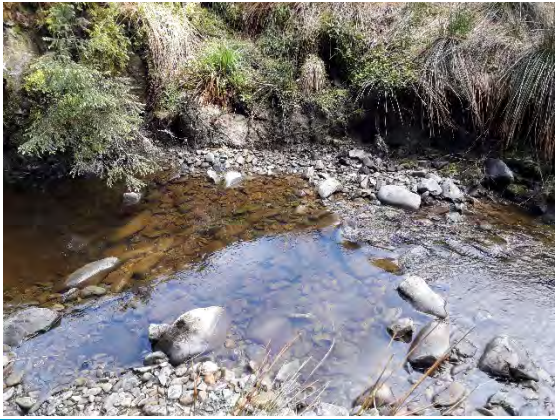
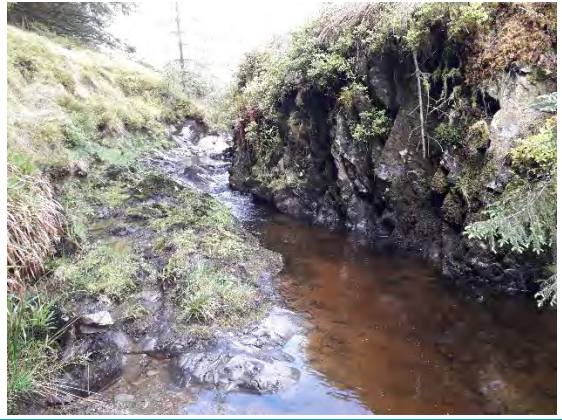
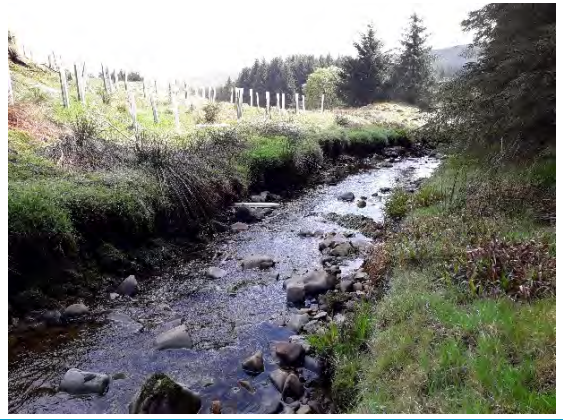
Watercourse Crossing: WX18 Status: New NGR: NS 68266 02107 Watercourse Width: 1.5 m Watercourse Depth: 0.2 m Notes: Watercourse in a channel that extends to approximately 1 m high and 2 m wide. A small gorge feature is located on the eastern slope of the channel where the watercourse is confined to approximately 0.9 m wide.

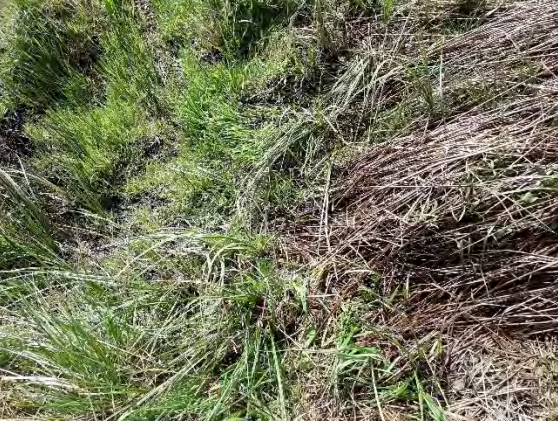
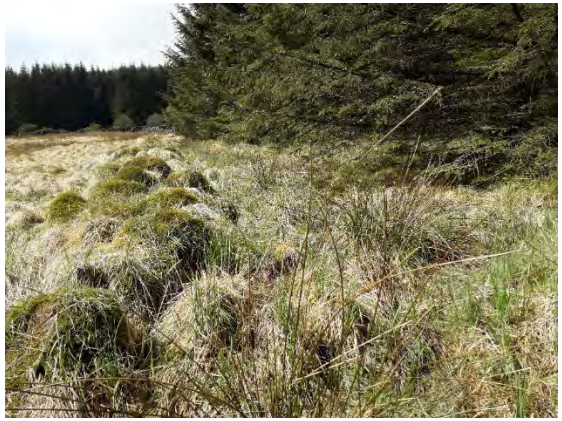
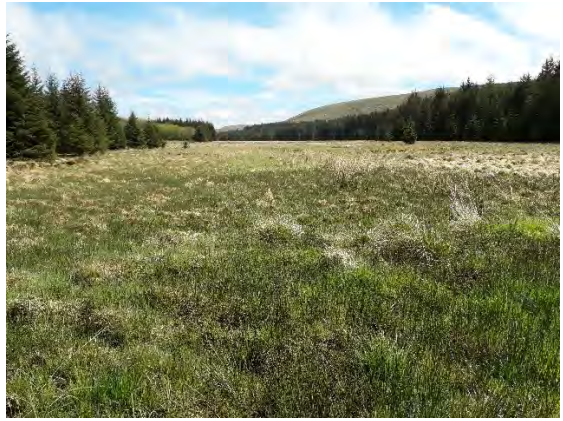
Watercourse Crossing: WX19 Status: New NGR: NS 68510 02157 Watercourse Width: N/A Watercourse Depth: N/A Notes: No defined watercourse found at the crossing location. The area comprised of soft waterlogged ground with reeds and long grasses.

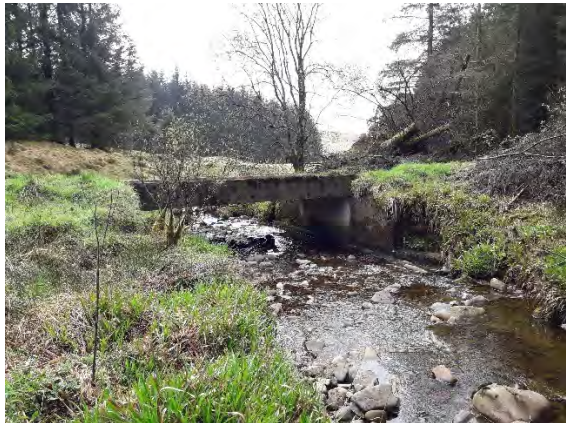
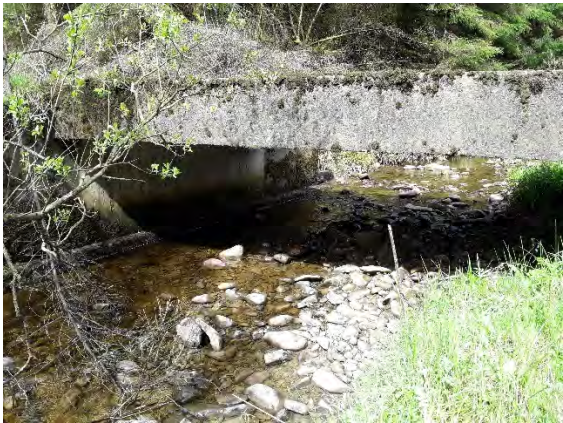
Watercourse Crossing Details	Photograph of New Watercourse Crossing Point	Photograph Looking Upstream of Watercourse Crossing	Photograph Looking Downstream of Watercourse Crossing
<p>Watercourse Crossing: WX20</p> <p>Status: Existing</p> <p>NGR: NS 68429 01887</p> <p>Watercourse Width: 3 m</p> <p>Watercourse Depth: 0.3 m</p> <p>Notes: Large bottomless single span bridge which has a span of approximately 4 m and is 1 m high. Evidence of boulders within the channel and surface water ponding was observed on the top of the bridge.</p>	Existing

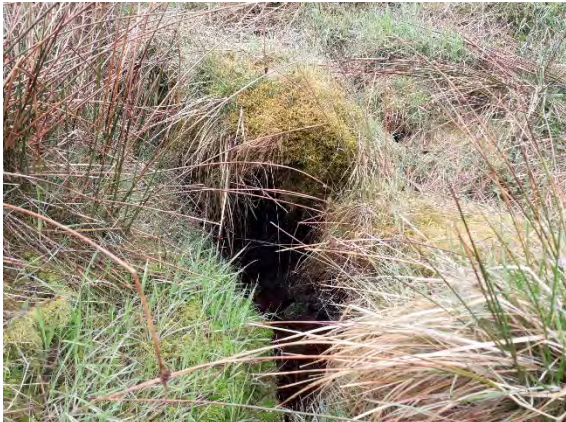
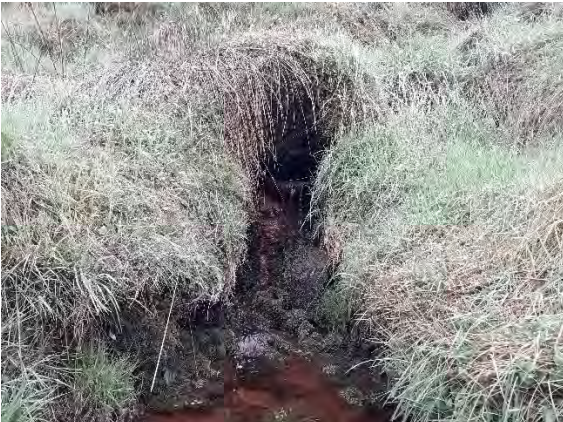
<p>Watercourse Crossing: WX21</p> <p>Status: Existing</p> <p>NGR: NS 69058 01195</p> <p>Watercourse Width: 0.5 m</p> <p>Watercourse Depth: 0.2 m</p> <p>Notes: Small existing concrete circular culvert approximately 0.4 m in diameter. It is noted that the culvert is slightly blocked by vegetation and there is evidence of some sediment deposition immediately downstream of the culvert.</p>	Existing

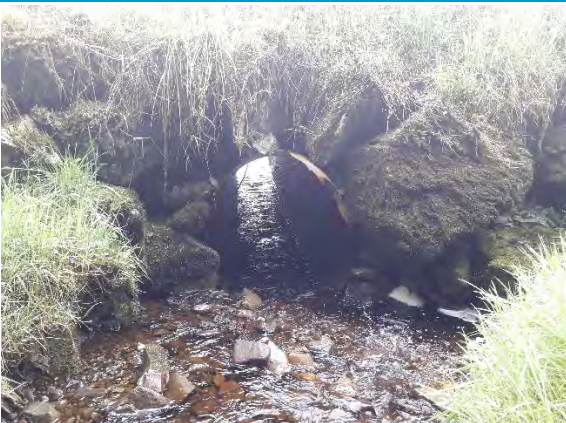
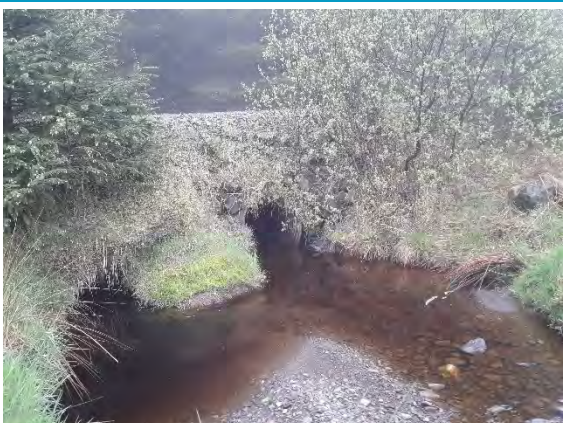
<p>Watercourse Crossing: WX22</p> <p>Status: Existing</p> <p>NGR: NX 69919 99940</p> <p>Watercourse Width: 1.2 m</p> <p>Watercourse Depth: 0.2 m</p> <p>Notes: Large existing steel circular culvert approximately 0.8 m in diameter. A small amount of water flow observed in the culvert. It is noted that a second culvert which has been blocked off is located adjacent to the existing crossing.</p>	Existing

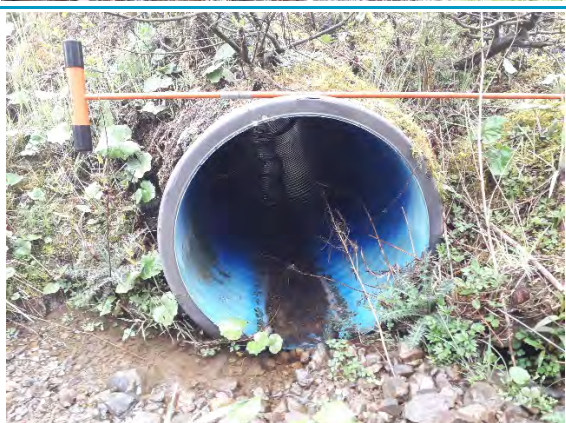
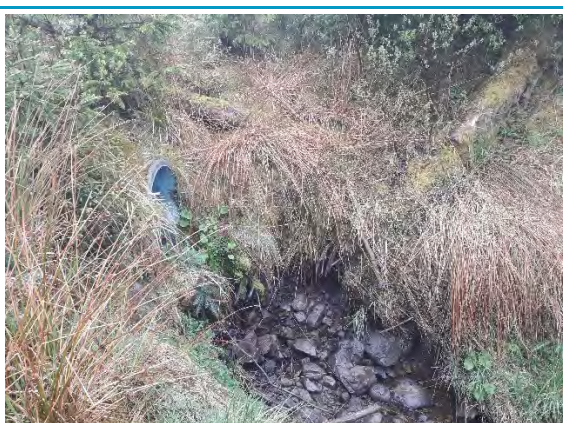
<p>Watercourse Crossing: WX23</p> <p>Status: Existing</p> <p>NGR: NX 69624 99441</p> <p>Watercourse Width: 0.5 m</p> <p>Watercourse Depth: 0.1 m</p> <p>Notes: Small existing plastic circular culvert approximately 0.4 m in diameter. Only a small amount of water observed in the culvert.</p>	Existing

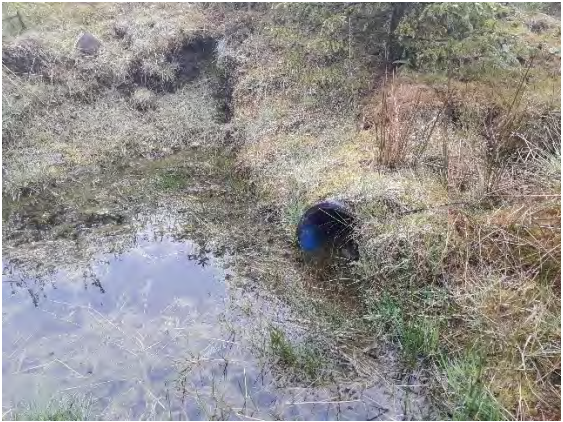
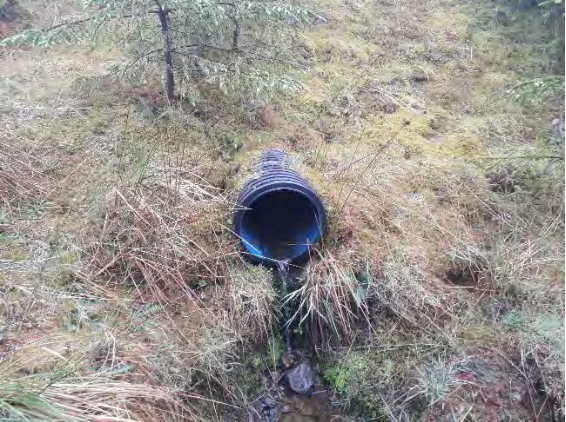
Watercourse Crossing Details	Photograph of New Watercourse Crossing Point	Photograph Looking Upstream of Watercourse Crossing	Photograph Looking Downstream of Watercourse Crossing
Watercourse Crossing: WX24 Status: Existing NGR: NX 69474 99300 Watercourse Width: 0.6 m Watercourse Depth: 0.2 m Notes: Small existing plastic circular culvert approximately 0.2 m in diameter. Area of ponding noted both upstream and downstream of the culvert.	Existing

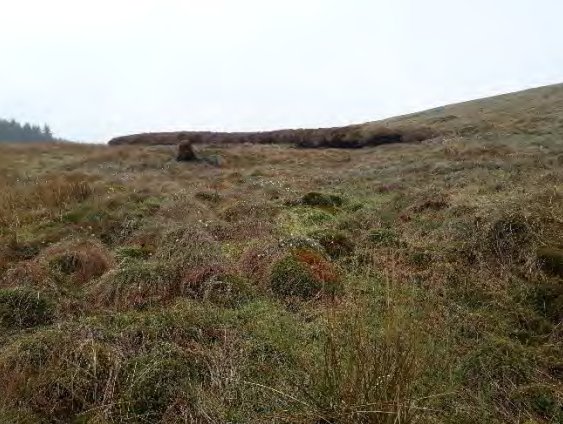
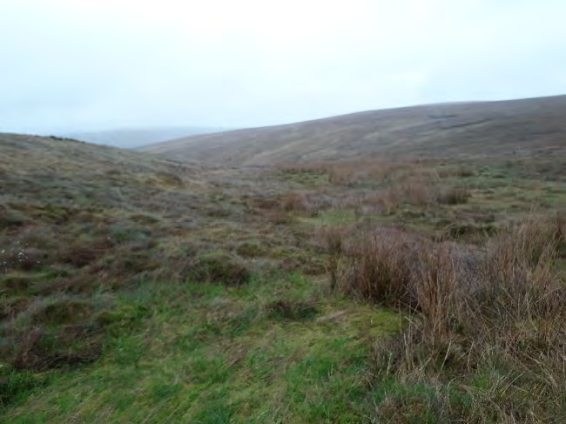
Watercourse Crossing: WX25 Status: New NGR: NS 66713 05527 Watercourse Width: N/A Watercourse Depth: N/A Notes: No defined watercourse found at the crossing location. The area comprised of soft waterlogged ground with reeds and mosses.	N/A

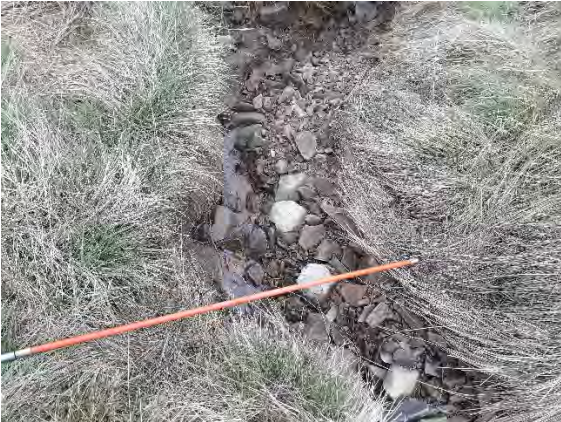
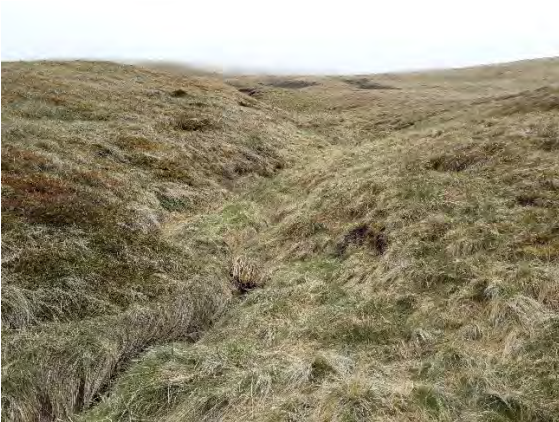
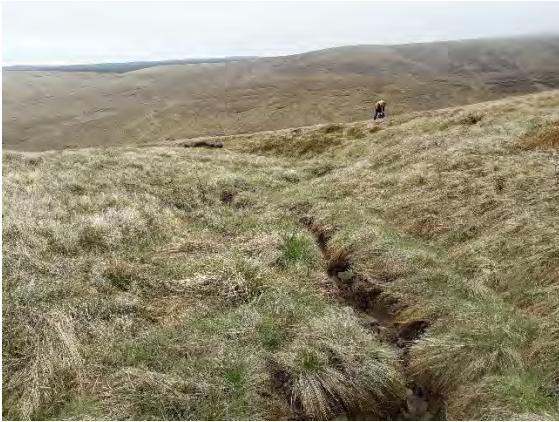
Watercourse Crossing: WX31 Status: New NGR: NS 65299 06284 Watercourse Width: 0.4 m Watercourse Depth: 0.2 m Notes: Minor watercourse with very low flow and evidence of pebbles and cobbles within the active channel. The broader channel comprises of long grasses and extends to approximately 0.5 m wide and 1 m high.

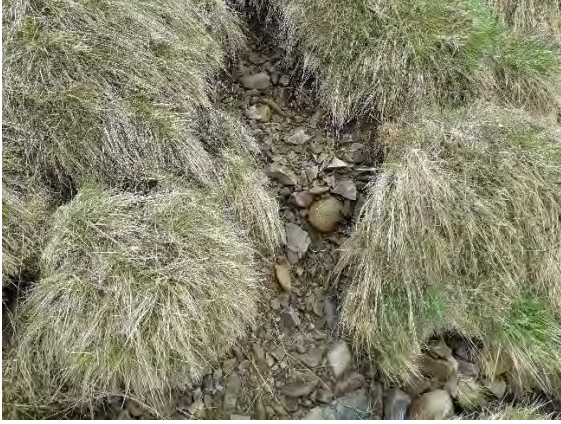
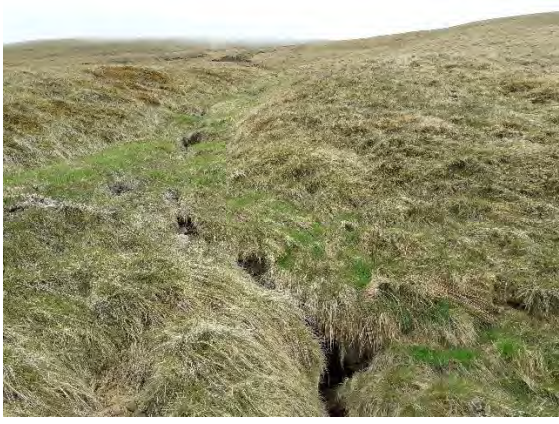
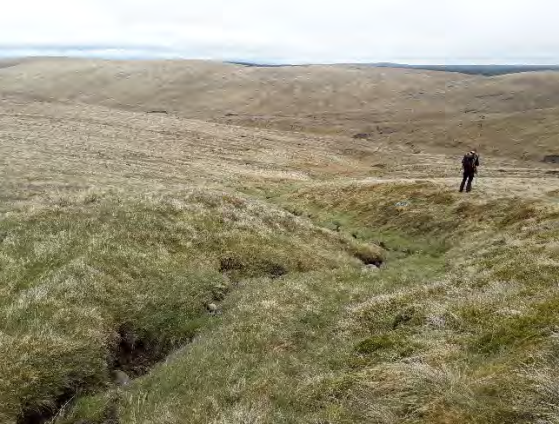
Watercourse Crossing: WX32 Status: New NGR: NS 65320 06365 Watercourse Width: 0.3 m Watercourse Depth: 0.5 m Notes: Minor watercourse which was noted dry during the site visit. Evidence of pebbles and cobbles within the channel which extends to approximately 0.3 m high and 1.5 m wide.

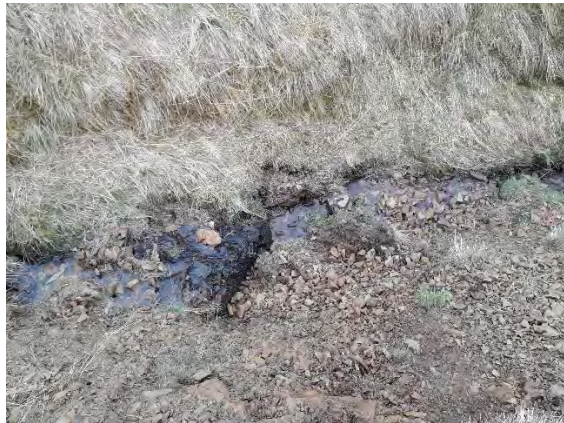
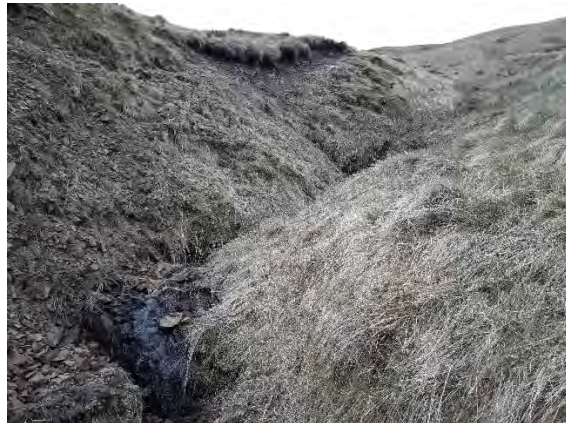
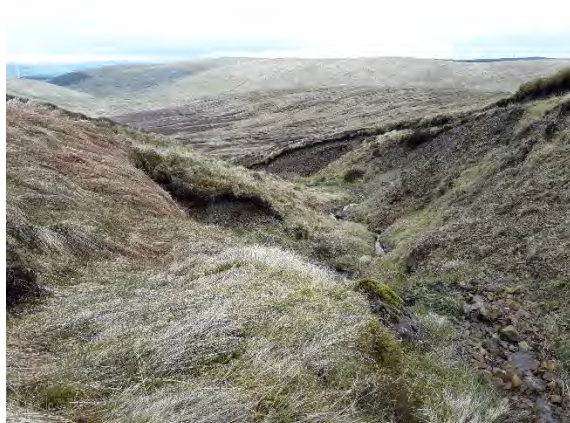
Watercourse Crossing Details	Photograph of New Watercourse Crossing Point	Photograph Looking Upstream of Watercourse Crossing	Photograph Looking Downstream of Watercourse Crossing
<p>Watercourse Crossing: WX34 Status: New NGR: NS 65355 06938 Watercourse Width: 0.2 m Watercourse Depth: 0.1 m Notes: Minor watercourse with low flow which is located in a steep sided channel comprising weathered bedrock and peat. The channel is approximately 2 m wide and 2.5 m high.</p>

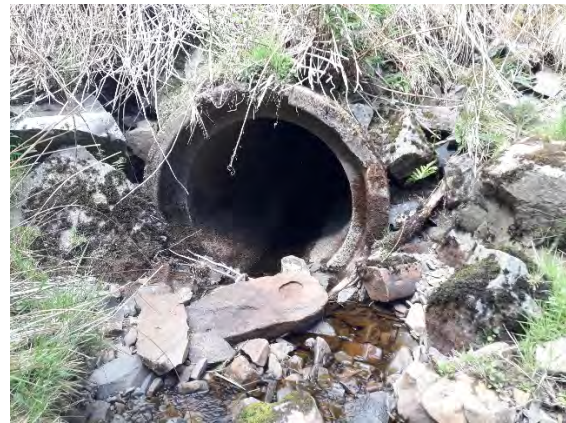
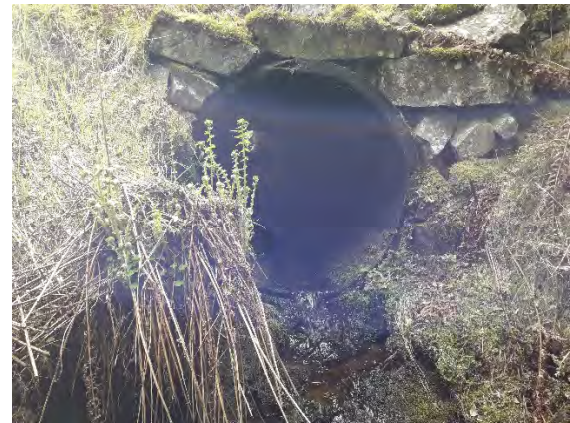
<p>Watercourse Crossing: WX35 Status: Existing NGR: NS 67938 11589 Watercourse Width: 1 m Watercourse Depth: 0.2 m Notes: Large existing circular culvert approximately 1.2 m in diameter. Only a small amount of water with low flow observed in the culvert.</p>	Existing

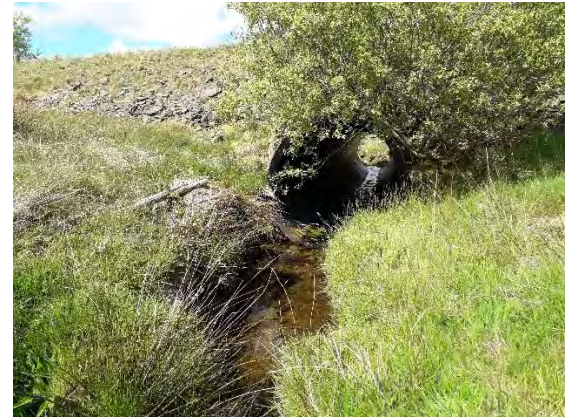
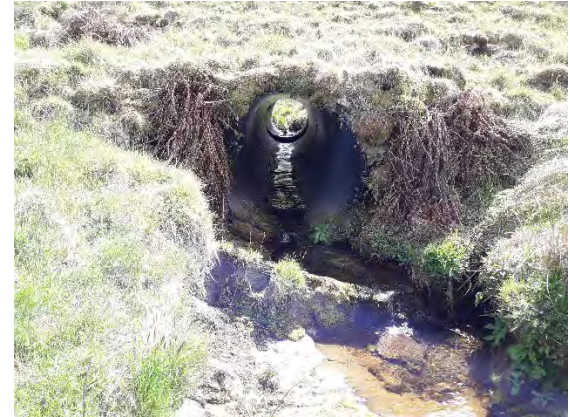
<p>Watercourse Crossing: WX36 Status: Existing NGR: NS 67220 12392 Watercourse Width: 1.2 m Watercourse Depth: 0.2 m Notes: Large existing plastic circular culvert approximately 1.4 m in diameter. Only a small amount of water with low flow observed in the culvert.</p>	Existing

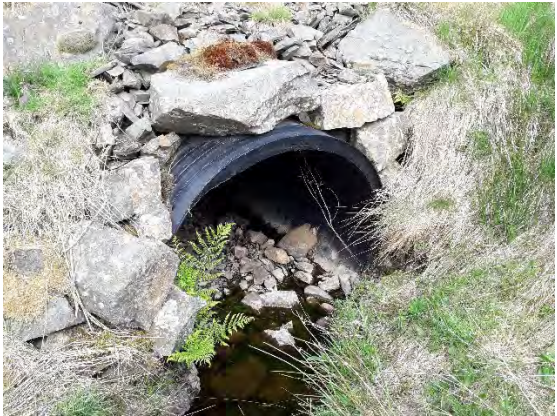
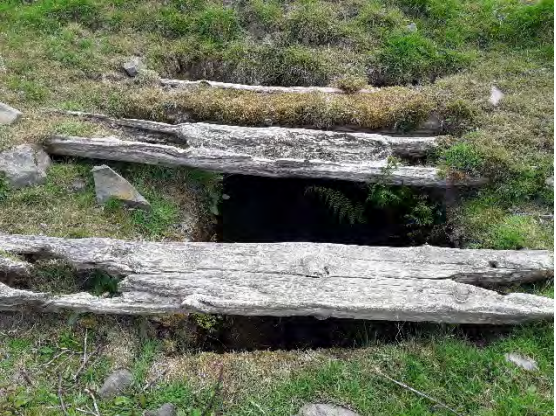
Watercourse Crossing Details	Photograph of New Watercourse Crossing Point	Photograph Looking Upstream of Watercourse Crossing	Photograph Looking Downstream of Watercourse Crossing
<p>Watercourse Crossing: WX38 Status: Existing NGR: NS 67075 12443 Watercourse Width: N/A Watercourse Depth: N/A Notes: Large existing plastic circular culvert which is approximately 0.9 m in diameter. Stagnant water was observed with no flow through the culvert. Immediately downstream of the crossing, the watercourse is culverted again underneath the field to the north. This culvert was noted as an open bottom plastic pipe and no flowing water was observed.</p>	Existing

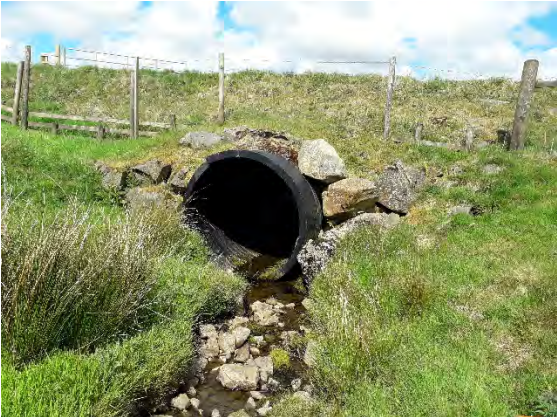
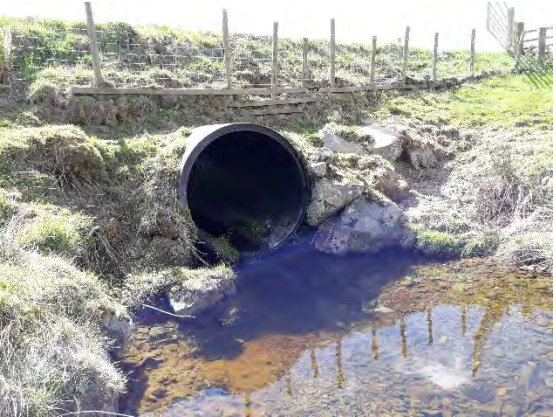
<p>Watercourse Crossing: WX39 Status: Existing NGR: NS 66904 12517 Watercourse Width: 1 m Watercourse Depth: 0.2 m Notes: Large existing plastic culvert which is approximately 1.2 m in diameter. Only a small amount of water with low flow observed in the culvert. The watercourse downstream of the culvert extends laterally into a small pool which is approximately 2.5 m wide.</p>	Existing

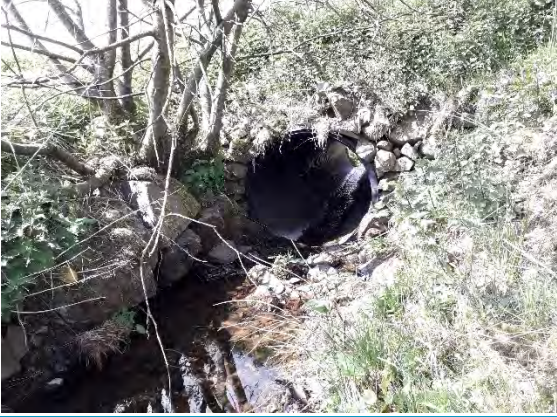
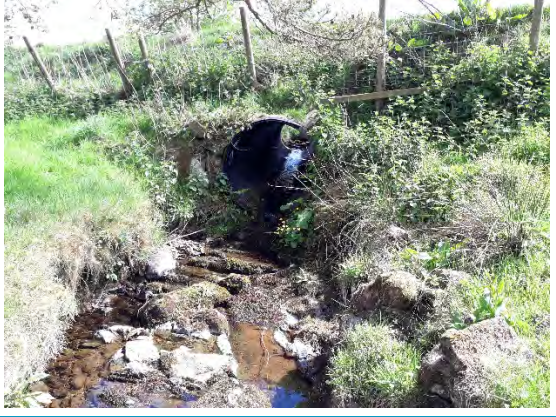
<p>Watercourse Crossing: WX40 Status: Existing NGR: NS 66589 12575 Watercourse Width: 1.2 m Watercourse Depth: 0.2 m Notes: Large existing plastic culvert approximately 0.9 m in diameter. Only a small amount of water with low flow was observed in the culvert itself.</p>	Existing

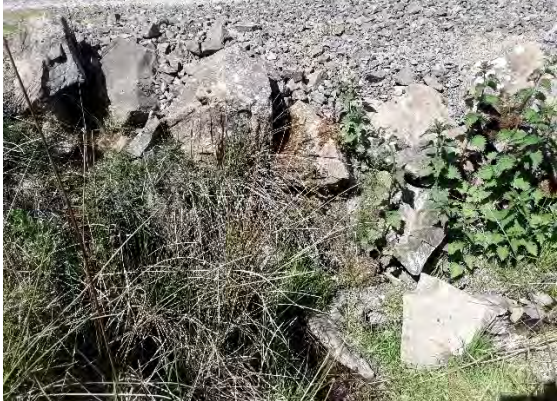
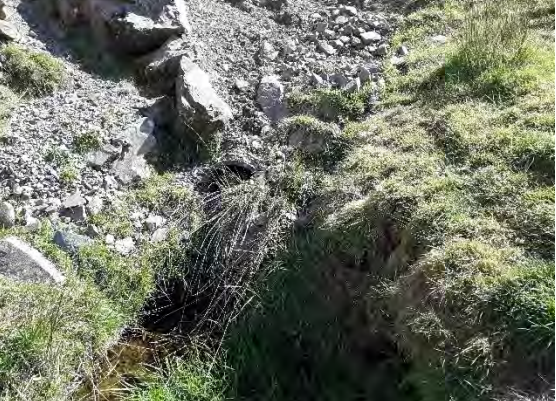
<p>Watercourse Crossing: WX41 Status: Existing NGR: NS 66351 12778 Watercourse Width: N/A Watercourse Depth: N/A Notes: Small existing plastic circular culvert approximately 0.2 m in diameter. The culvert was noted as partially blocked on the upstream side with vegetation and small boulders. Stagnant water was noted on the downstream end of the culvert. No flowing water was observed.</p>	Existing

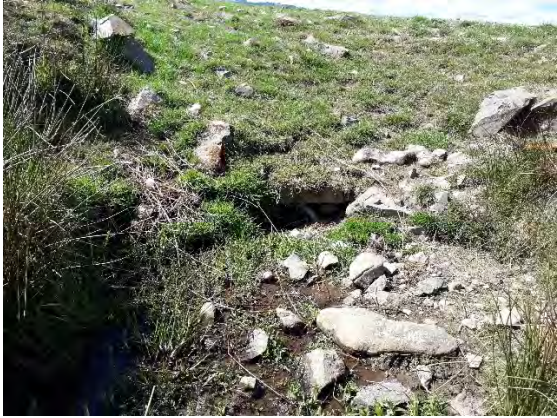
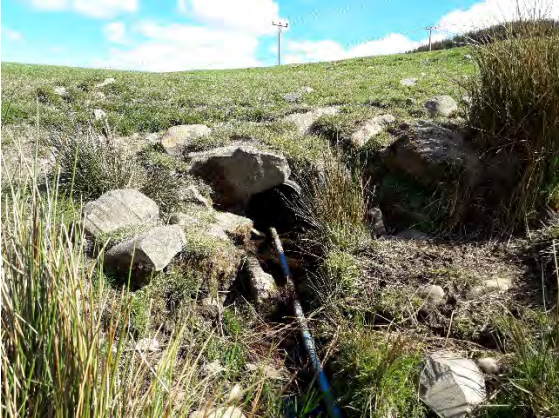
Watercourse Crossing Details	Photograph of New Watercourse Crossing Point	Photograph Looking Upstream of Watercourse Crossing	Photograph Looking Downstream of Watercourse Crossing
<p>Watercourse Crossing: WX42 Status: Existing NGR: NS 66131 12870 Watercourse Width: 0.2 m Watercourse Depth: 0.1 m Notes: Small existing concrete circular culvert which is approximately 0.2 m in diameter. The culvert was noted as half buried on the upstream end and a smaller pipe is also located through the centre of the culvert.</p>	Existing

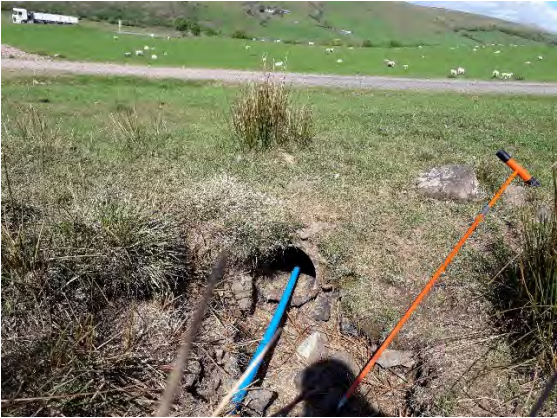
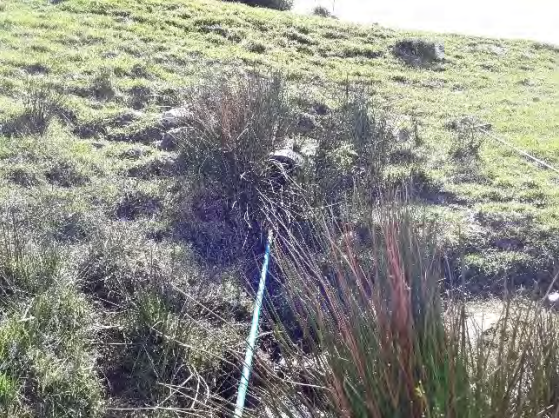
<p>Watercourse Crossing: WX43 Status: Existing NGR: NS 66050 12904 Watercourse Width: N/A Watercourse Depth: N/A Notes: Watercourse was noted dry during site visit. The crossing consists of an existing concrete circular culvert which is approximately 0.2 m in diameter with a smaller pipe running through the centre of the culvert.</p>	Existing
