Annex B. Detailed Assessment Datasheet Descriptions

Harestanes South Windfarm Extension Project Team

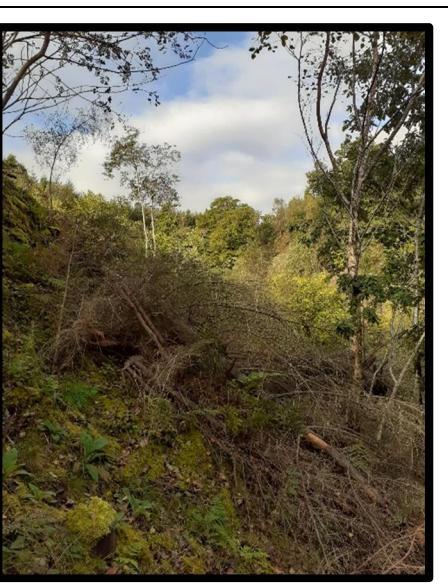
The factor of safety values for peat probes ranged from 0.83 to 15.80, with the closest Initial Moderate Risk cell to planned infrastructure recording a factor of safety value of 0.97, based on an indicative peat depth of 0.99m and mean slope angle of 25 degrees. It is likely that shallower peat is present than the 0.99m estimated value, however, as mentioned above, this area was not safely accessible. If applying a shear strength value of 4KN/m², as literature lower-bound value, to this FoS grid cell, the revised FoS outcome would be 1.07. If applying the lowest shallow hand shear vane outcome from Site investigations (6kN/m²), the cell FoS value would be revised further to 1.61.

Photograph 6.11: View west along the steep banks of Tor Linn, from NGR: 303506, 590792 Photograph taken at approximately 175mAOD, looking along the upper break of slope. Also see **Photographs 6.1** and **6.9**, in the Site Reconnaissance section.

The grid cells closer to the Scheduled Monument retain Extremely High consequence status, however, as this feature is located above the Black Linn / Tor Linn valley on the opposite side to the track upgrade it will not be influenced by construction activities. Although this general area is identified by GeoSure as Class C, it does not exhibit typical peatland characteristics or any evidence of peat instability including from previous track construction, with non-peat soil cover predominant.

Taking account of the peatland morphology, individual peat probe FoS, design and mitigation (including micrositing to avoid deeper peat), peat-related instability is reduced to Unlikely and the Revised Risk reduced to Low. This area remains highlighted for ongoing slope instability risk, rather than peat instability risk.

Section 1.8 lists standard mitigation measures. Additional peat depth surveys shall enable a better understanding of the area to reduce the risk of any small-scale peat instability. This area is not considered at risk of mass peat instability as non-peaty soils are predominant, however, there is potential risk of non-peat instability and should be recorded in the Geotechnical Risk Register. Care should be taken to avoid increasing loading of slope to the north of the track upgrade, with slope support to be maintained for slopes to the south of the upgrade. Slope monitoring should be instigated preconstruction to both sides of this track section and additional slope management measures considered, which may lead to a requirement for slope support or erosion protection, such as use of gabion terraces/mattresses or other measures. Track drainage should avoid converging large or high velocity flows onto slopes to north in order to avoid scour and/or bank collapse.

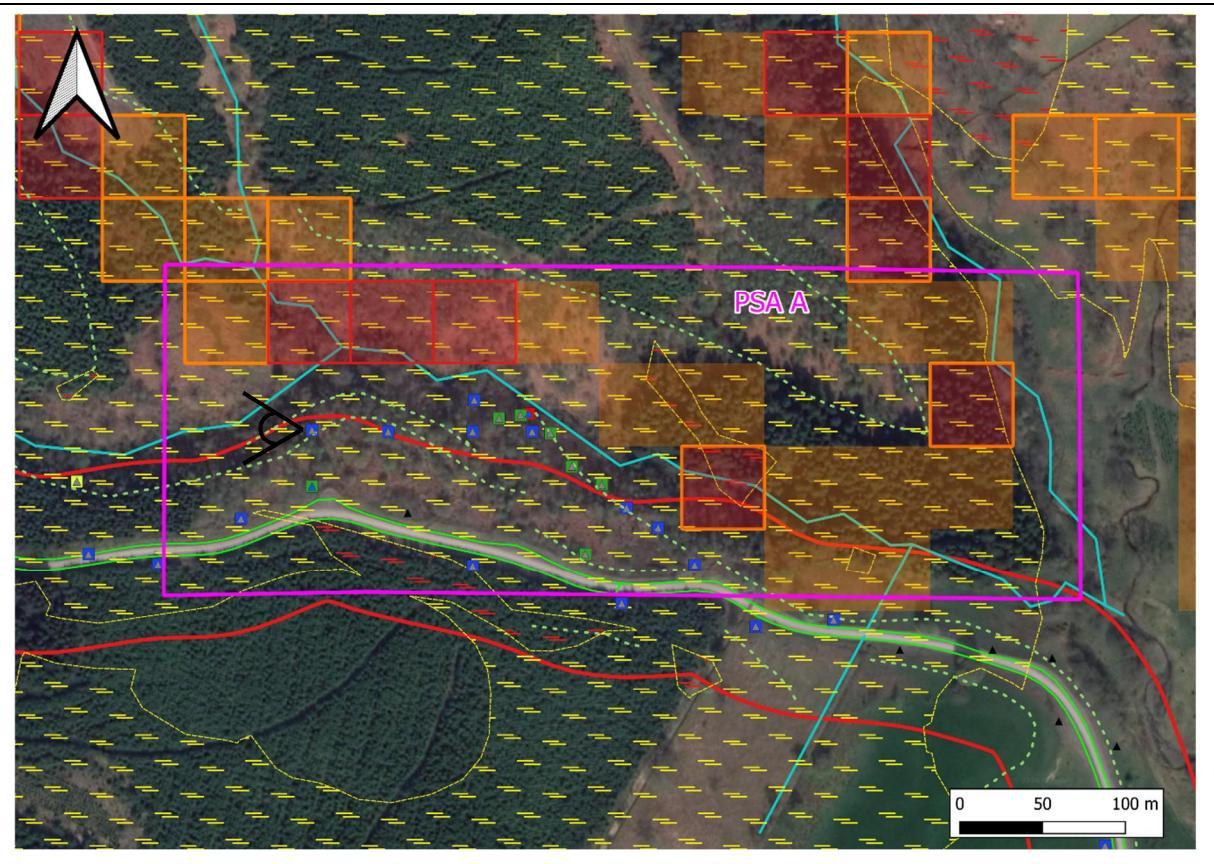
Illustration 6.5: Aerial Image of PSA Area A

This area is primarily identified due to the steeply sloping incised valley of the Tor Linn on the south eastern slope of Pumro Fell. Wallace's House Scheduled Monument is located in the north west of PSA Area A, north of the confluence of the Black Linn and Tor Linn channels, with grid cells within 100m evaluated with 'Extremely High' consequence outcomes. Aerial imagery shows this area as afforested with no evidence of instability. PSA Area A images with OS background and DTM data are also provided in Annex C. BGS GeoSure mapping has identified this general area as Class C where '*slope instability problems may be present or anticipated*', with a small area on the lower slopes of the Torr Linn valley classified as Class D where '*slope instability problems are probably present or have occurred in the past. Land use should consider specifically the stability of the site*'.

Peat depths in PSA Area A are typically less than 0.5m, with some isolated results of up to 0.70m and a mean probing depth of 0.25m for PSA Area A. Peat depths were generally non-peat or shallow peat within 100m of planned infrastructure. Limited additional probing was collected within the Initial High and Moderate Risk cells due to survey safety concerns in relation to steep slopes combined with unstable fallen trees, with a further limitation applied to avoid potential probing damage to Wallace's House Scheduled Monument. Slope gradients are generally steeper in the area north of the planned track upgrade, with two distinct breaks of slope below the existing track noted, where slope angles ranging up to 47 degrees. Local slope angles are increased by the bankings immediately to the north of the existing track, presumably using material excavated during the original track construction (see **Photograph 6.9** in Site Reconnaissance section). From observation, this material appeared to be a mix of peaty soil, mineral soil and boulder clay, with no obvious bank instability. A peat core was initially planned to the north of the existing track, however due to locally shallow depths and visual evidence of non-peaty

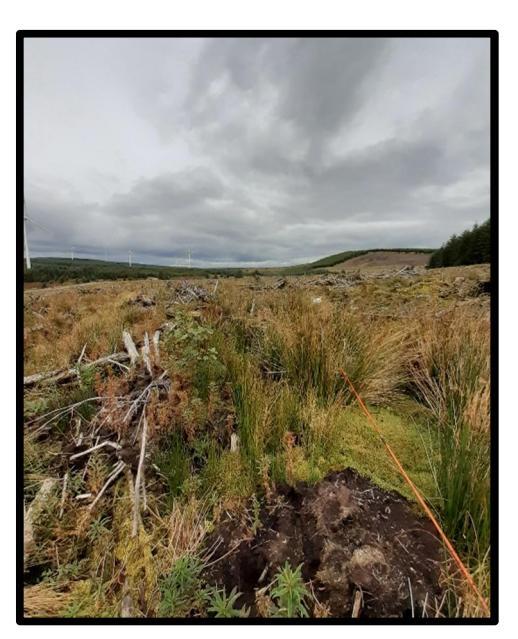
Photograph 6.12: Looking north from PSA Area B at NGR 302172, 593616.

Photograph taken at approximately 320mAOD, looking north toward existing track planned for upgrade. This photo shows the deep peat pocket on level ground to the east and the incised valley of the Glenkiln Burn to the west, as well as the existing track embankment. Also see **Illustration 6.1** and **Photographs 6.3**, **6.4** and **6.10**, in Sections 1.2 and 1.3.

The existing track planned for upgrade retains 'High' consequence status. An isolated pocket of deep peat has been identified at the PC03 location, however, no peat instability evidence was observed at this location or identified on GeoSure data. The steep gradients and breaks of slope relating to the Glenkiln Burn are within the west of PSA Area B and identified as GeoSure Class C, however, all planned infrastructure avoids these fluvial erosion features. Taking account of the peatland morphology, existing drainage network, *in situ* retained tree roots, individual peat probe FoS, design and mitigation (including micrositing to avoid deeper peat), the Likelihood is reduced to Unlikely and the Revised Risk reduced to Low.

Section 1.8 lists standard mitigation measures. Additional peat data would be recommended, with peat characteristics recorded and micrositing considered to minimise peat disturbance. The upgrade of the existing track will require care to avoid removal of slope support to east or increased loading of slope to west. Slope monitoring should be undertaken of slopes close to the Initial Moderate Risk cell, which may lead to a requirement for slope support or erosion protection, such as use of gabion terraces/mattresses or other measures. Track drainage design should avoid converging flows into areas potentially prone to failure, such as the area adjacent to the Glenkiln Burn where active erosion and bank failure is evident. Blasting at BP01 to consider peat stability. This location should be recorded in the Geotechnical Risk Register. Although considered unlikely, should peatslide occur; approximated width 20m, length 20m, volume of peat 600m³; receptors being local hillside and/or access track.

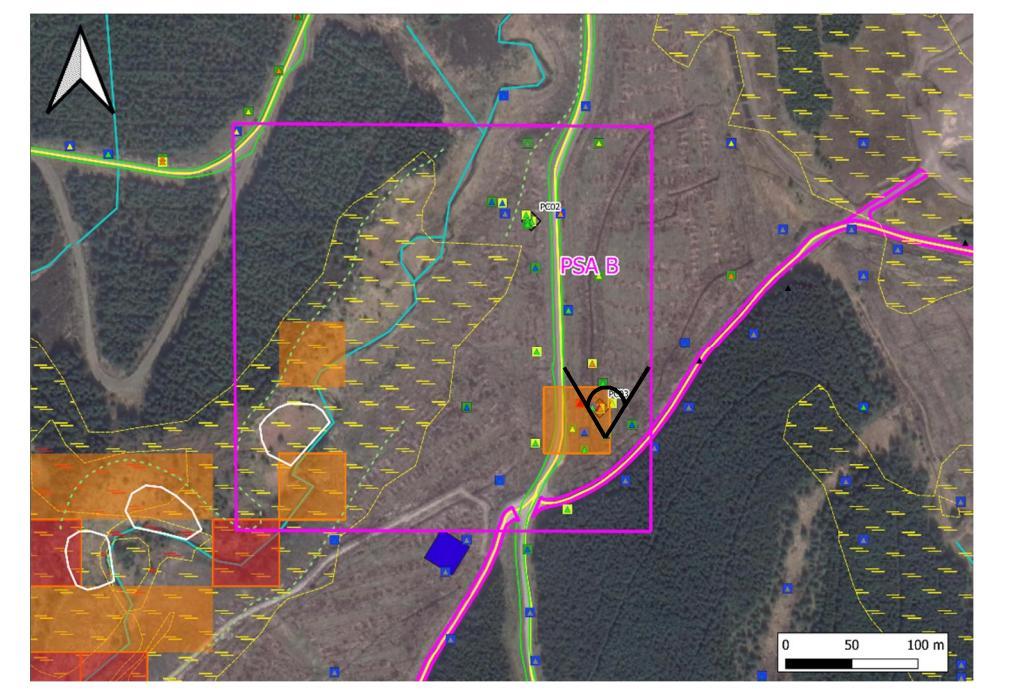
Illustration 6.6: Aerial Image of PSA Area B

This area is primarily identified due to deep peat deposits on the lower slopes to the north of Whitefauld Hill, above the existing track. Given the proposed control building within 100m, the consequence value for the Initial Moderate Risk grid cell, with peat core PC03 within, is 'High'. Aerial photography identified slope instability and the site visit verified that this occurs adjacent to the incised watercourse channel on the left back (north of channel), with active channel erosion and unvegetated slopes along this corridor, with more notable breaks of slope to the north. These instability features are not considered as peat-related, with fluvial erosion as the causal factor of local ground failure. BGS GeoSure mapping has identified large parts of the steeply sloping incised valley of the Glenkiln Burn as Class C where '*slope instability problems may be present or anticipated*'. There were no instability signs within the area to the east of the existing track.

This location has been clear-felled, with stumps retained *in situ* and large drainage channels flowing to north. These features have modified the peat body and limited potential for instability by reducing water content and anchoring peat via retained tree roots, also confining the extent of any mass movement. Deep peat of up to 3.0m was recorded on the level ground to the east of the existing track as an isolated deposit with nearby peat depths generally 0.5 to 1.5m, with a mean probe depth of 1.27m for PSA Area B. Further north, peat depths were generally less than 1.0m and non-peat soil was recorded below the break of slope to the west of the existing track, near PC02. At this location, there was exposure evidence of boulder clay / mineral soil underlying shallow surface peat on the Glenkiln Burn left bank (see **Photograph 6.10** in the Site Reconnaissance section). Slope angles are generally less than 7 degrees to the east of the existing track, steepening west of the track to approximately 20 degrees below the break of slope above the incised Glenkiln Burn valley. Local to the track route, slope angles are increased by the embankment sections immediately to the west. This material appeared to be a mix of peaty soil, mineral soil and boulder clay, with no obvious bank instability.

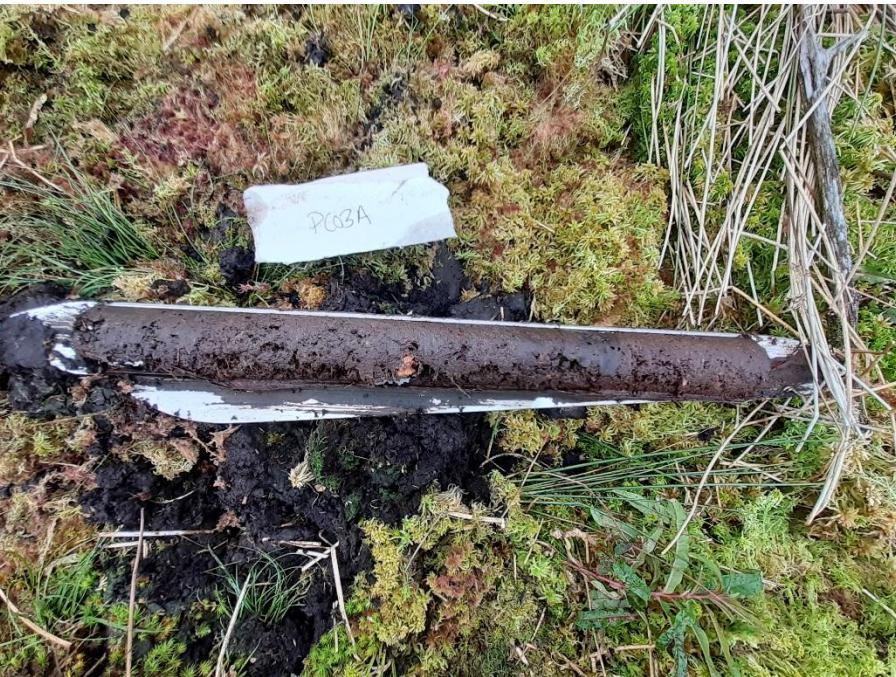
Photograph 6.16: Peat Core PC03a (shallow), NGR 302172, 593616

Peat core location PC03 had 2 cores taken (PC03a and PC03b) at a slope angle of 5 degrees, collected at depths of 1.5m and 3.0m, respectively, each recording Von Post humification class H4; Weakly Decomposed. This data suggests that amorphous catotelmic peat is not generally found at depths less than 3.0m locally. The hand shear vane's lowest recorded value, within a drainage channel at a depth of 1.0m, was 6kN/m². A peat core was also collected at PC02 on a 6 degree embankment slope below the existing track; H5 Von Post and lowest shear vane of 11kN/m².
