Harehill Windfarm Repowering

Appendix 9.6 - Peat Slide Risk Assessment
Stage 2

ScottishPower Renewables

November 2025

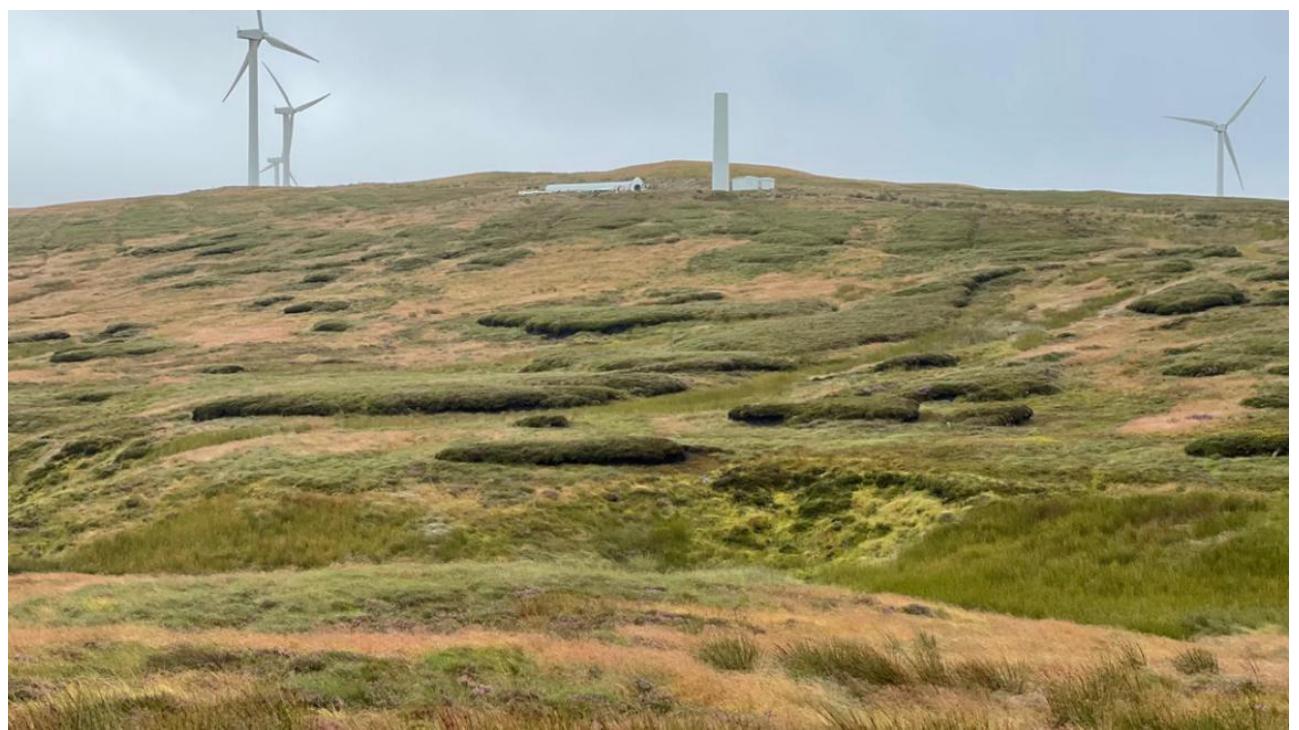
Figure 1.6: Facing south from around T15, peat hags and evidence of instability on the north face

No evidence of cracking, compression features of peat creep was identified during the site walkover. As described and illustrated in Section 1.5, evidence of damaged peat in the form of peat hag collapse were identified on the proposed Development. Although these features are not primarily typically associated with major peat instability, they can increase weathering rates and influence water flow pathways.

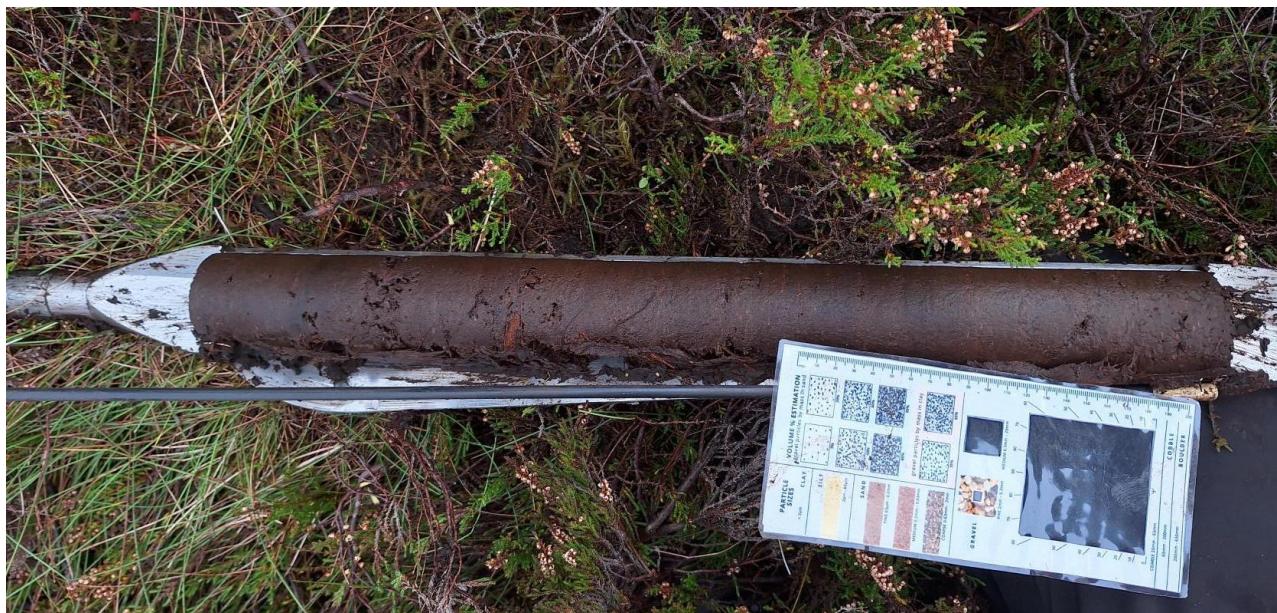
Figure 3.2: Photograph of the peat core from T03 (1.25-1.80 m depth below ground level)

None of the peat areas are considered dry (they range from B2 to B4 Wetness) and have humification levels between H2 and H6.

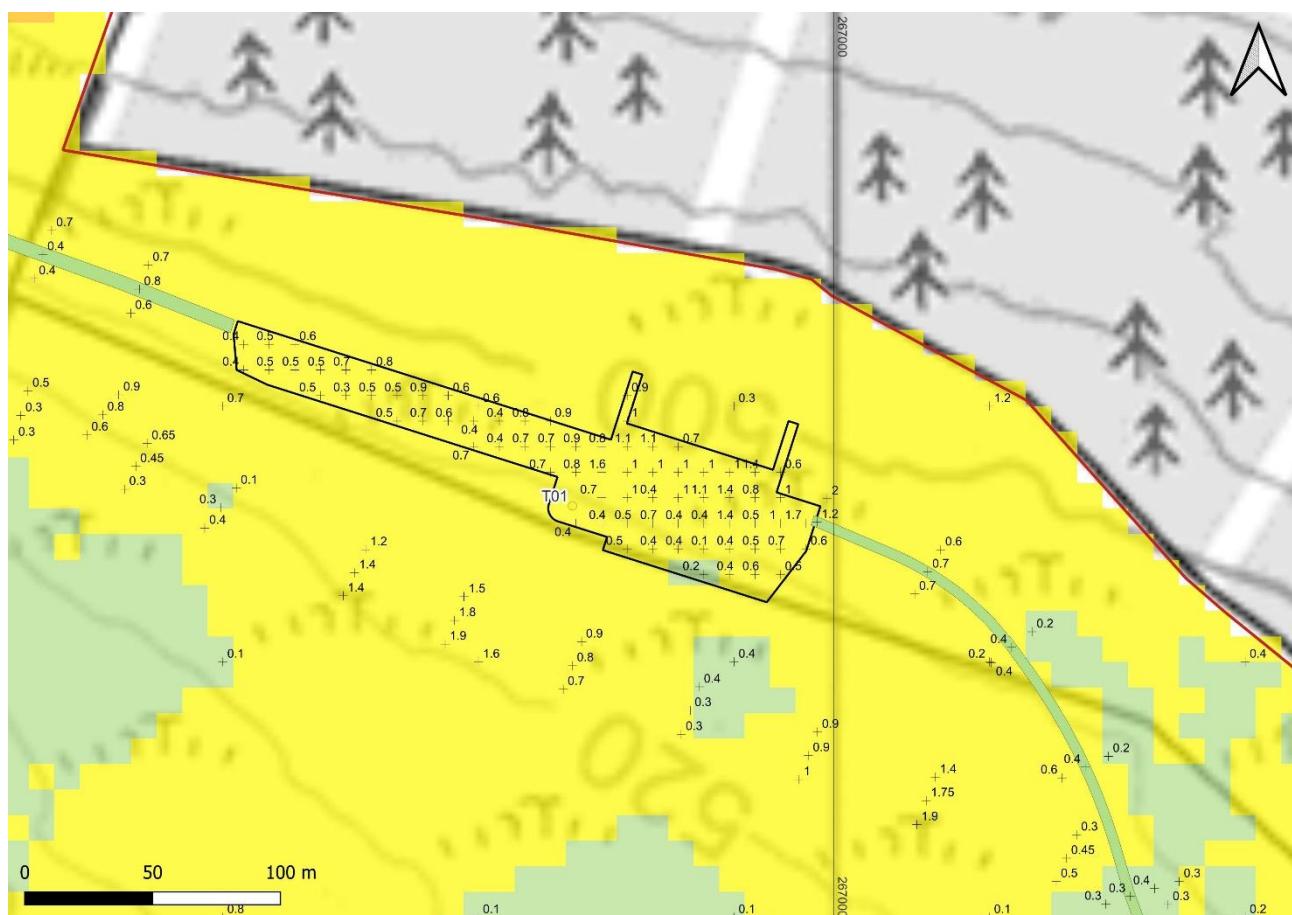
T01 Location – OS Mapping 1:25,000 – 1:1250 Scale

Location	Development Infrastructure	Environmental	Contributory Factors (Probability/Exposure)		Risk Ranking
			FoS	Value	
			Peat cracking / infiltration	1	
			Groundwater Flow	1	
			Hydrology	1	
			Previous Instability	1	
			Land Management	2

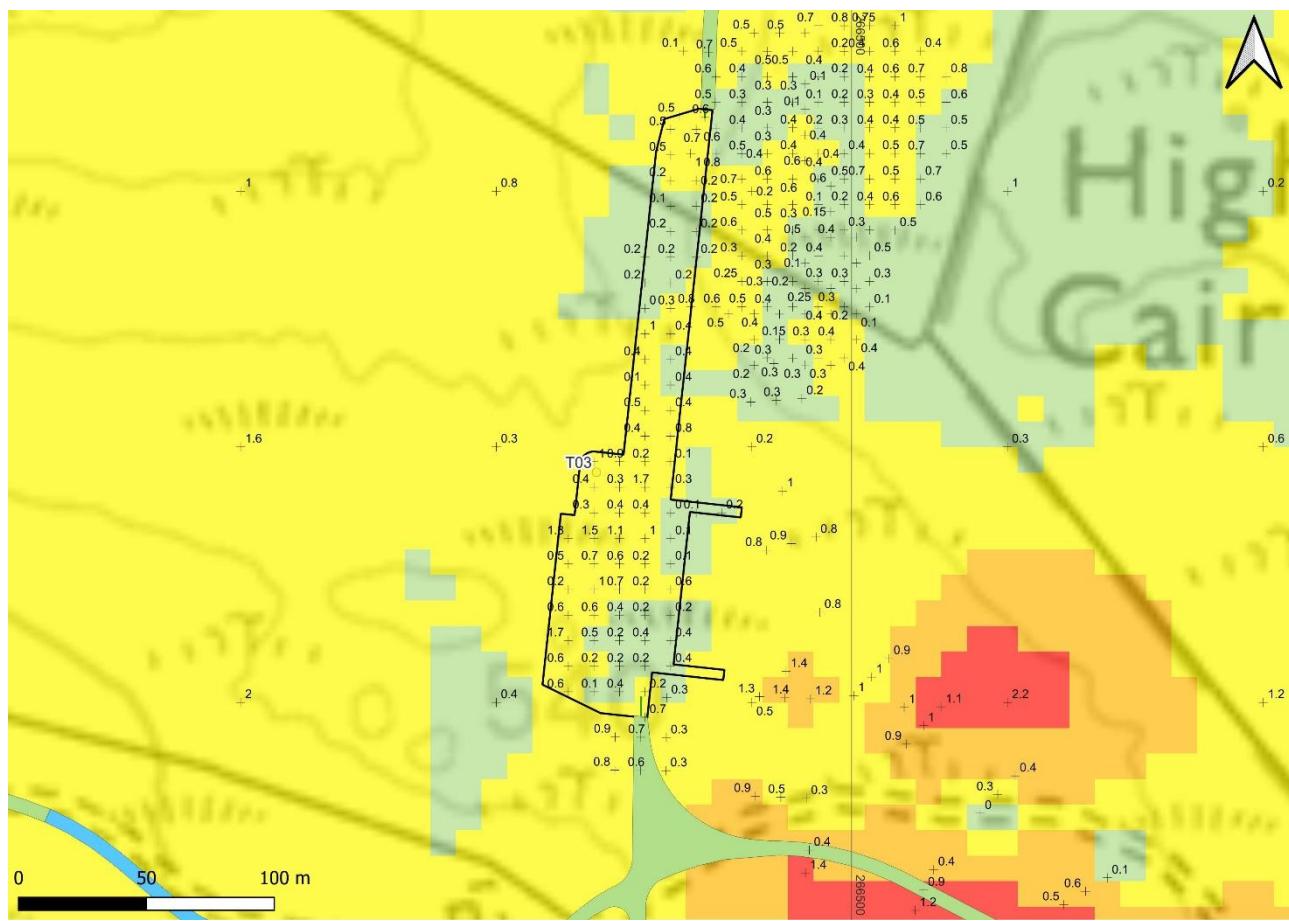
Location	Development Infrastructure	Environmental	Contributory Factors (Probability/Exposure)	Risk Ranking
T03	1	1	Peat Depth (Mean = 0.60m) 3 Slope Angle (6°) 3 FoS 1 Peat cracking / infiltration 1 Groundwater Flow 1 Hydrology 1 Previous Instability 1 Land Management 2	3+3+2 = 8 (Low)

Location Specific Mitigation:

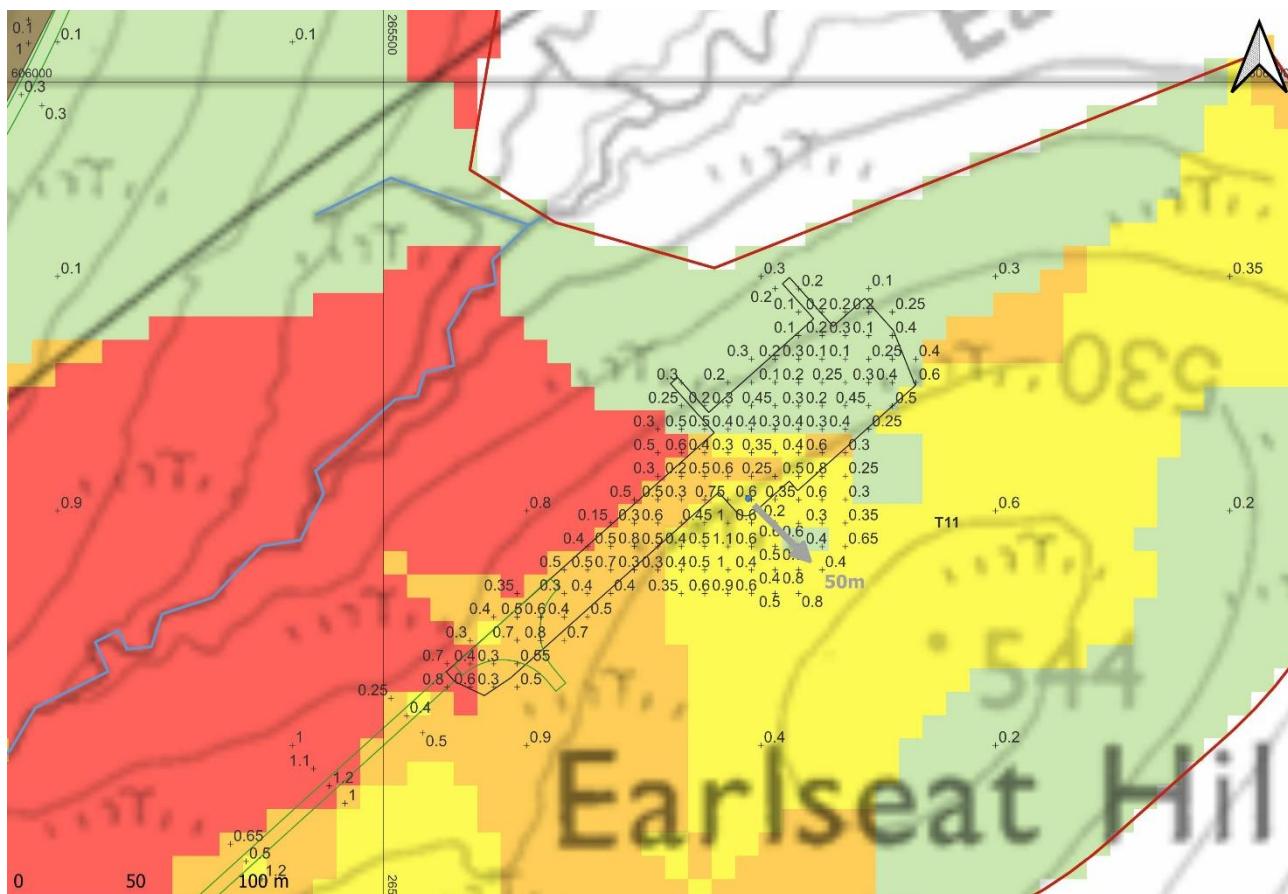
T11 Location – OS Mapping 1:25,000 – 1:1250 Scale

Location	Development Infrastructure	Environmental	Contributory Factors (Probability/Exposure)	Risk Ranking
T11	1	3	Peat Depth (Mean = 0.55m) 3 Slope Angle (9°) 3 FoS 1 Peat cracking / infiltration 1 Groundwater Flow 1 Hydrology 1 Previous Instability 1 Land Management 2	3+3+2 * (3) = 24 (High)

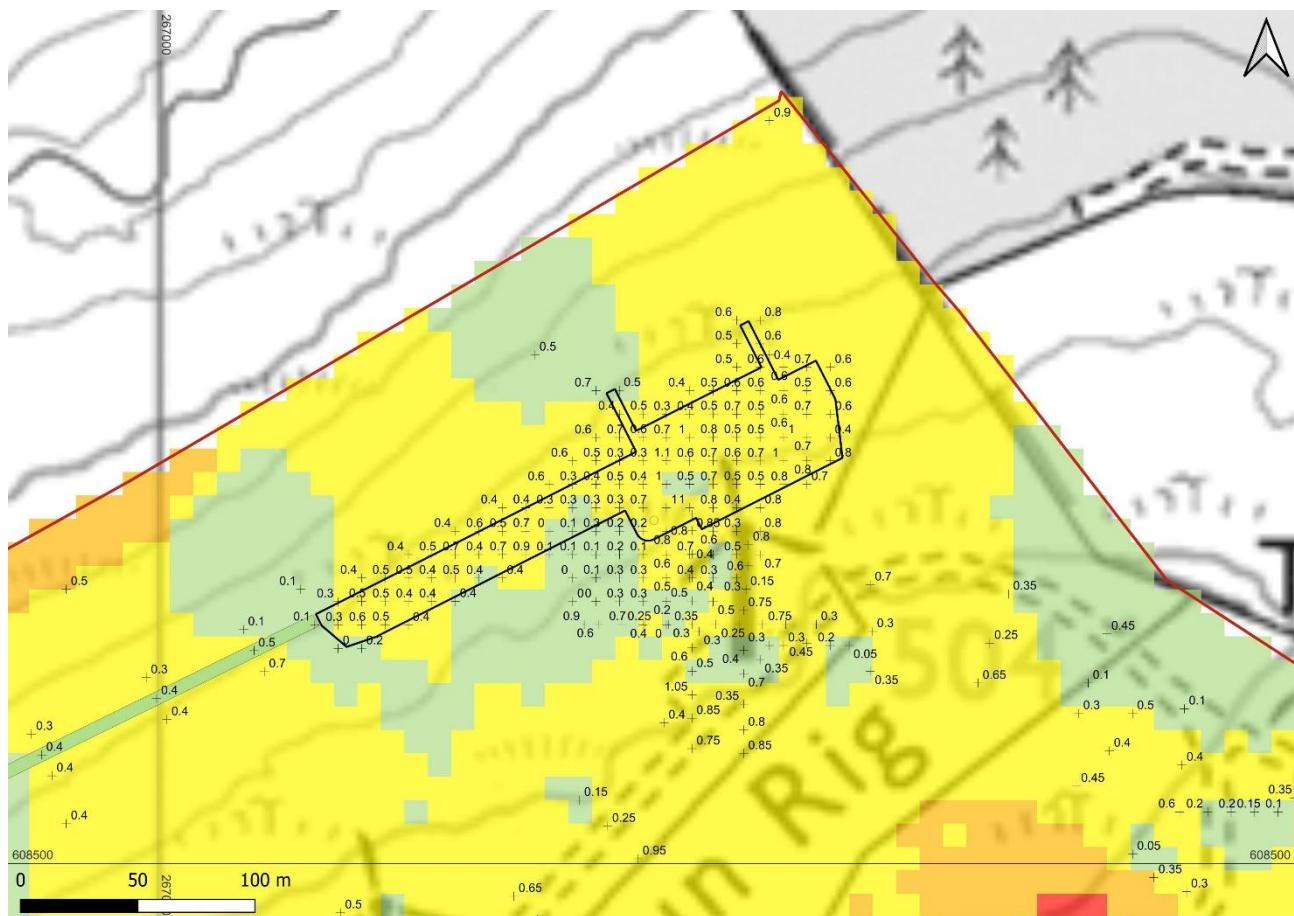
T21 Location – OS Mapping 1:25,000 – 1:1250 Scale

Location	Development Infrastructure	Environmental I	Contributory Factors (Probability/Exposure)	Risk Ranking
T21	1	1	Peat Depth (Mean = 0.60m) Slope Angle (10°) FoS Peat cracking / infiltration Groundwater Flow Hydrology Previous Instability Land Management	3 5 1 1 1 1 1 2 3+5+2 = 10 (Low)

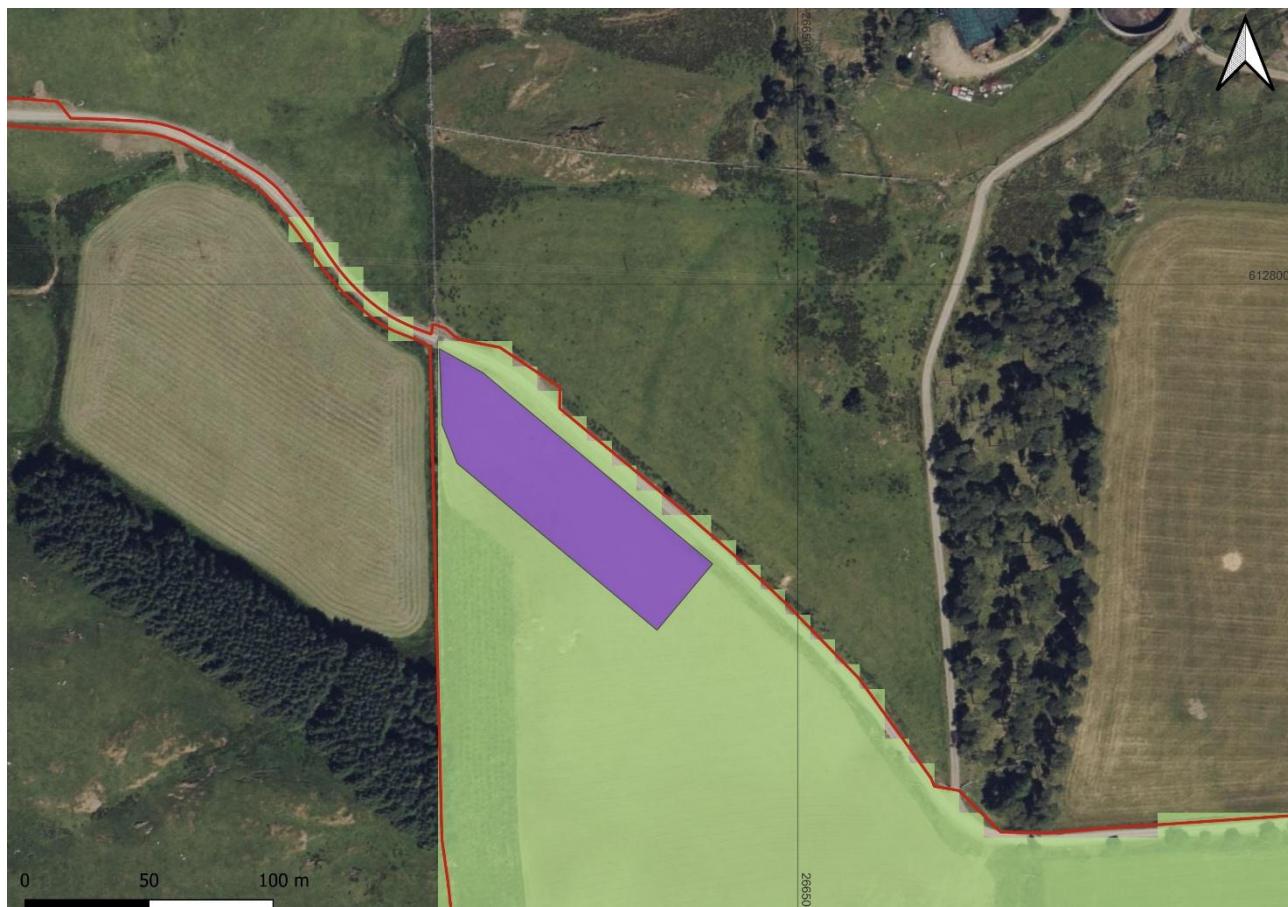
Location	Development Infrastructure	Environmental	Contributory Factors (Probability/Exposure)	Risk Ranking
Access Compound			Peat cracking / infiltration Groundwater Flow Hydrology Previous Instability Land Management	1 1 1 1 2

Access Construction Compound – Bing Satellite Imagery 1:1250 Scale

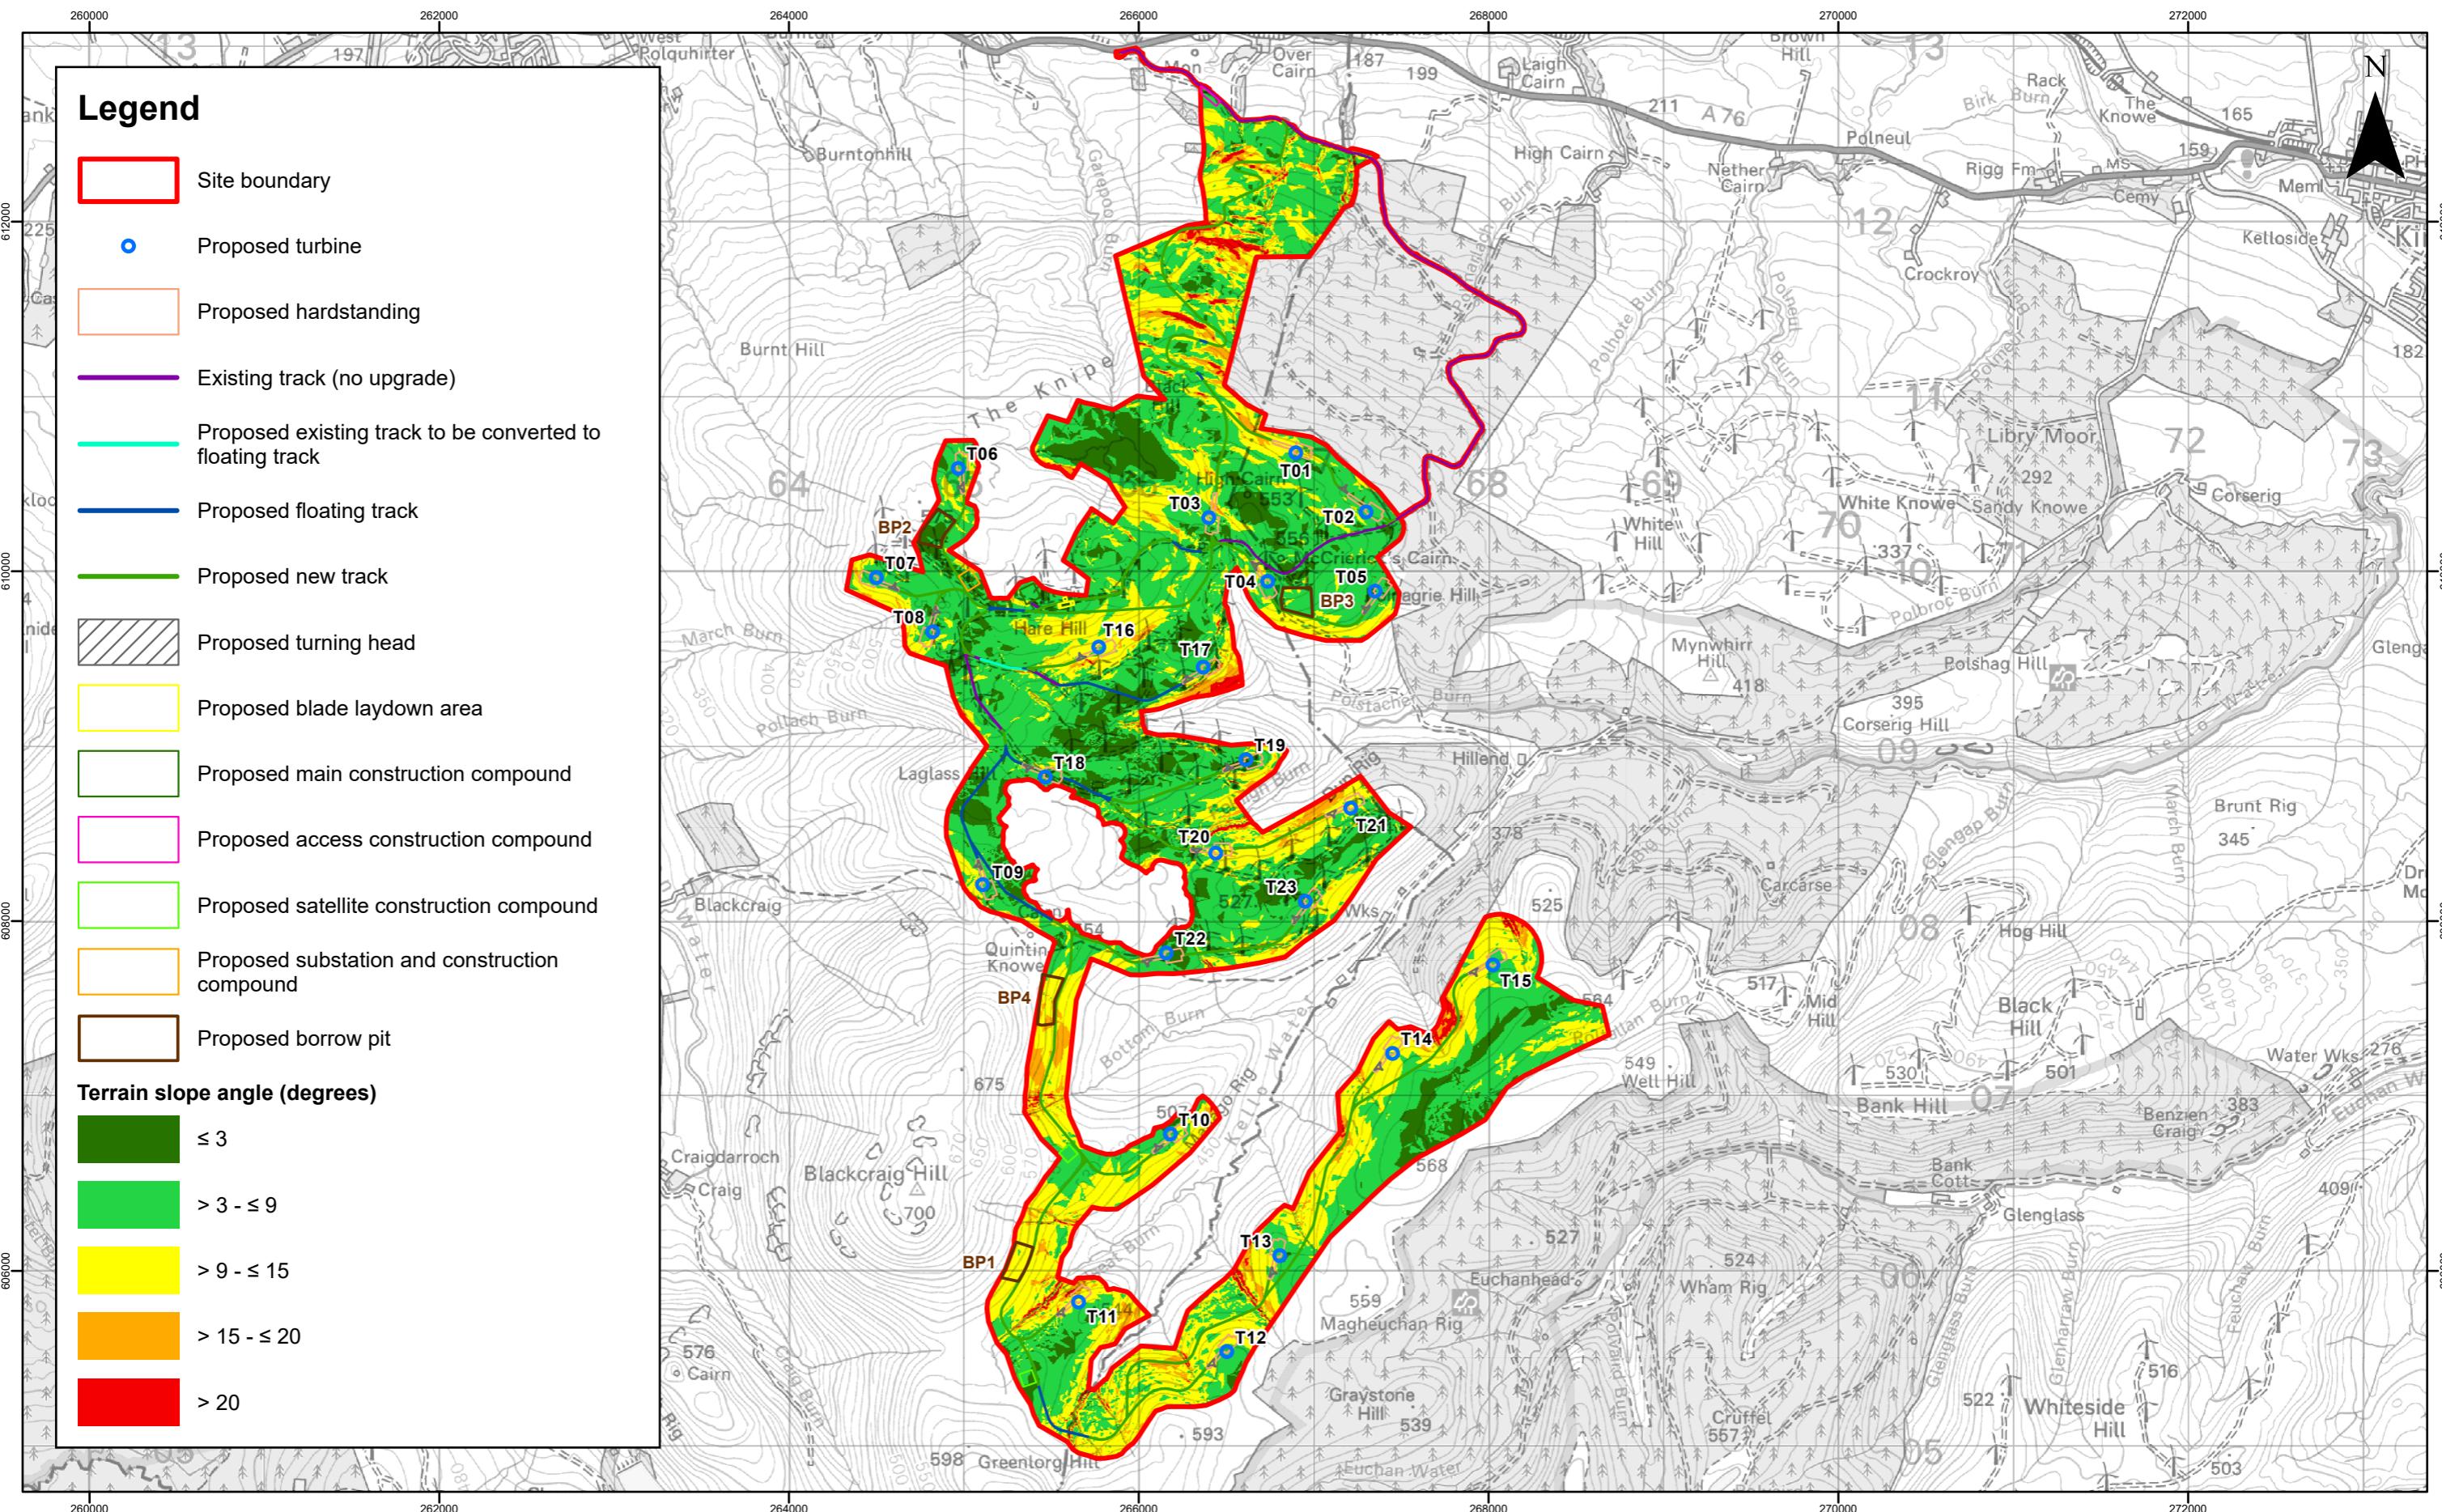
C	31/10/25	DM	Third Issue.	1:35,000 Scale @ A3 	Hare Hill Windfarm Repowering and Extension Terrain Slope Angle	Drg No	GB200665_M_070		
	B	09/05/25	DM	Second Issue.			Rev	C		
	A	21/03/25	DM	First Issue.			Date	31/10/25		
	Rev	Date	By	Comment			Figure	A.2		
© Crown Copyright 2025. All rights reserved. Ordnance Survey Licence AC0000808122.							Datum:	OSGB36		
							Projection:	OS BNG

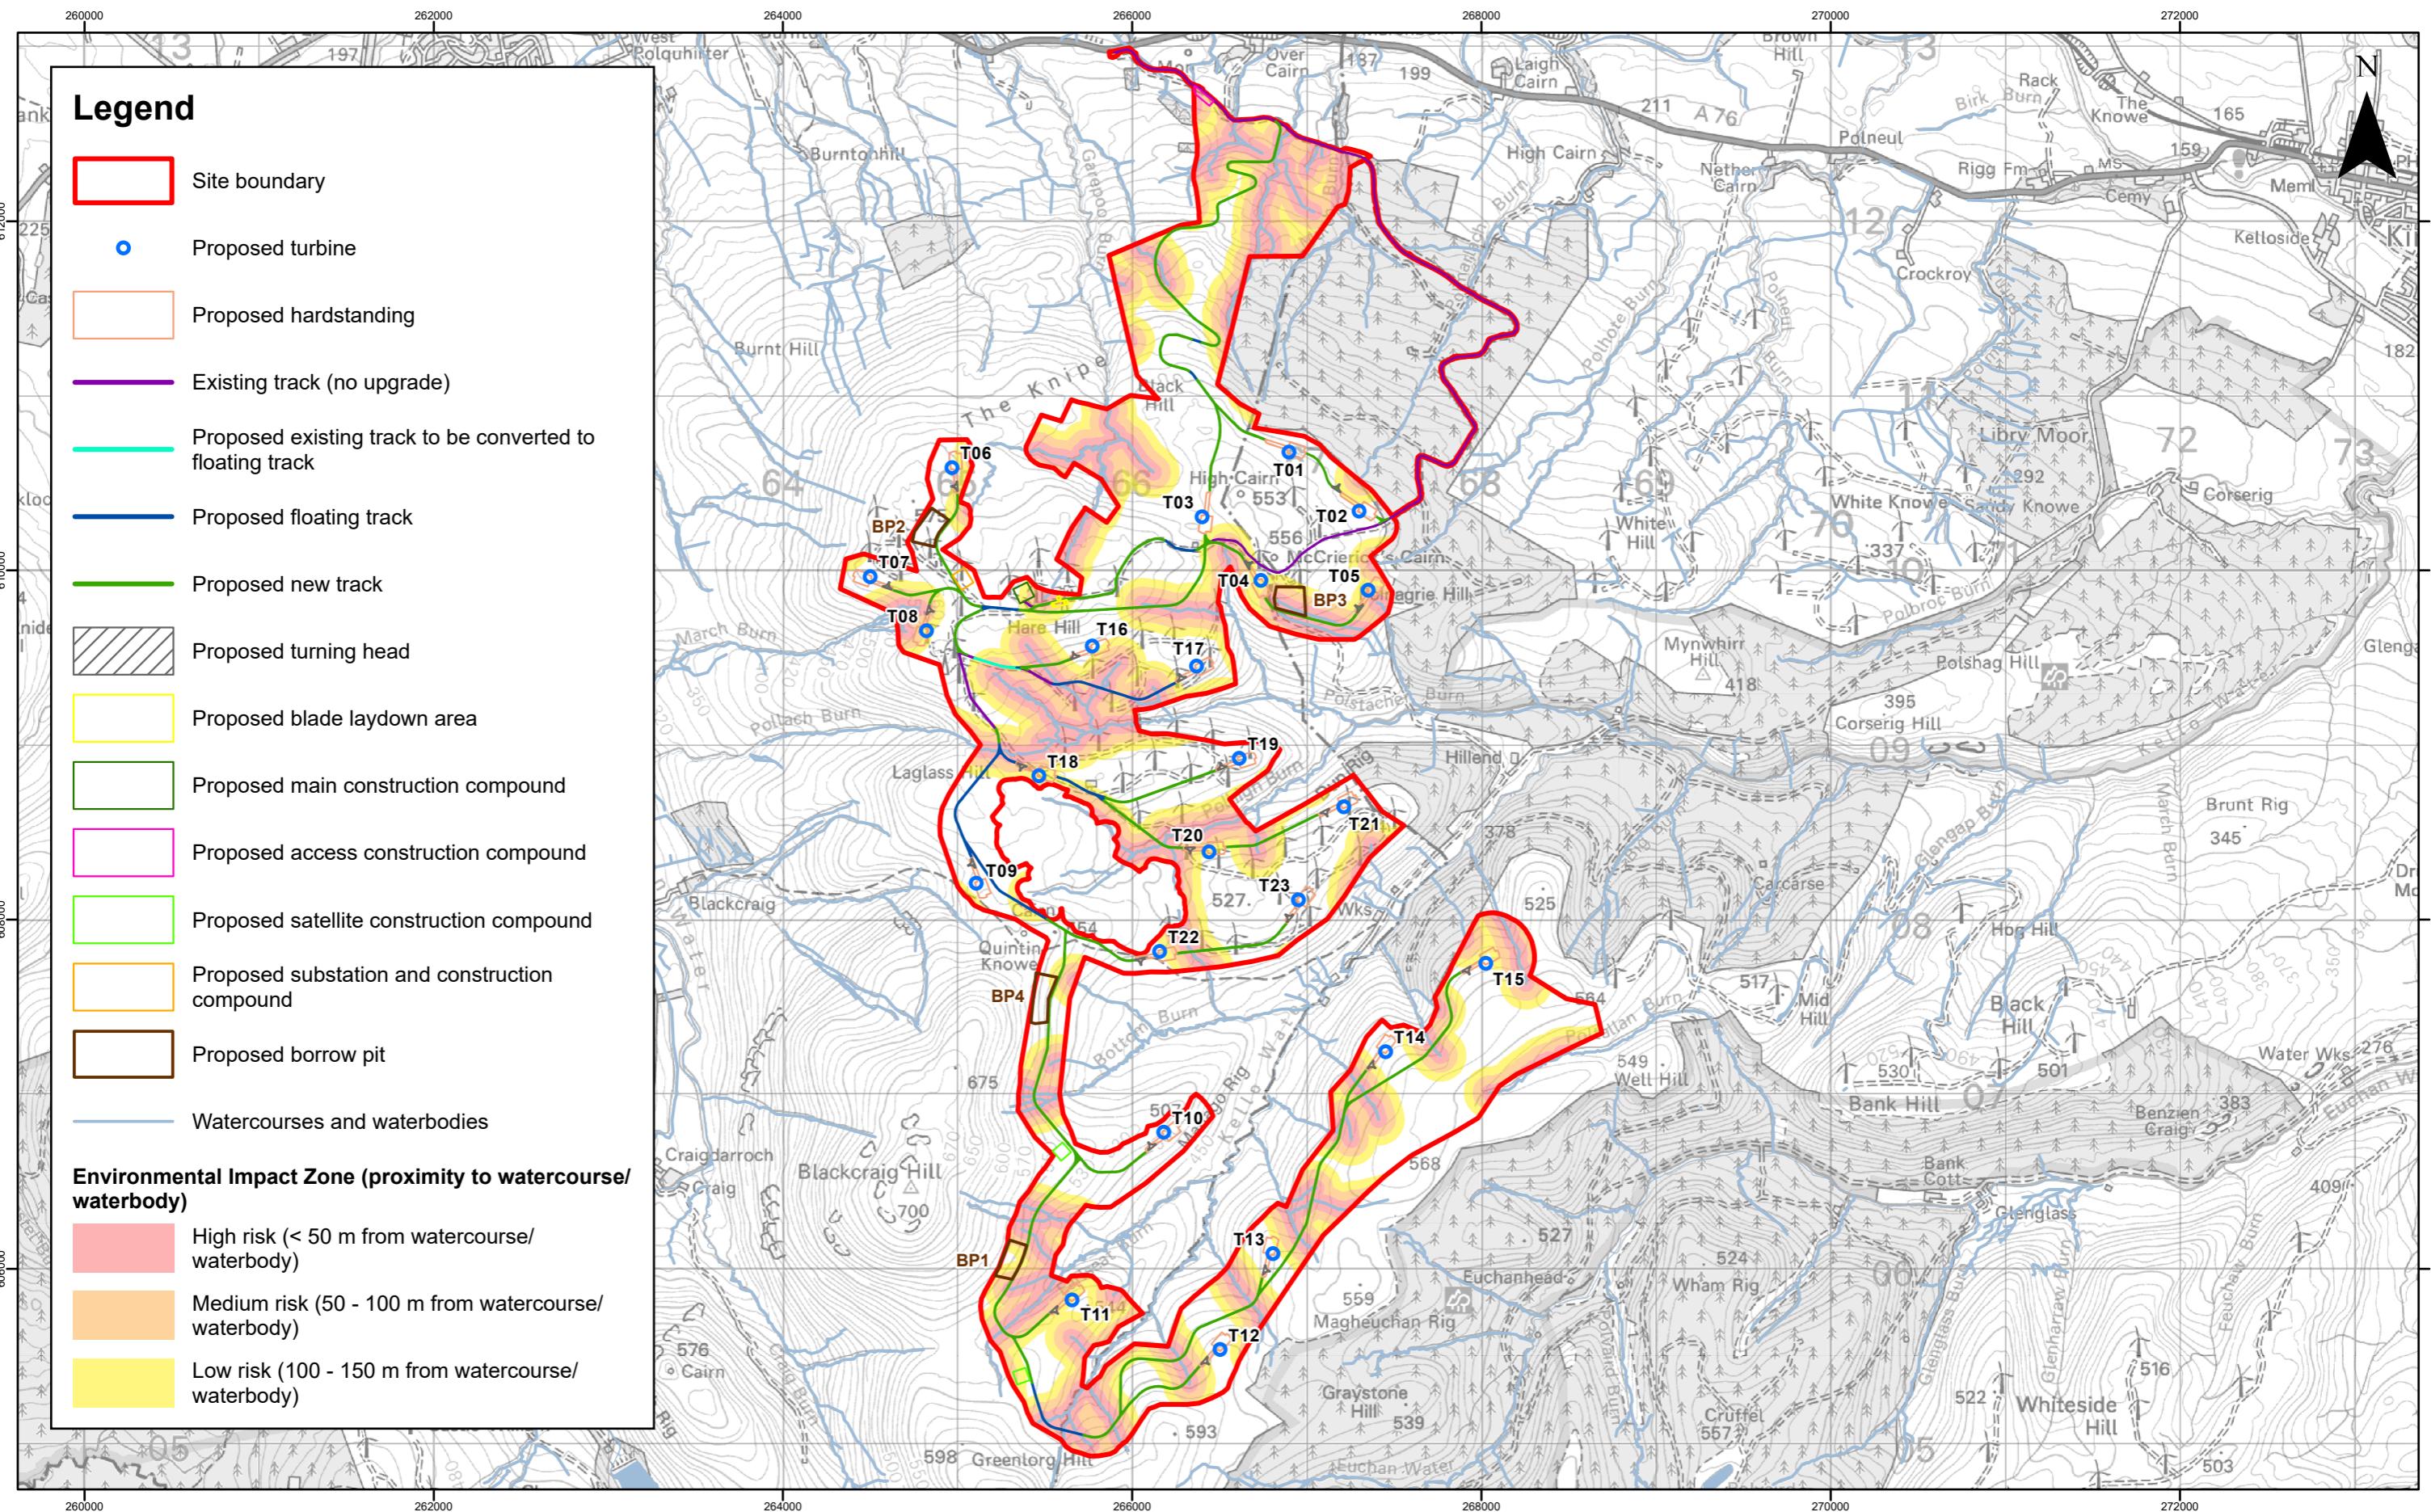
C	31/10/25	DM	Third Issue.	1:35,000 Scale @ A3 	Hare Hill Windfarm Repowering and Extension Environmental Impact Zonation	Drg No	GB200665_M_071		
	B	09/05/25	DM	Second Issue.			Rev	C		
	A	21/03/25	DM	First Issue.			Date	31/10/25		
	Rev	Date	By	Comment			Figure	A.3		
© Crown Copyright 2025. All rights reserved. Ordnance Survey Licence AC0000808122.							Datum:	OSGB36		
							Projection:	OS BNG

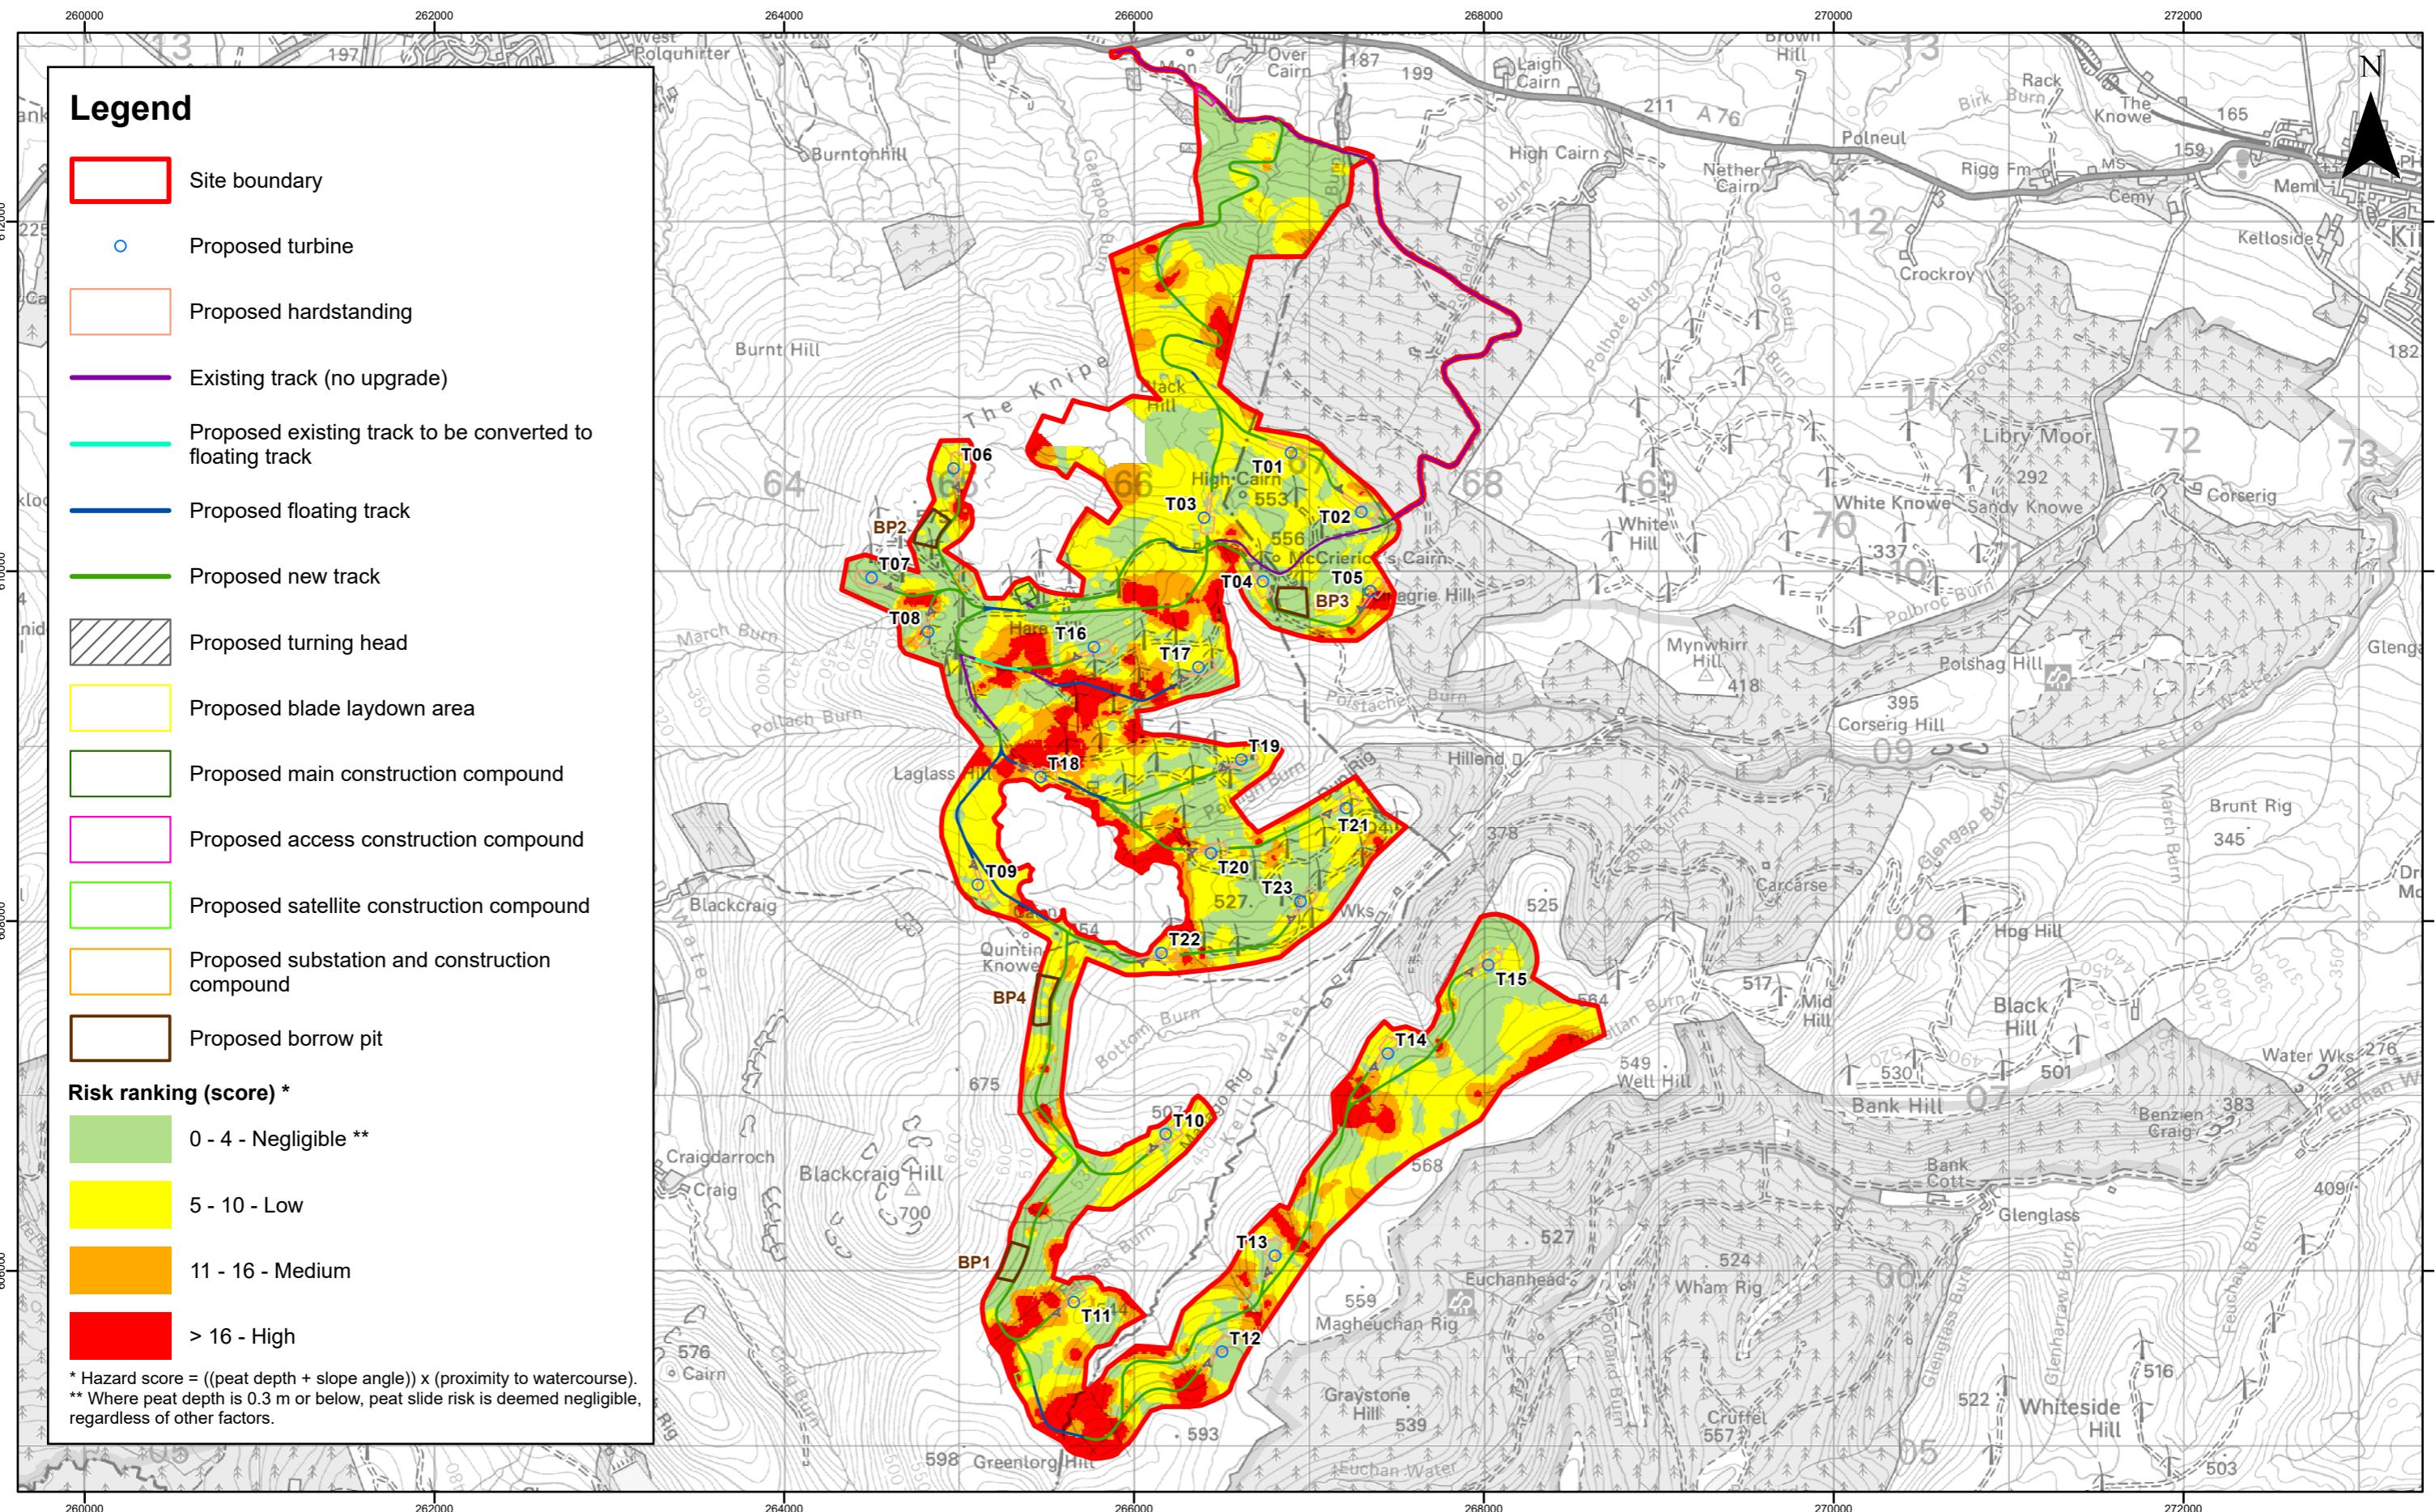
C	31/10/25	DM	Third Issue.	1:35,000 Scale @ A3 	Hare Hill Windfarm Repowering and Extension Peat Slide Risk Ranking	Drg No	GB200665_M_072
	B	09/05/25	DM	Second Issue.			Rev	C
	A	21/03/25	DM	First Issue.			Date	31/10/25
	Rev	Date	By	Comment			Figure	A.4
© Crown Copyright 2025. All rights reserved. Ordnance Survey Licence AC0000808122.				Datum: OSGB36 Projection: OS BNG
