Appendix 6.1

Peat Landslide Hazard and Risk Assessment

Carrick Windfarm Project Team

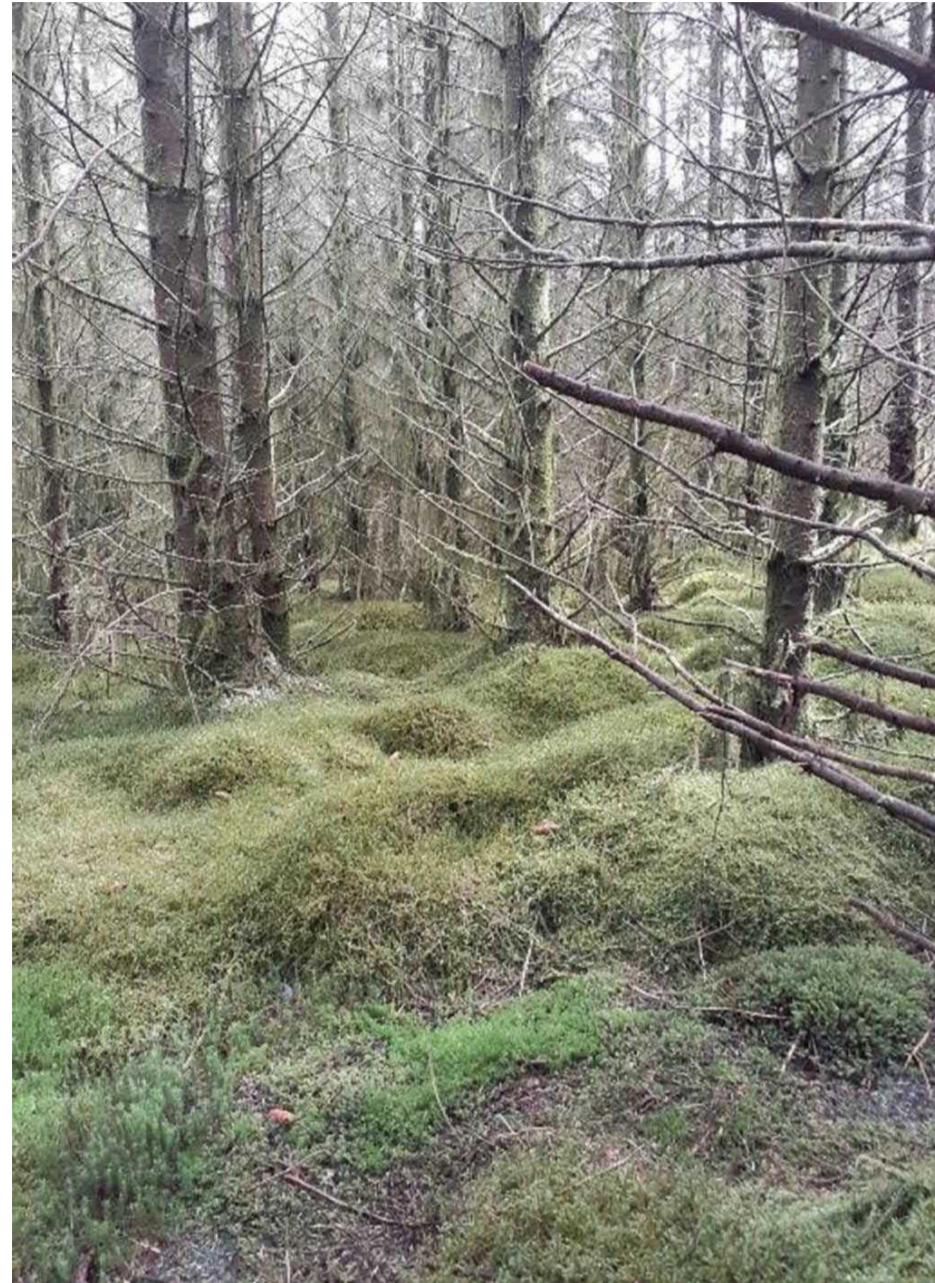
Photograph 6.3 Looking east, lower southern slopes of Black Hill of Garleffin, taken at NGR 234298 599022.

Photograph taken at approximately 392m AOD, west of Garleffin Fell in the western part of the Site. This location was identified for its deep peat records and visited due to the proximity of wind turbine 1. The slope at this location is approximately 7°, increasing to 13° downslope. Measured peat depths in the area range between 0.82m and 2.77m. No signs of instability were noted within this afforested area.

This area is discussed in PSA Area B in **Annex B**.

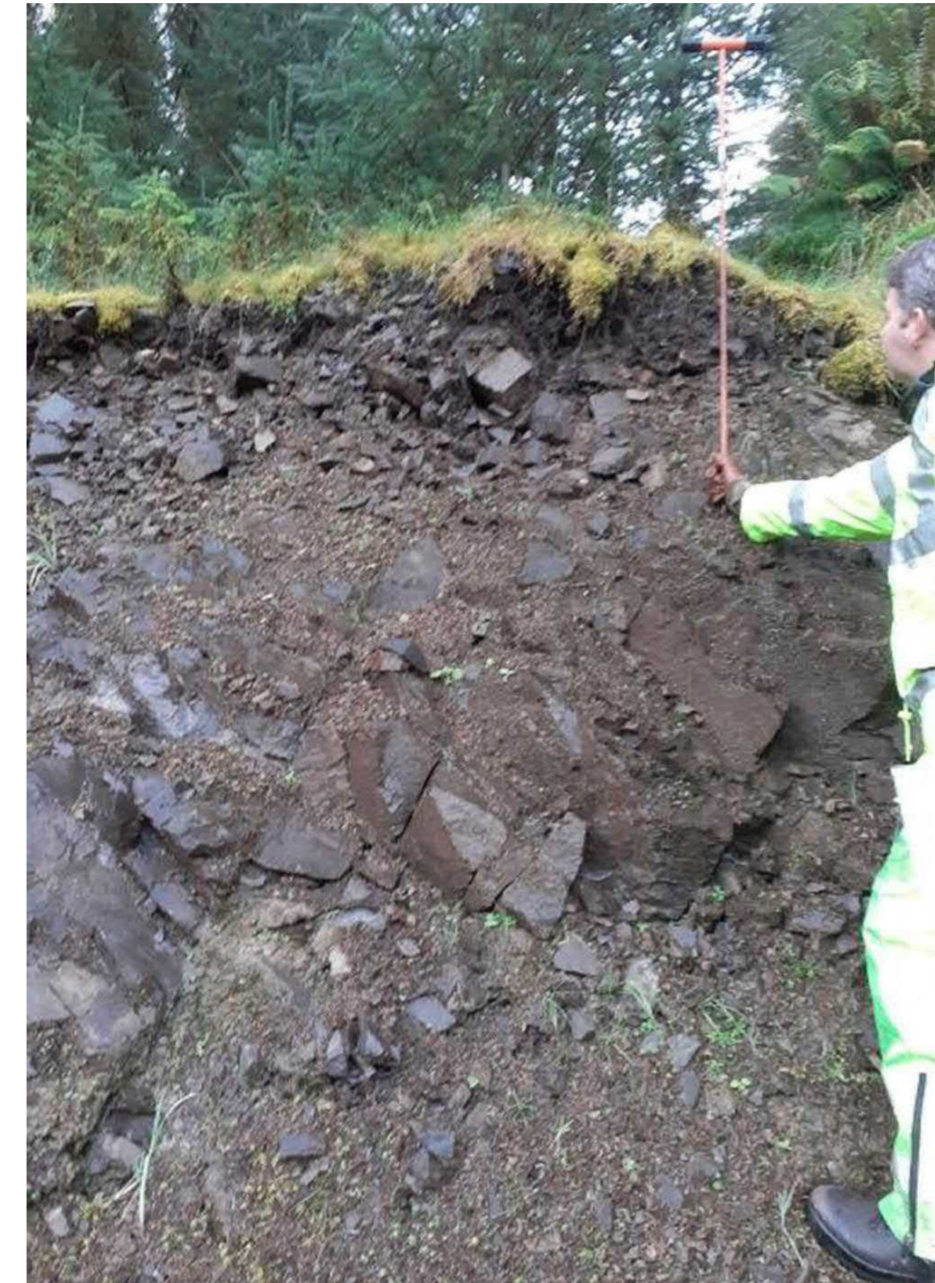
Photograph 6.5 View south within a drainage channel on the existing quarry in the central part of the Site, from NGR 237519, 598468.

Photograph taken at approximately 300m AOD showing exposed peat bank within a channel in the existing quarry, planned to be enlarged as borrow pit BP02. This horizon shows approximately 0.30m of peaty soil, overlying boulder clay and igneous rock material.

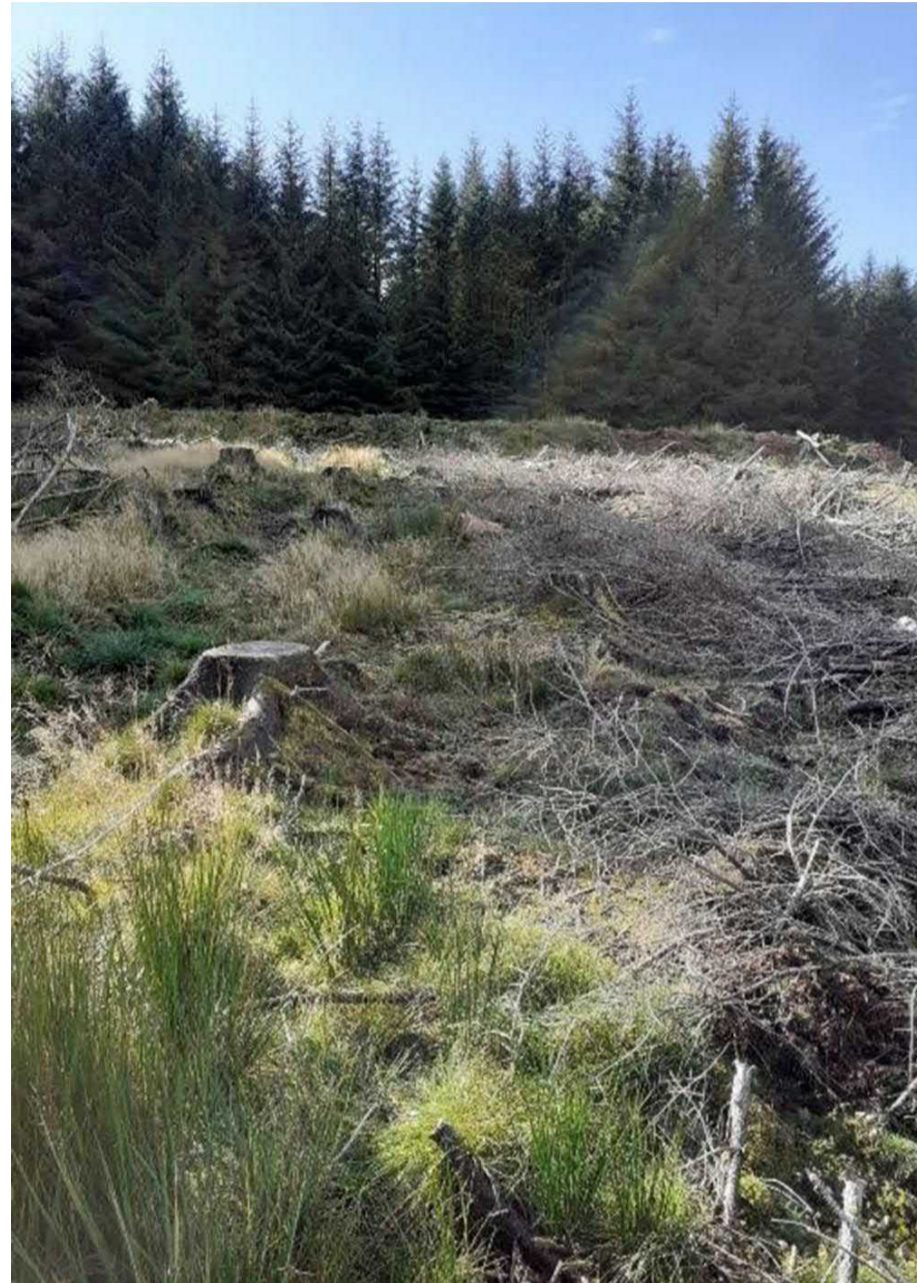
Photograph 6.7 View looking south towards the existing forestry track at NGR 235121, 599351.

Photograph taken at approximately 349m AOD downslope of the existing forestry track in the western part of the Site, showing a recent clear-felled area with legacy forestry drainage. Tree roots are likely to bind the surface soil. Measured peat depths in the area ranged between 0.10m and 0.74m. The slope gradient is gentle, with no signs of instability noted.

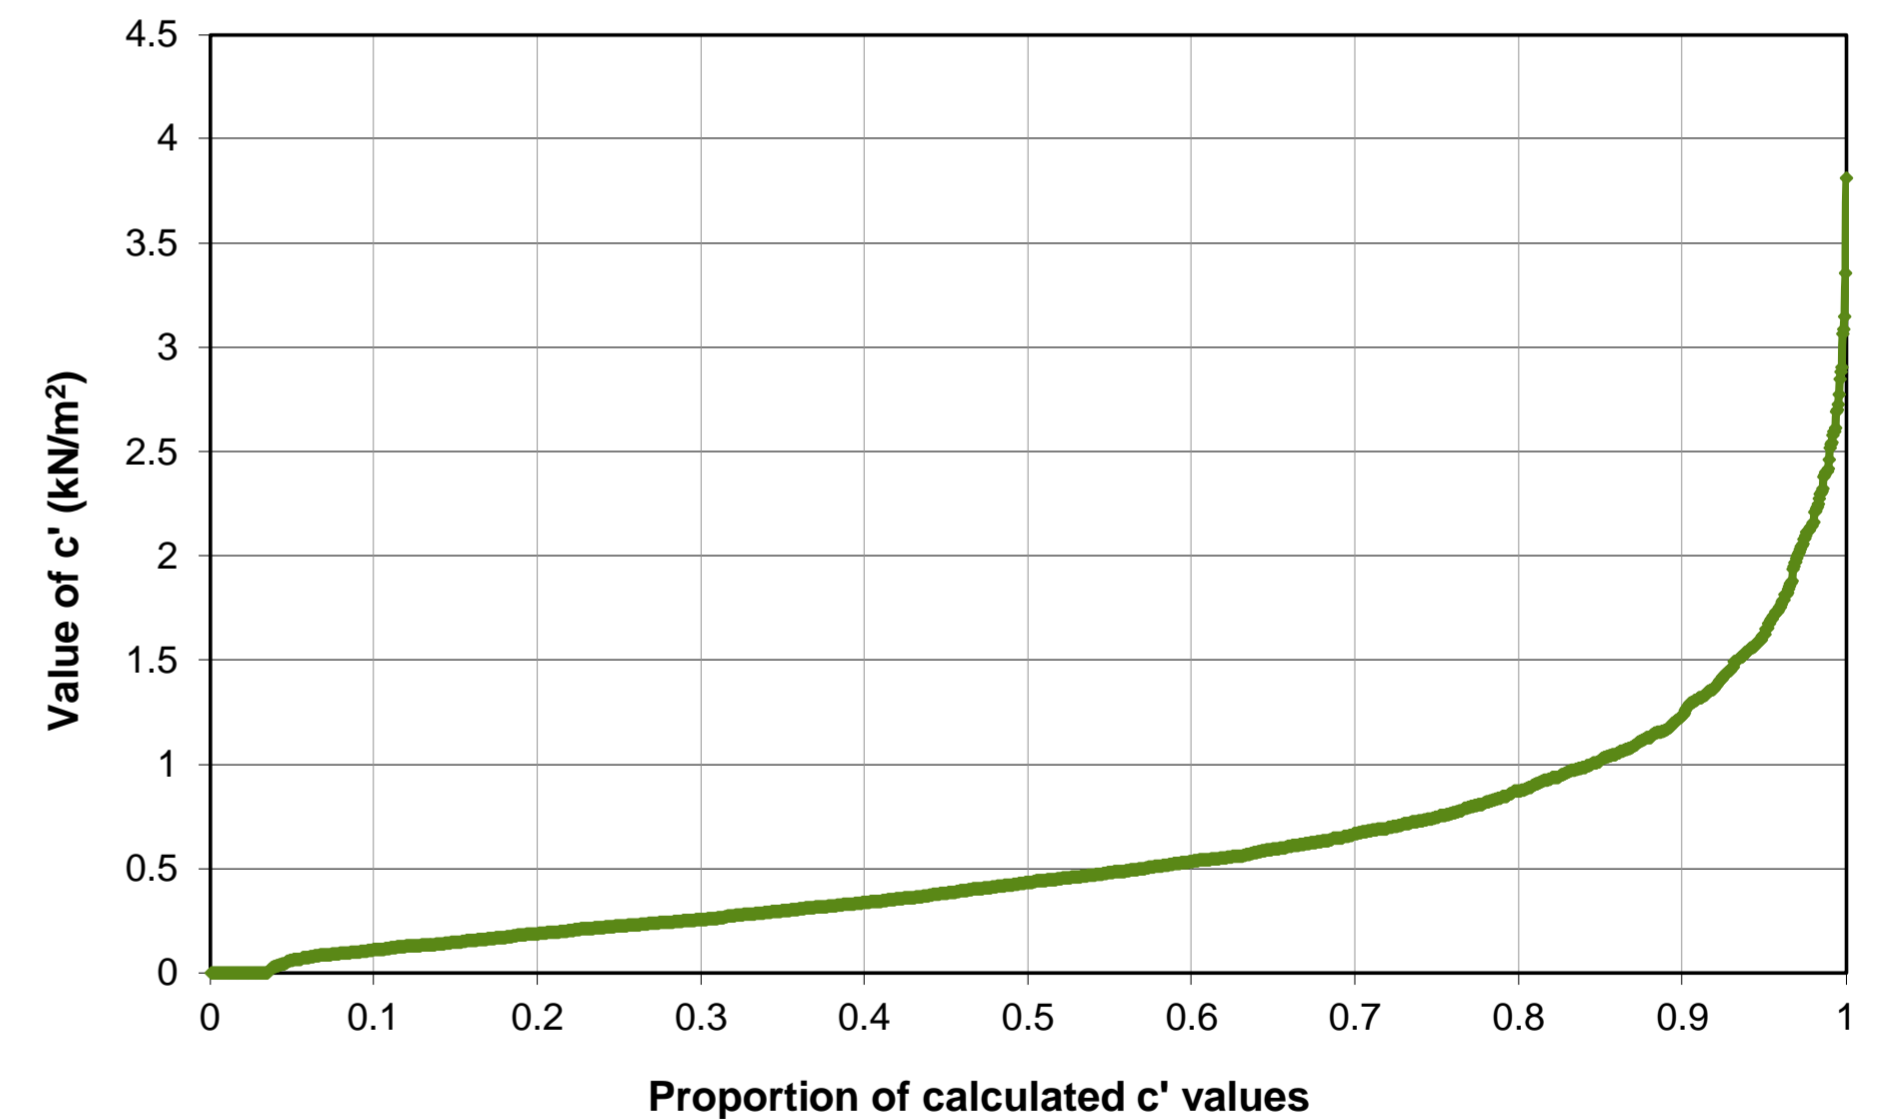
Plate 6.4 Estimate of Minimum Cohesive Strength, c'

106. In the Study Area, 1,818 locations have been probed during the different phases of fieldwork, c' values for each of these have been calculated and the distribution of these values is shown in **Plate 6.4**. For example, reading from the graph, 0.8 (or 80%) of the probing locations require a theoretical c' value of 0.87kN/m² or less to be stable and retain peat on the slope.

107. From this work it is possible to state, with reasonable confidence, that across the Site as a whole the shear strength of the peat is unlikely to be less than 2.51kN/m² as this is the value of the 99th percentile point on the graph.
108. A similar approach was undertaken for determining the 99th percentile for grid cells, determined as 3.96kN/m², this value being higher than the point data due to inclusion of indicative depths for a number of cells.
109. The basis for applying these calculation details depends upon:

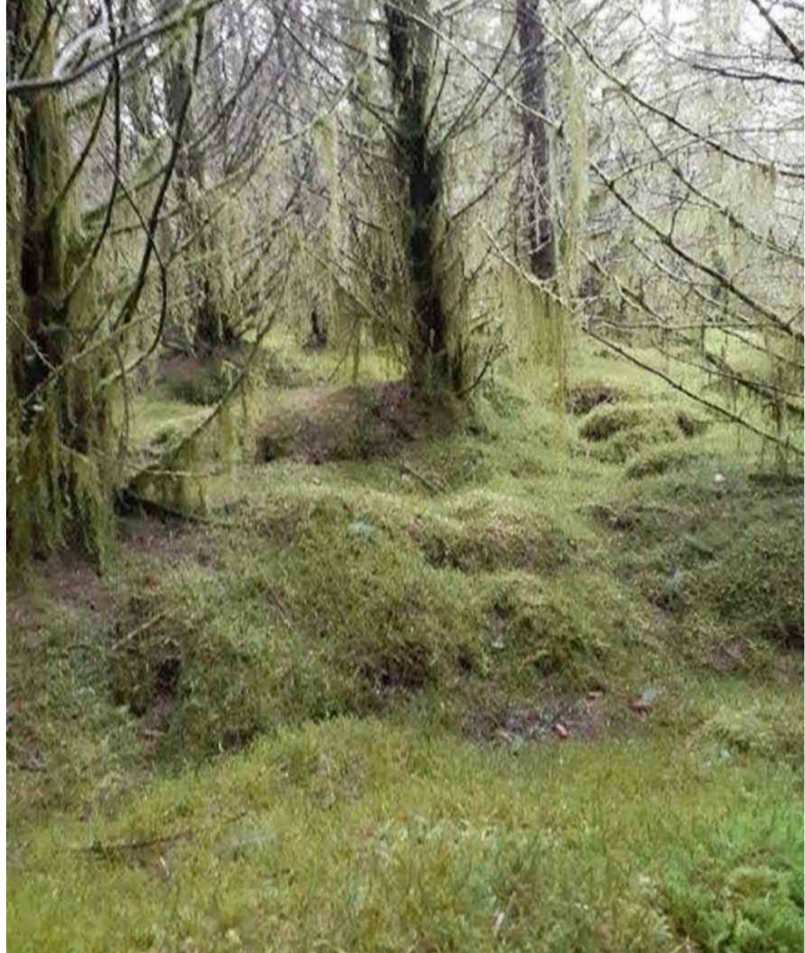
<p>Photograph 6.9 Looking west from PSA Area A, on the northern slopes of Garleffin Fell, from NGR 234997, 599145 Photograph taken at approximately 380m AOD, looking west from the proposed wind turbine 2 hardstanding towards wind turbine 1. Also Plates 6.1 and 6.7-6.9 and Photographs 6.4 and 6.8, in Desk Study, Site Reconnaissance and Annex C.</p>

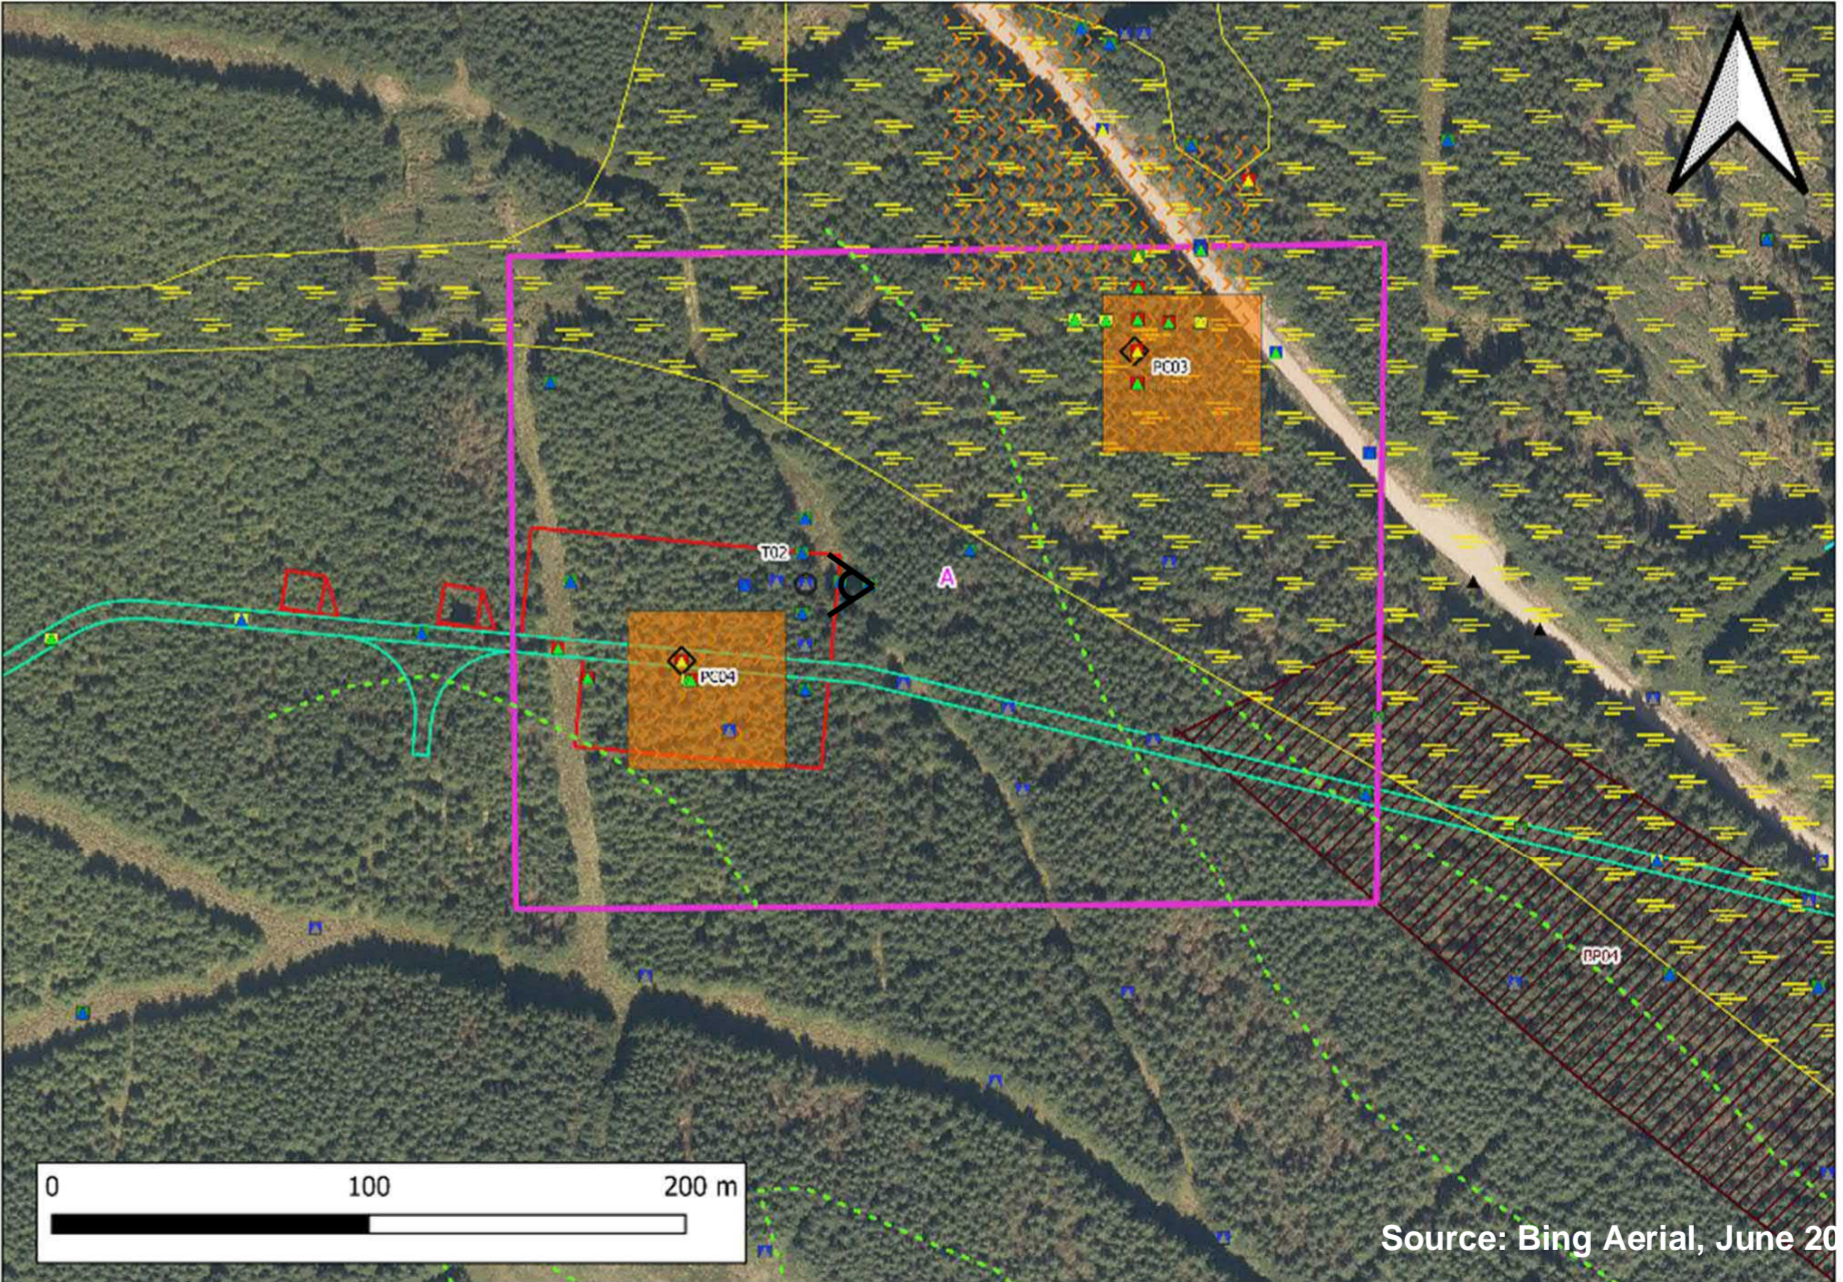
<p>Source: Bing Aerial, June 2020</p>
<p>Revised Risk</p> <p>Although this general area is identified by GeoSure as Class C, it has highly modified and variable peatland features with no evidence of peat instability from Site visit or aerial photograph, including from previous track construction.</p> <p>Taking account of the peatland morphology, existing drainage, anticipated retention of tree roots, individual peat probe FoS, design and mitigation (including micrositing to avoid/minimise disturbance of deeper peat recorded at PC04), peat-related instability is reduced to Unlikely and the Revised Risk remains Low.</p>	<p>Plate 6.5 Aerial Image of PSA Area A</p>

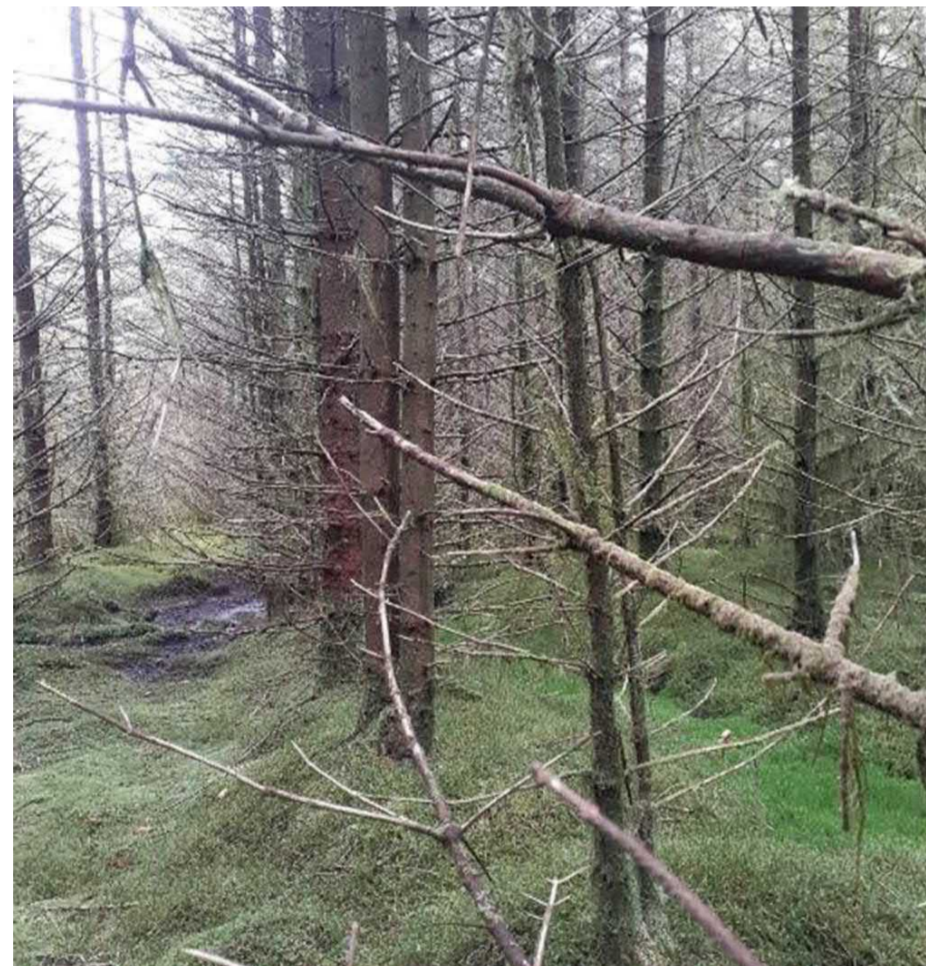
Photograph 6.10 Looking north from PSA Area B at NGR 234298, 599022.

Photograph taken at approximately 390m AOD, looking north towards the proposed wind turbine 1. Also see **Plates 6.1** and **6.10-6.12** and **Photograph 6.3**, in **Desk Study, Site Reconnaissance** and **Annex C**.

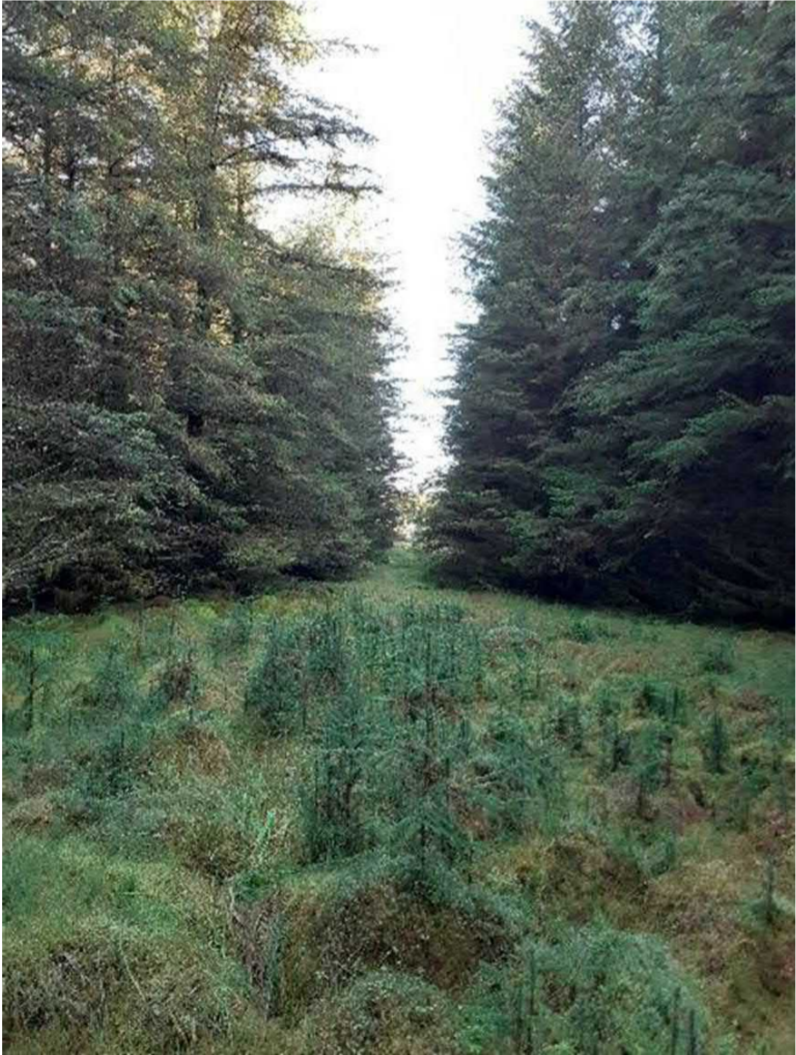
<p>Photograph 6.11 Looking south from PSA Area C at NGR 237446, 598524</p> <p>Photograph taken at approximately 296m AOD, looking south towards the proposed track to be upgraded. Also see Plates 6.13-6.15 and Photographs 6.13-14 in Annex C.</p>	<p>Revised Risk</p> <p>The proposed infrastructure avoids crossing this deeper peat area, where amorphous catotelmic peat has been identified in this area. No peat instability evidence was observed at this peatland location or identified on aerial imagery or GeoSure data.</p> <p>Taking account of the peatland morphology, existing drainage network, anticipated retention of tree roots, proposed design and mitigation, the Likelihood is reduced to Unlikely and the Revised Risk remains Low.</p>

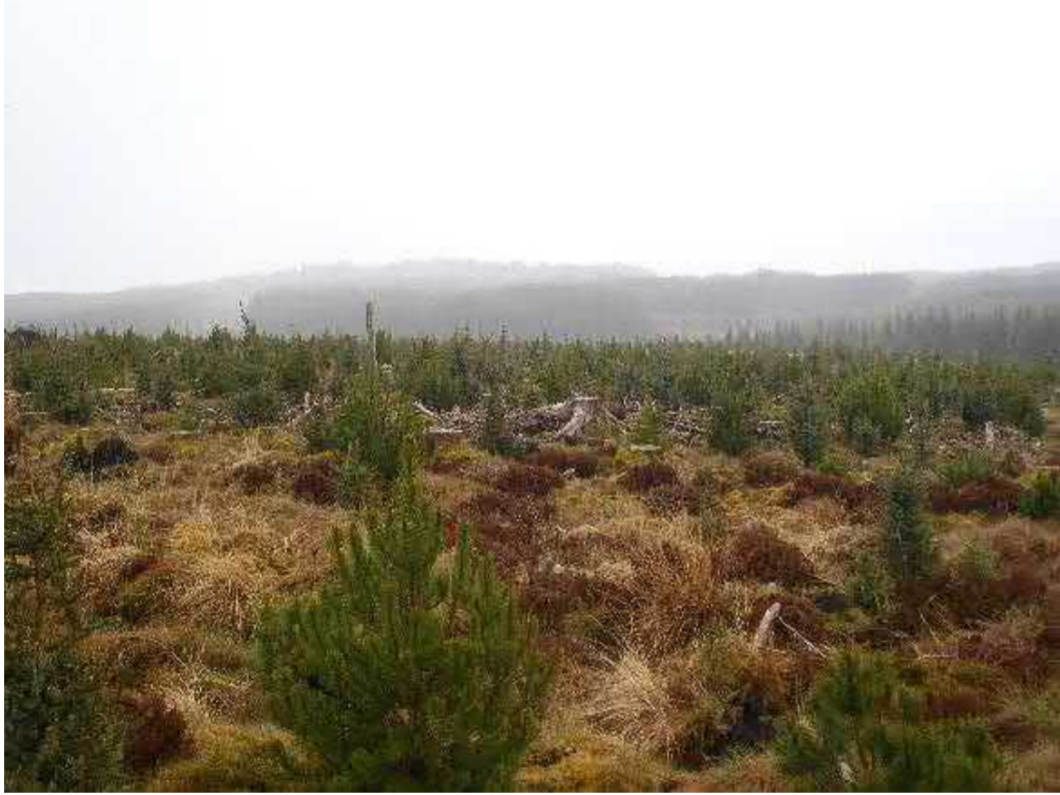
<p>Photograph 6.12 Looking north from PSA Area D at NGR 238839, 597575. Photograph taken at approximately 290m AOD, looking south from the temporary SPEN Construction Compound towards the PSA Area D. Also see Plates 6.16-6.18 and Photographs 6.13-14 in Annex C.</p>

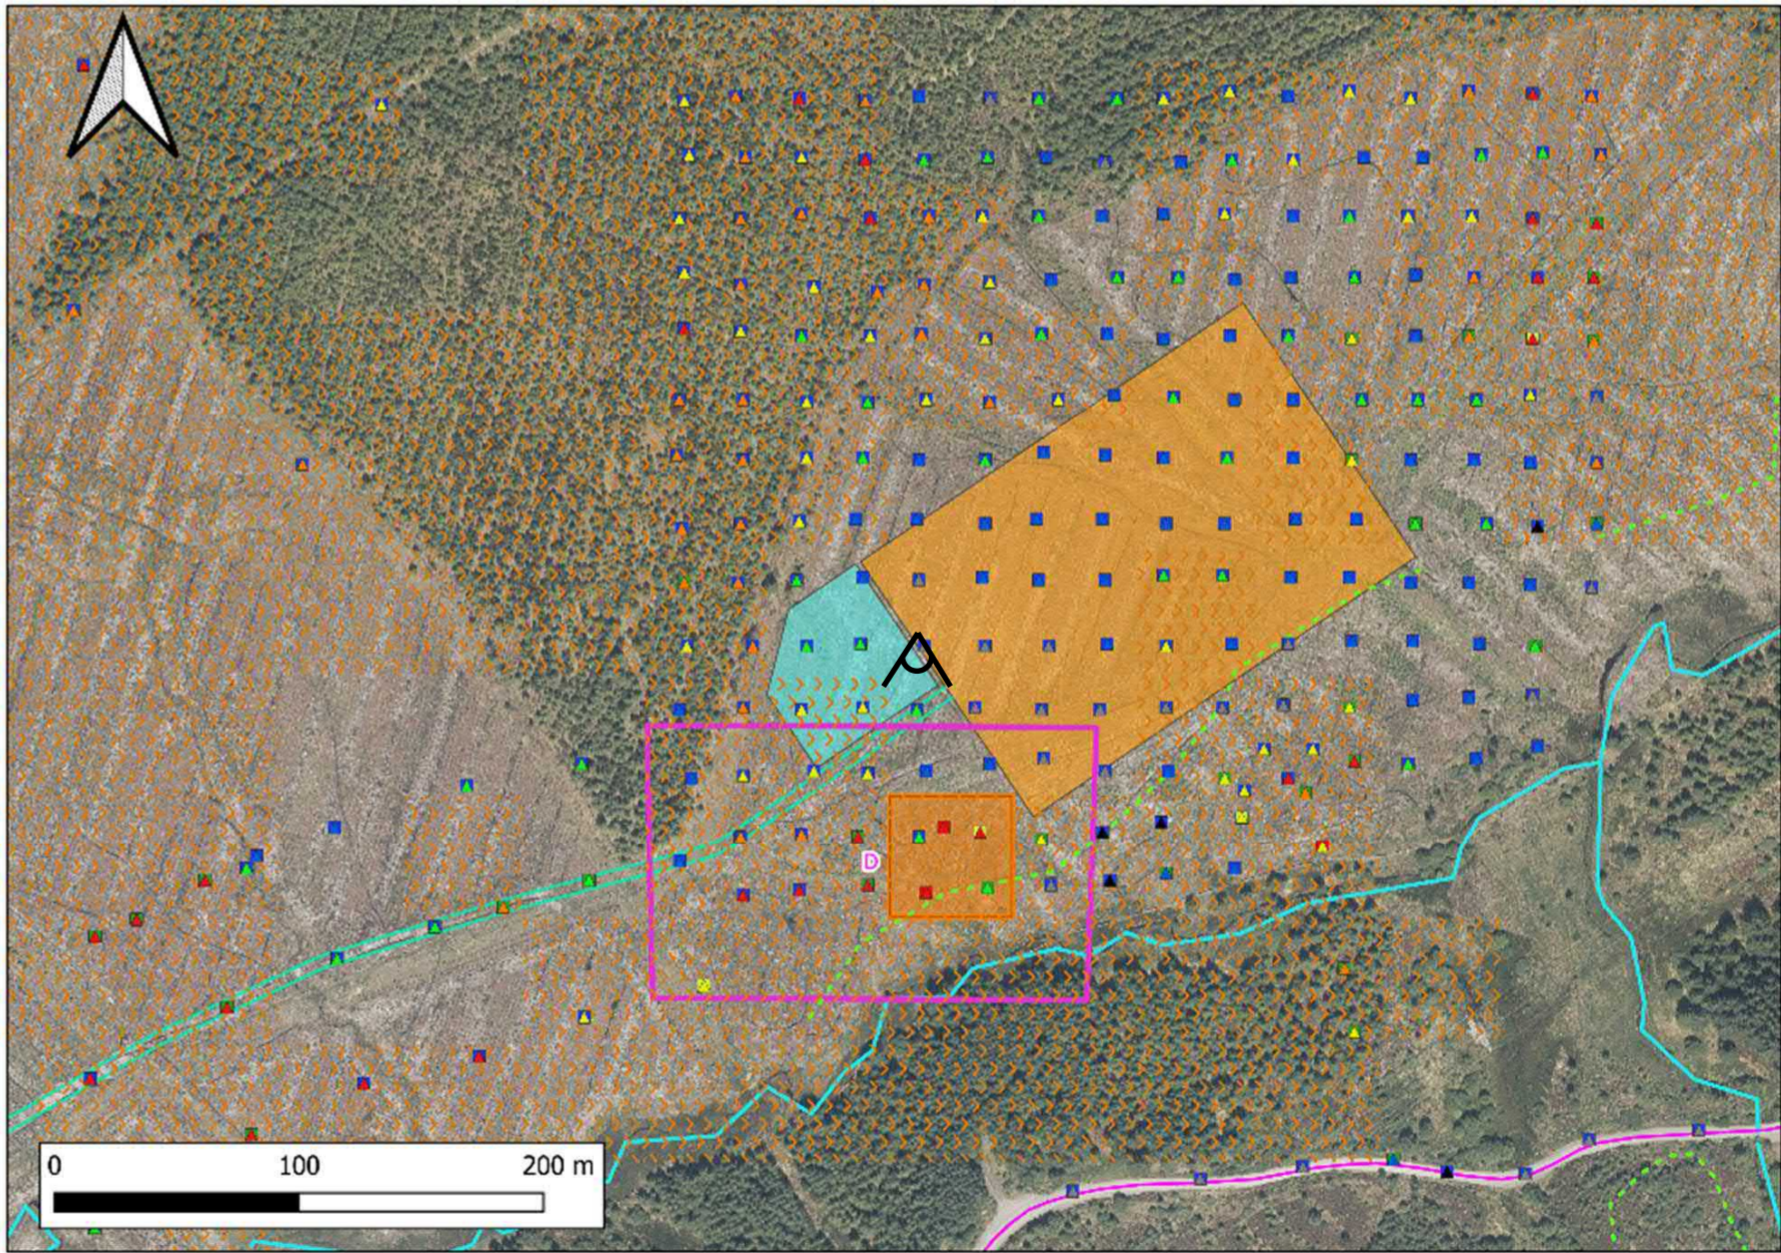
<p>Revised Risk</p> <p>Although there is an indistinct break of slope running parallel to the southern edge of the Substation Compound and deep peat south-west of the Substation Compound, no peat instability evidence was observed at this highly modified peatland location or identified on aerial imagery or GeoSure data.</p> <p>Taking account of the peatland morphology, existing drainage network, tree roots retained, design and mitigation (including slope management and micrositing to avoid the break of slope and minimise disturbance of deeper peat), the Likelihood is reduced to Unlikely and the Revised Risk is Low.</p>	<p>Plate 6.8 Aerial Image of PSA Area D</p>
