East Anglia ONE
Offshore Windfarm

Written Scheme of Potentially
Contaminated Land Mitigation
DCO Requirement 17
Final for Discharge

ID: EA1-CON-R-IBR-010156

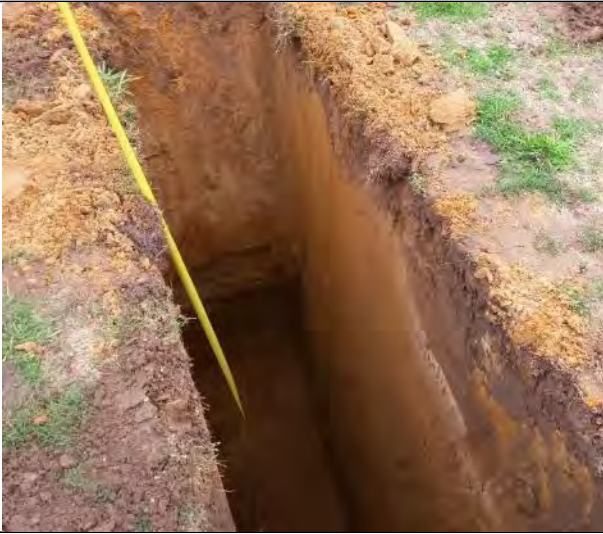
TP03-CH

Long face

135. Underlying Topsoil, natural drift deposits, generally comprising light brown slightly silty slightly gravelly sand were encountered. This sand stratum with flint gravel is typical of the Kesgrave Catchment Subgroup of pre Glacial fluvial drift deposits. Although fairly consistent across the investigated area, some localised variations within this stratum were noted, including variations in colour to pale yellow, variable quantities of gravel within the sand, clay laminations towards the base of TP05-CH and TP06-CH and rare orange veining below 2.00m depth in TP09-CH.

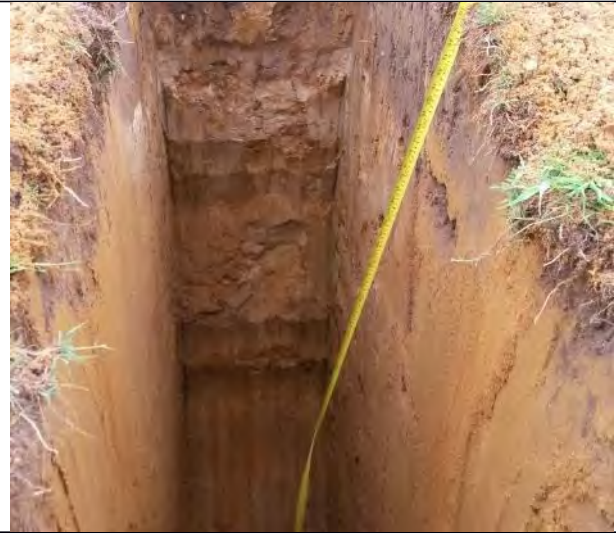
Short face

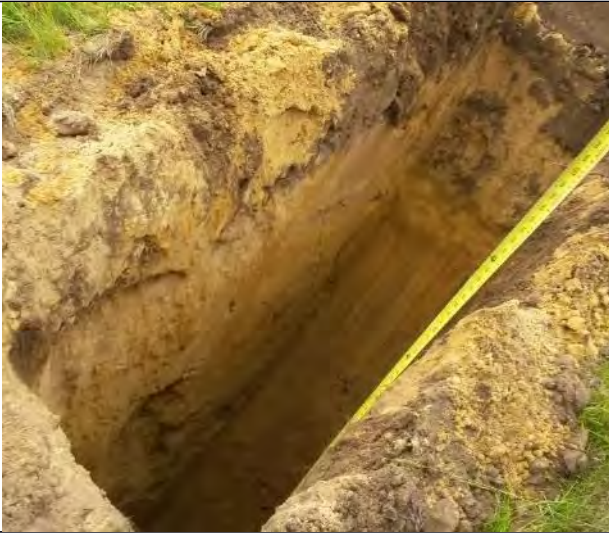
TP08-CH

Long face

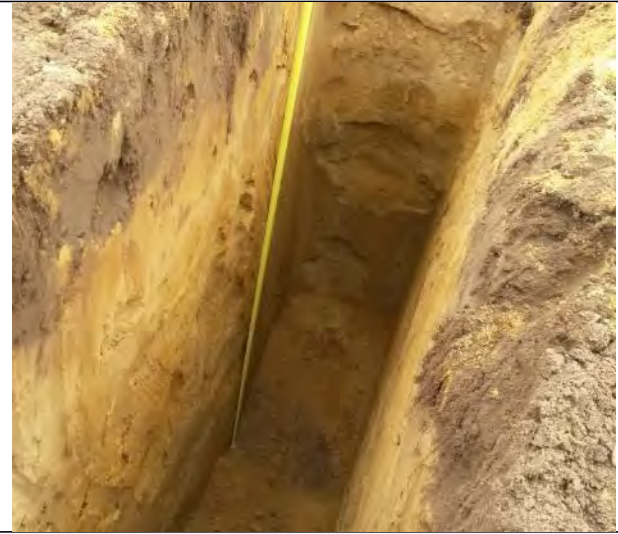
Short face

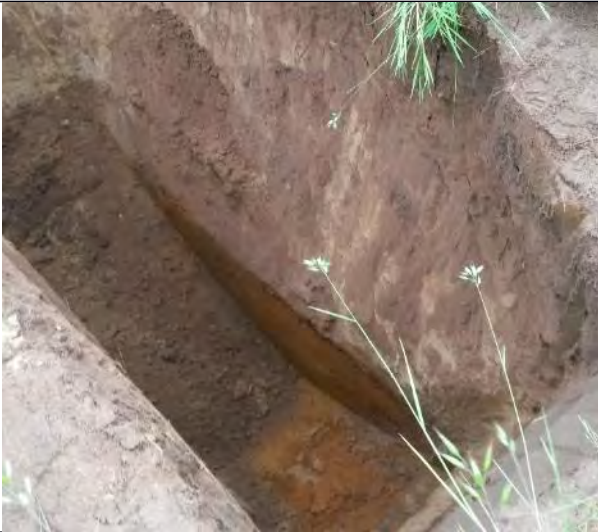
TP09-CH

Long face

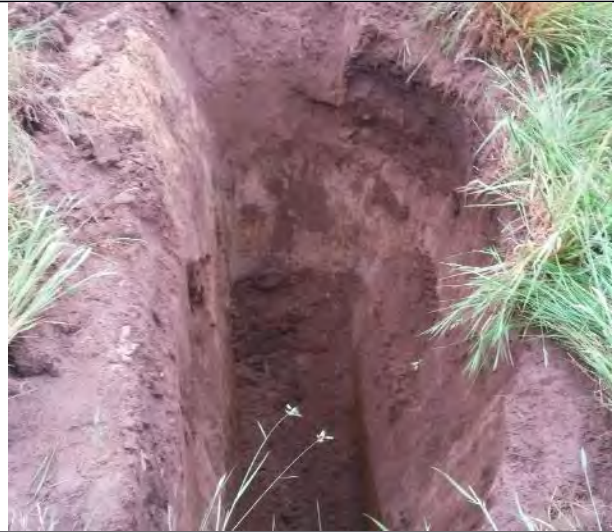
Short face
