Technical Appendix 6.1

Peat Stability Assessment

2. The Proposed Development comprises eight wind turbines and associated infrastructure including access tracks and borrow pits. The Proposed Development is located approximately 13km north of Dumfries, entirely within the Dumfries and Galloway Council area, and is described more fully in **Chapter 4: Development Description**. The Site consists mainly of commercial conifer plantation, with clear-felled areas predominantly in the north east. Peat is notable in open areas, such as forestry rides, clearings and in the vicinity of surface water bodies.

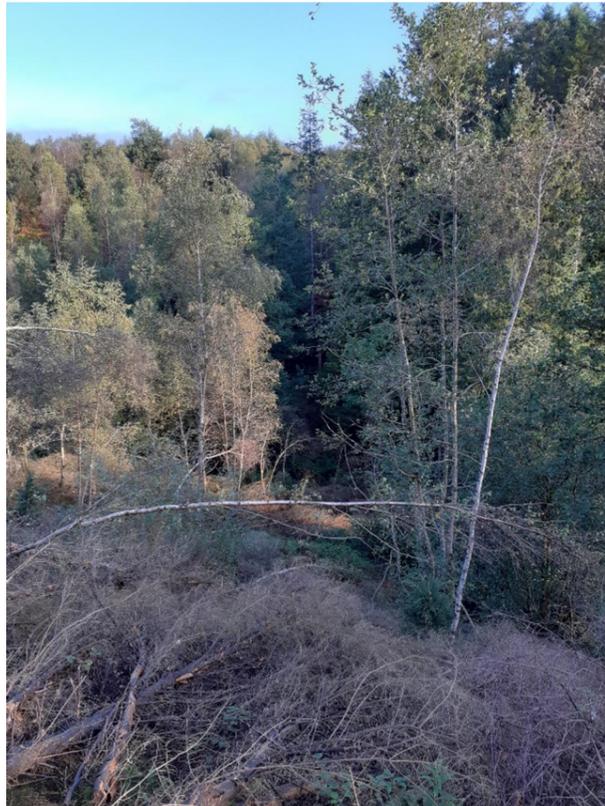
Photograph 6.1: Looking north towards the Tor Linn from the break of slope at NGR 303696, 590745.

Photograph taken at approximately 155mAOD on the southern banks of Tor Linn in the southern part of the Site, looking north from the break of slope. This location was identified for its steep gradient using OS mapping and Digital Terrain Model (DTM) and visited due to the proximity of the proposed track to be upgraded. Measured peat depths in the area are generally less than 0.5m. At the location where the photograph is taken, the slope angle is approximately 25 degrees, decreasing to 10 degrees upslope of the break of slope. Although fallen trees were abundant on this steep slope, there were no signs of peat instability or mass movement.

This area is discussed in Peat Stability Assessment (PSA) Area A in Annex B.

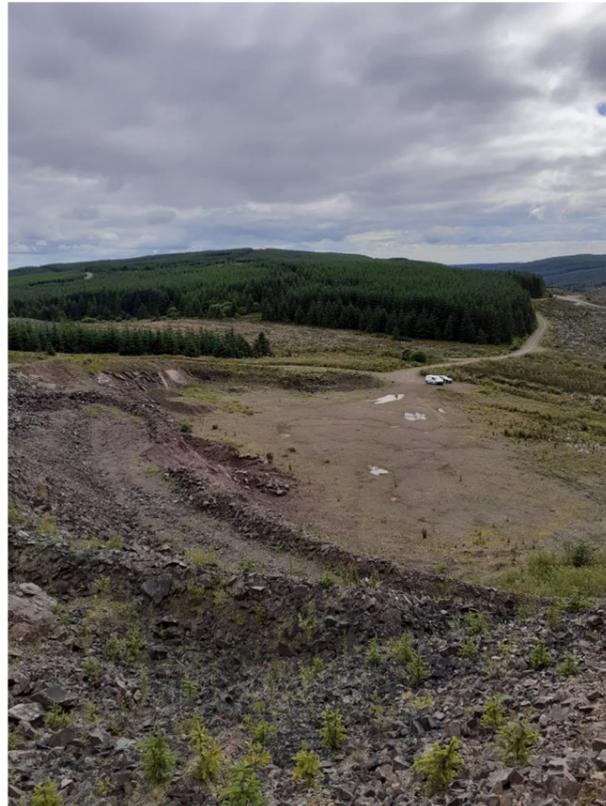
Photograph 6.2: View south west to Whitefauld Hill from top of existing quarry, from NGR 302484, 593948

Photograph taken at approximately 355mAOD at the top of the existing quarry in the eastern part of the Site, where steep gradients were identified using OS mapping and DTM. Measured peat depths in the area were up to 0.9m at the top of the slope. At the location where the photograph is taken, the slope angle is approximately 14 degrees, increasing to 44 degrees downslope when entering the quarried area. Although afforestation masks the topography, this image also shows the typically gentle slopes identified across the majority of the Site.

The northern extent of PSA Area B including Peat Core PC03 location is shown in the background of this image; as the clear-felled area to the right of the parked vehicles.

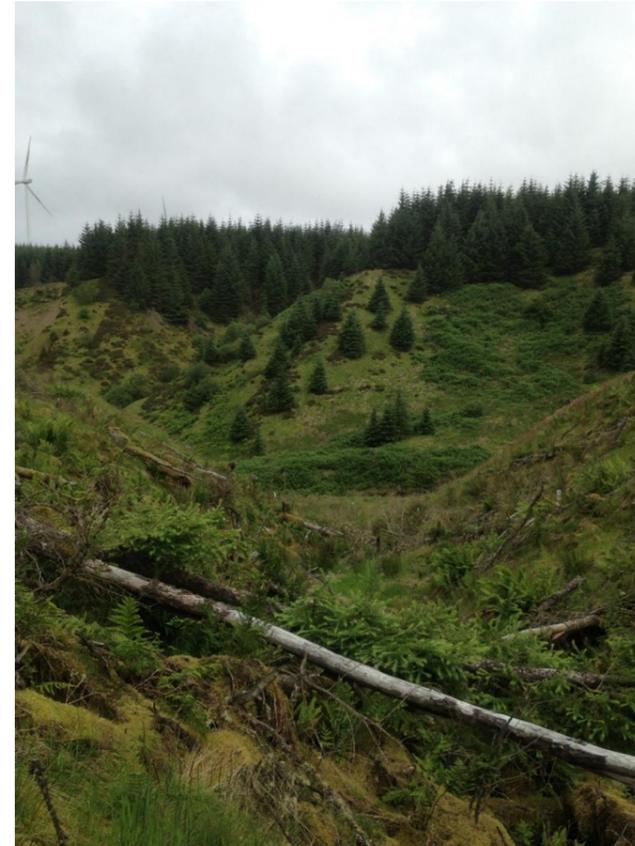
Photograph 6.3: View north west from top of steep slope towards the Glenkiln Burn, from NGR 301717, 593217

Photograph taken at approximately 290mAOD, east of the Glenkiln Burn in the central part of the Site. This location was identified for its steep gradient using OS mapping and DTM and visited due to the proximity of Turbine 4. The slope at this break of slope location is approximately 32 degrees, decreasing to 10 degrees downslope. Measured peat depths at the top of the slope are between 0.2m and 0.4m and therefore not considered a peat zone. Evidence of slope instability were noted within these incised banks of the Glenkiln Burn (also see Photograph 6.4).

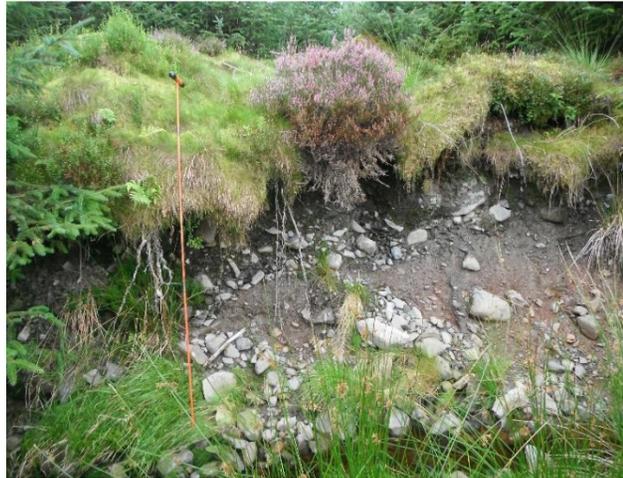
Photograph 6.4: View west towards eroding channel bank of the Yellowtree Grain, from NGR 303228, 593371

Photograph taken at approximately 305mAOD in the central part of the Site, showing active erosion on the right Yellowtree Grain bank, with a shallow surface peat layer underlain by boulder clay containing mineral soil material. The average slope gradient derived from the DTM at the eroding bank location is 10 degrees. This is a non-peat failure.

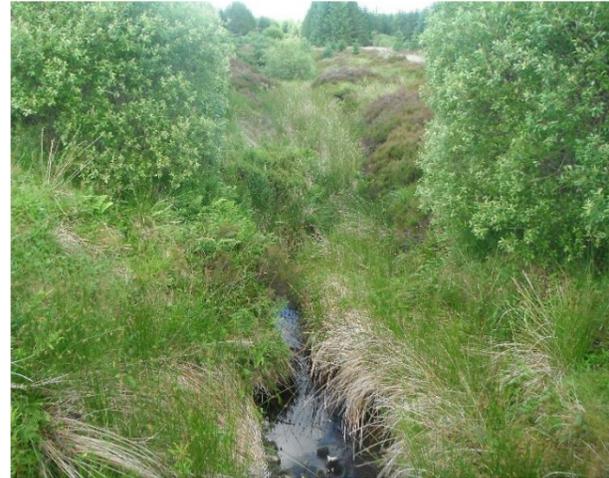
Photograph 6.6: View looking north upstream on the Ox Cleuch, from NGR 301660, 593821

Photograph taken at approximately 320mAOD at the proposed crossing location of the Ox Cleuch, in the northern central part of the Site. Measured peat depth at this crossing was 1.40m. The slope gradient is gentle and the flow observed was slow at the time of visit. The watercourse is located within an incised channel and downstream there is evidence of bank collapse, as a non-peat failure.

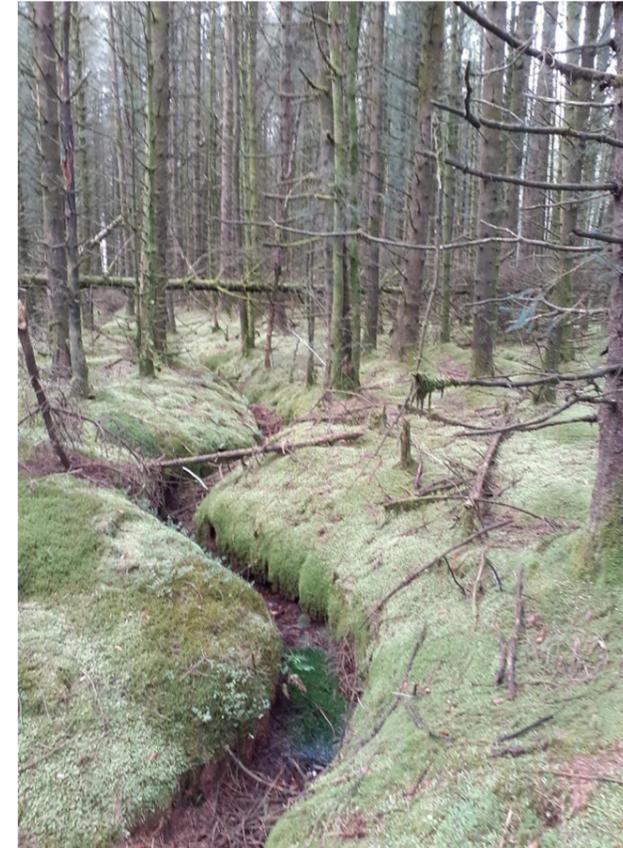
Photograph 6.7: View looking north from PC01 at NGR 300492, 593418

Photograph taken at approximately 340mAOD at the proposed PC01 location, showing a semi-natural forestry drainage channel within conifer plantation in the north western part of the Site. Measured peat depths in the area ranged between 0.1m and 2.75m. The slope gradient is gentle and no apparent runoff was noted at the time of the visit.

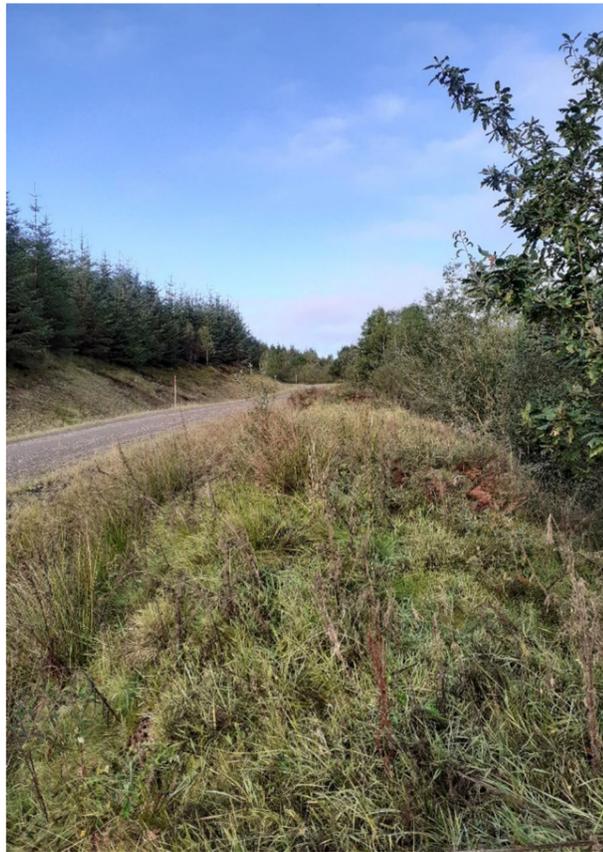
Photograph 6.9: Looking west at existing track embankment at NGR 303641, 590718, as per the viewpoint shown.

Photograph taken at approximately 170mAOD, looking west along existing track embankment to the north of the track to be upgraded.

This location was identified as an Initial Risk concern due to its steep gradient using OS mapping and DTM, in tandem with the proximity of the proposed track to be upgraded. Measured peat depths in the area are generally less than 0.5m. Such bankings were noted in various trackside locations and may skew slope stability results when combining the artificially engineered slope angle with the depth of banked material. At the location where the photograph was taken, the slope angle is approximately 5 degrees, increasing to 15 degrees at the break of slope. Although fallen trees were abundant on the steep slope below, there were no signs of peat instability or mass movement.

This area is discussed in PSA Area A in Annex B.

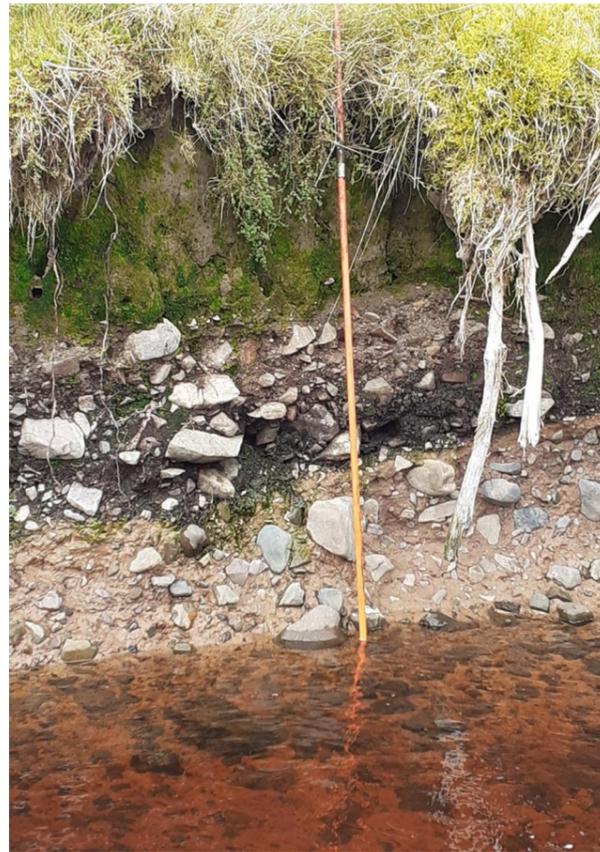
Photograph 6.10: View west towards eroding channel bank of the Glenkiln Burn, from NGR 302099, 593853.

Photograph taken at approximately 305mAOD in the central part of the Site, showing active fluvial erosion on the right bank of the Glenkiln Burn, with a shallow surface peat layer (approximately 0.5m depth) underlain by boulder clay containing mineral soil material. The average slope gradient derived from the DTM at the eroding bank location is 5 degrees. This is a non-peat failure.
