# Technical Appendix 6.5

## Initial Borrow Pit Assessment

**Harestanes South Windfarm Extension Project Team**

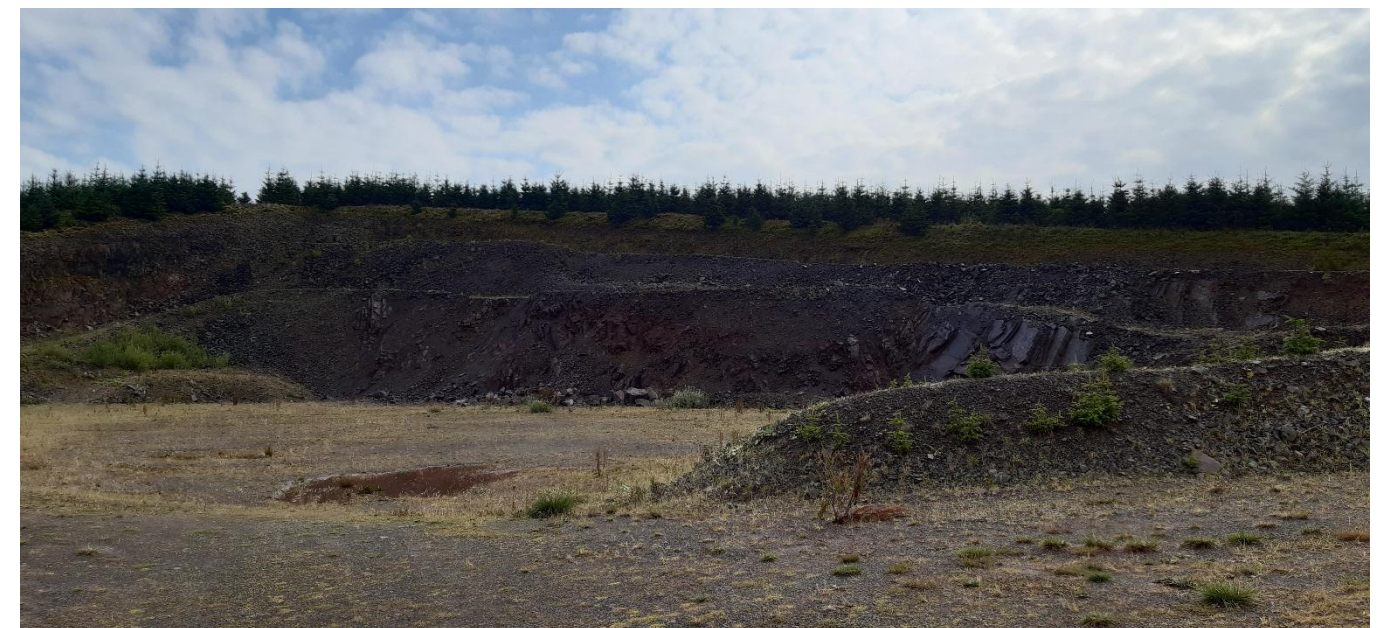
Photograph 1: Photograph taken at NGR: 302416 593813, looking north east across existing quarry and proposed borrow pit BP01.

27. Borrow Pit BP01 is located to the north of Whitefauld Hill within the Forest of Ae, centred at NGR 302437, 593874. It is located at the site of a quarry, likely used to extract aggregate for the existing tracks. **Photograph 1** and **2** show the current area where proposed excavation would take place.

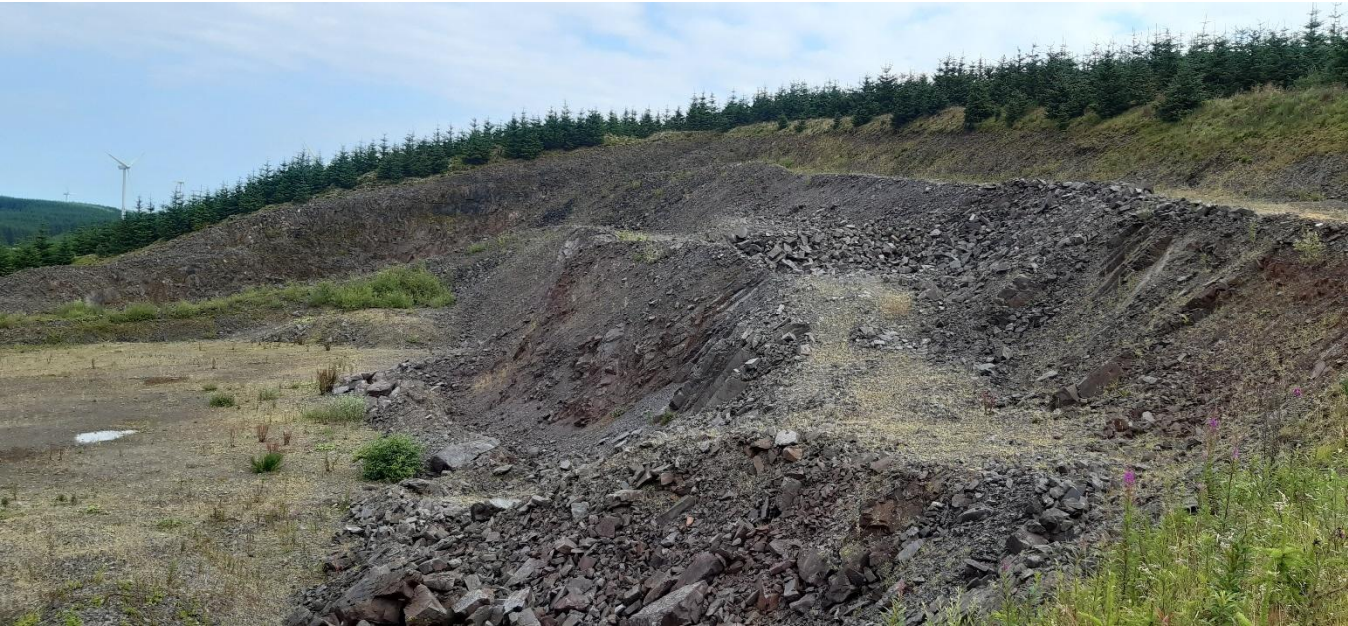
Photograph 2: Photograph from NGR: 30247 59378, showing view from side of quarry, looking north. Proposed borrow pit BP01 will continue quarry into hillside to the right.

28. Bedrock is clearly exposed in the quarry. The lithology is:
- reddish brown and grey;
  - medium strong to strong;
  - fine to medium grained;
  - thin to thickly bedded; and
  - interbedded sandstone and siltstone.
29. There is a high proportion of fine-grained siltstone which is more susceptible to weathering once exposed at the surface. **Photograph 3** shows a closer view of the quarry face; a lot of weathered fine material is evident.

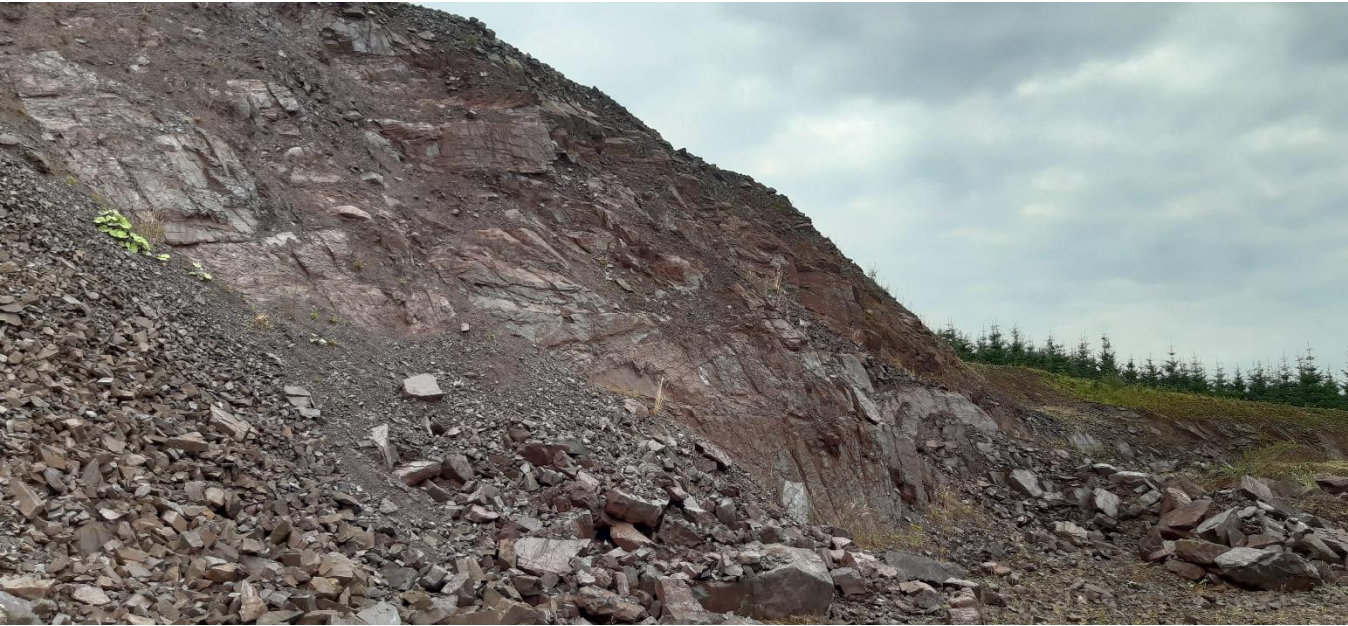
Photograph 3: Photograph from NGR: 30246 59386, showing view of quarry face, looking south.

30. Geological mapping and onsite peat probing surveys indicate that superficial deposits on the ground above the quarry consist of peat, with depths ranging from 0 – 0.9m, resulting in an average of 0.3m. The surface elevation in this area is approximately 340 to 360m AOD.
31. Bedrock in the area above the quarry is generally not visible, being covered by superficial deposits and vegetation. The geological mapping indicates no change in the rock type so it can be assumed to be the same as the quarry.

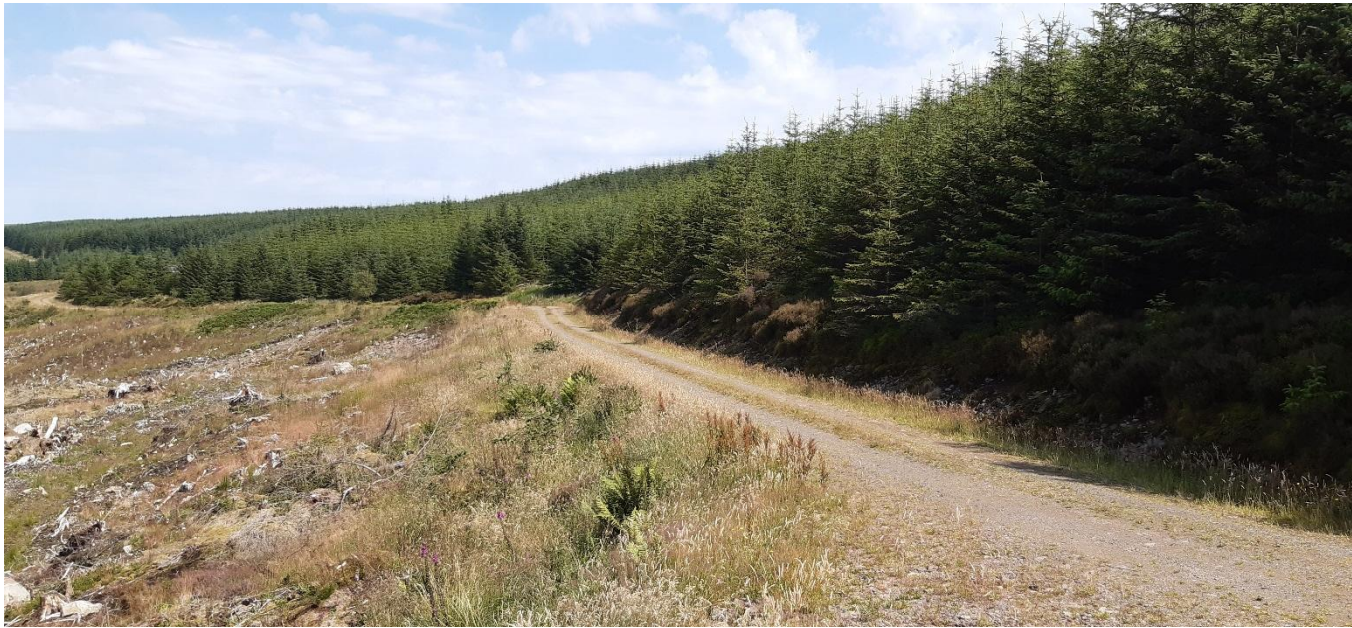
Photograph 4: Photograph taken at NGR: 30143 59250, looking north. Proposed BP02 would extend into the forest in the foreground.

32. Proposed Borrow Pit BP02 is located on the west slope of Pumro Fell within the Forest of Ae, centred at NGR 301446, 592335. It is located approximately 300m east of the Glenkiln Burn. **Photograph 4** and **5** show the current area where proposed excavation would take place.

33. Geological mapping indicates that superficial deposits consist of Glacial Till. Onsite peat probing surveys have confirmed this is overlain by peat, with depths ranging from 0.1 – 0.5m, resulting in an average of 0.3m. The surface elevation in this area is approximately 320 to 380mAOD.
34. Bedrock is generally not visible, being covered by superficial deposits and vegetation, however the geological mapping indicates this is the same rock strata as seen in the quarry. Boulders seen beside the track and in cuttings are of the same rock type.

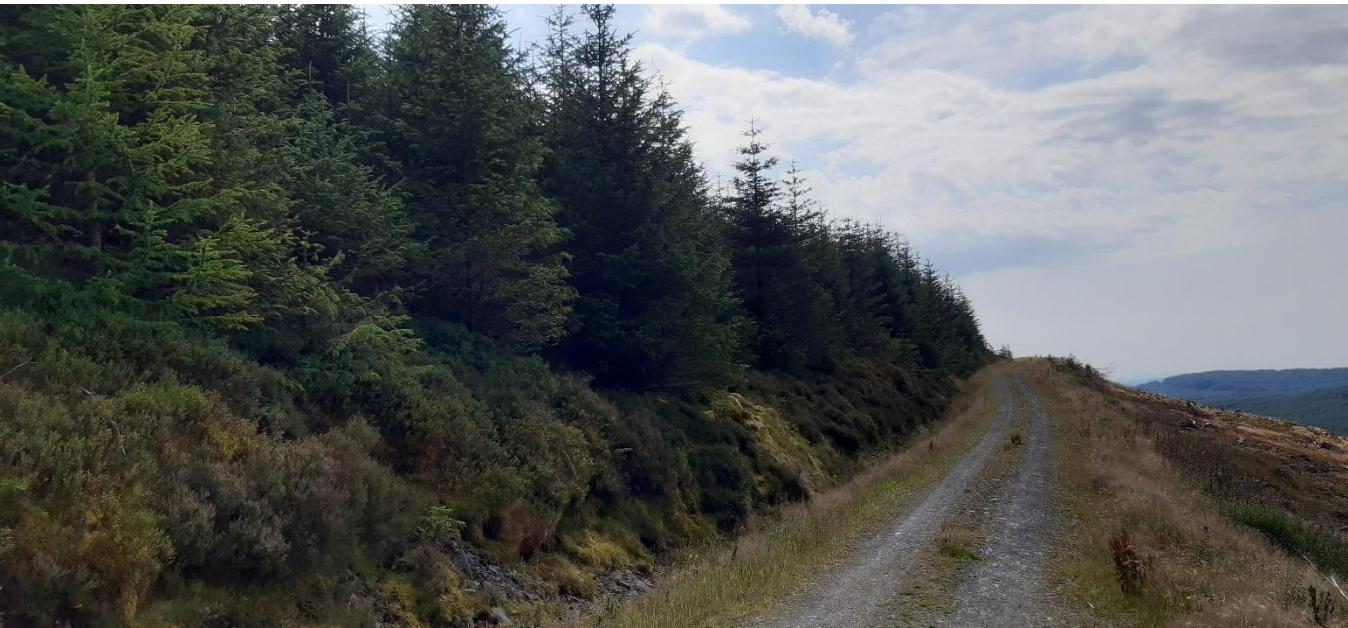
Photograph 5: Photograph taken at NGR: 30143 59250, looking south. Proposed BP02 would extend into the forest in the foreground.

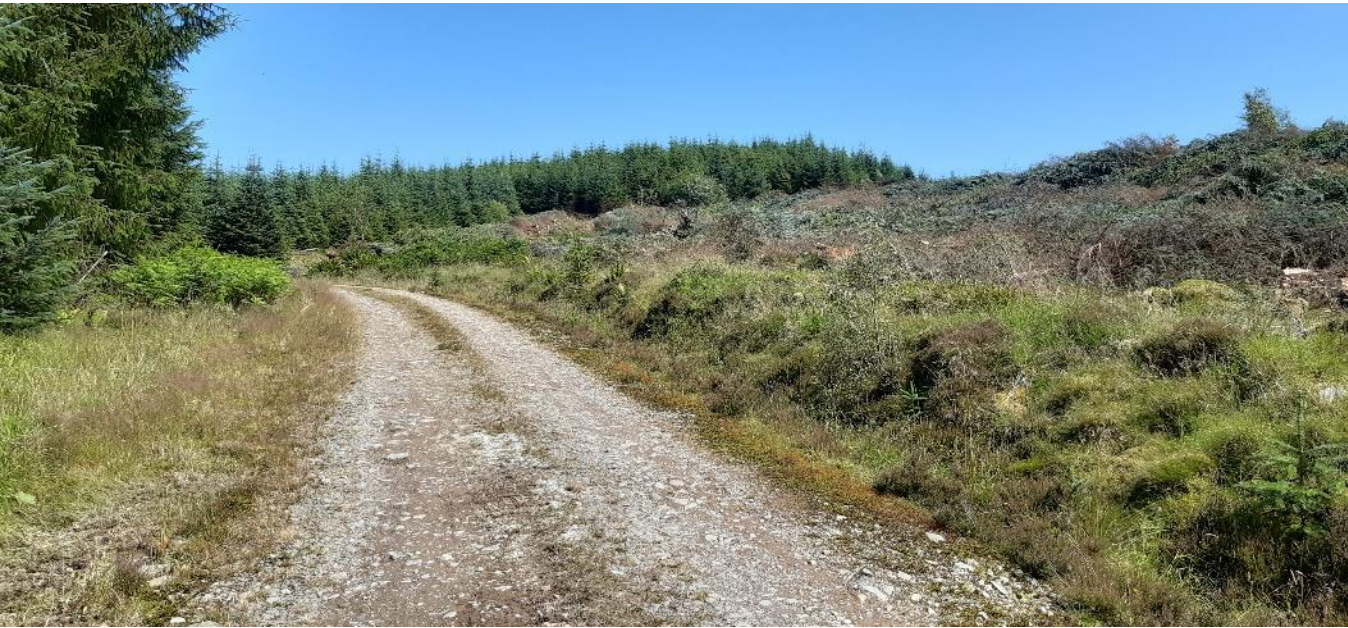
Photograph 6: Photograph taken at NGR: 30056 59200, looking north. Proposed BP03 would be on the hillside to the right and extend into the forest in the background.

35. Proposed Borrow Pit BP03 is located on the north east of Brownmoor Hill within the Forest of Ae, centred at NGR 300629, 592257. It is approximately 1km west of BP02. **Photograph 6** shows the current area where proposed excavation would take place.

36. Geological mapping and onsite peat probing surveys indicate that superficial deposits are peat, with depths ranging from 0.2 – 0.5m, resulting in an average of 0.4m. The surface elevation in this area is approximately 260 to 320mAOD.

37. Bedrock is generally not visible, being covered by superficial deposits and vegetation. The geological mapping indicates this is of a different geological unit to BP01 and BP02 although the rock type is the same; they are both sandstone bedded with siltstone and mudstone. Sandstone and siltstone can be seen in boulders seen beside the track and in cuttings but there is not enough exposure to note any difference between this locality and the others.
