SHEIRDRIM RENEWABLE ENERGY DEVELOPMENT

Technical Appendix 10.4: Schedule of Watercourse Crossings
Prepared for: ScottishPower Renewables

SLR Ref: 405.00481.00051
Version 1
October 2019

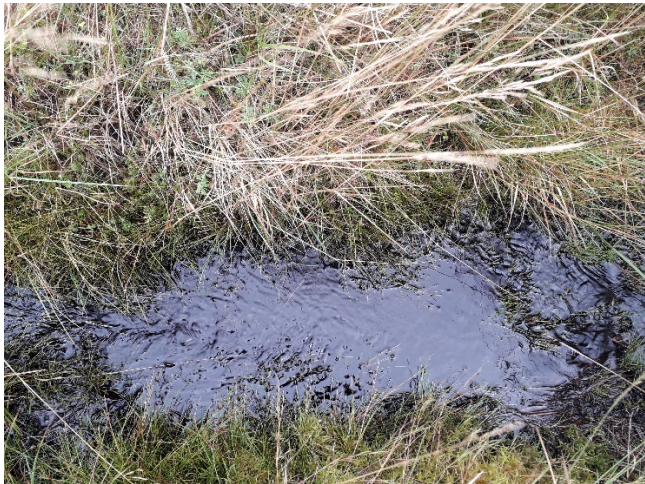
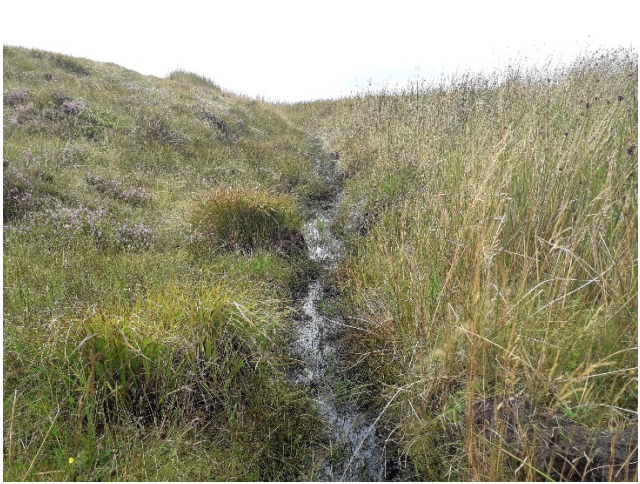
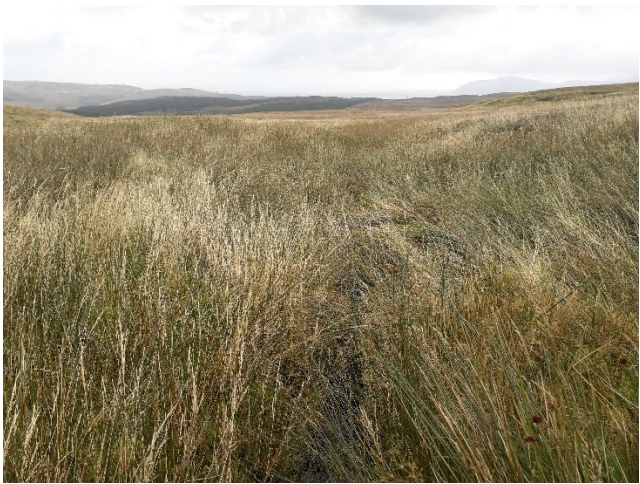
Watercourse Crossing Details	Photograph off Existing/New Watercourse Crossing Point	Photograph Looking Upstream of Watercourse Crossing	Photograph Looking Downstream of Watercourse Crossing
Watercourse Crossing: WX07 Status: New NGR: NR 82365 56841 Watercourse Width: 0.2 m Watercourse Depth: 0.05 m Notes: Minor watercourse incised in peaty soil with grasses. Low flow.

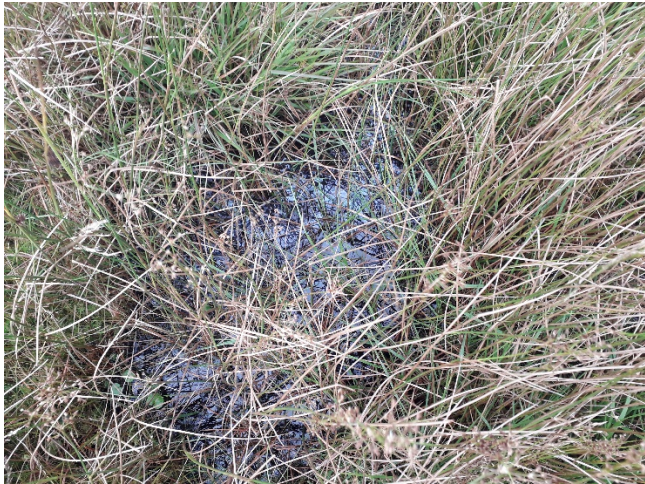
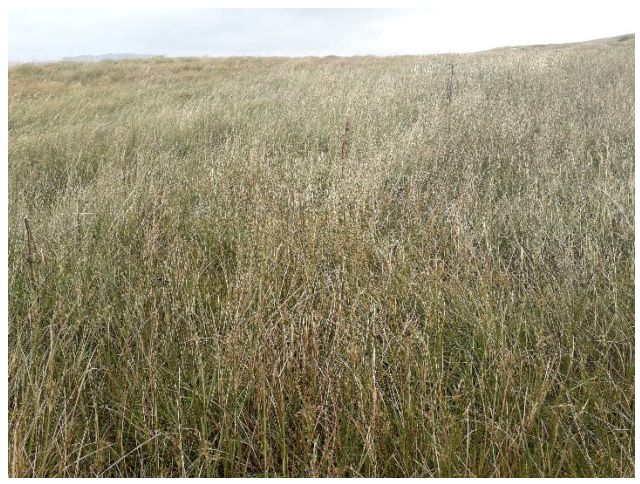
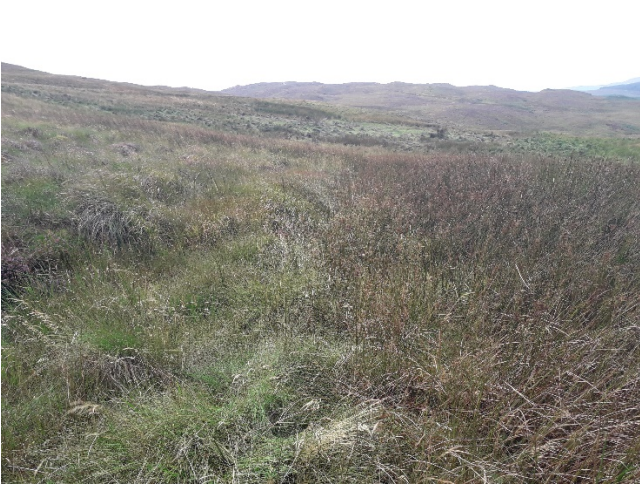
Watercourse Crossing: WX08 Status: New NGR: NR 81819 57071 Watercourse Width: N/A Watercourse Depth: N/A Notes: No flow was observed but some water ponding. Ponded area is located within peat, reeds and mosses and extends to approximately 0.4 m wide and is 0.1 m deep.

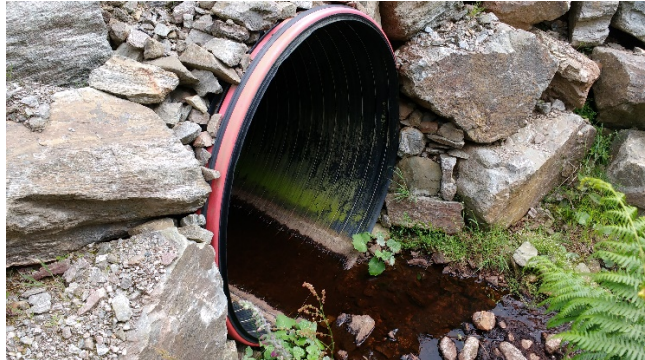
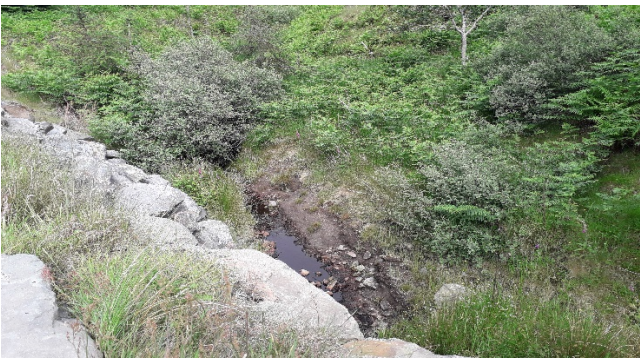
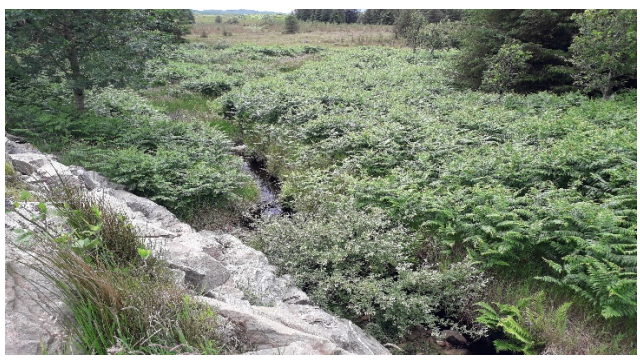
Watercourse Crossing: WX09 Status: Existing NGR: NR 80021 56873 Watercourse Width: 0.5 m Watercourse Depth: 0.4 m Notes: Large existing circular plastic culvert (1.8 m in diameter).

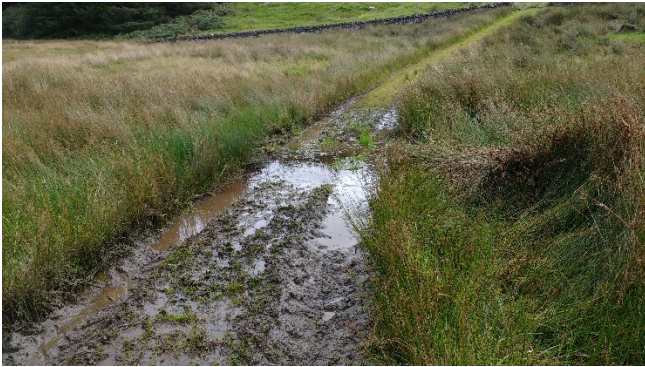
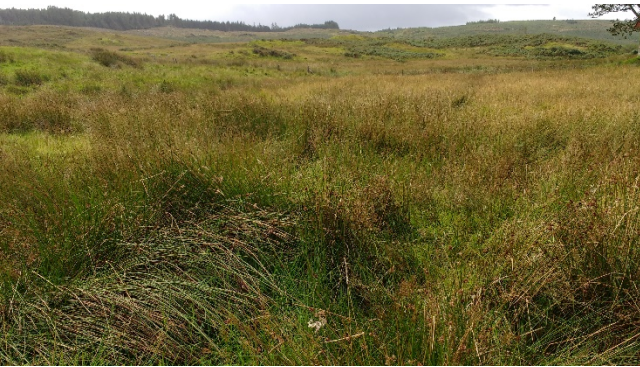
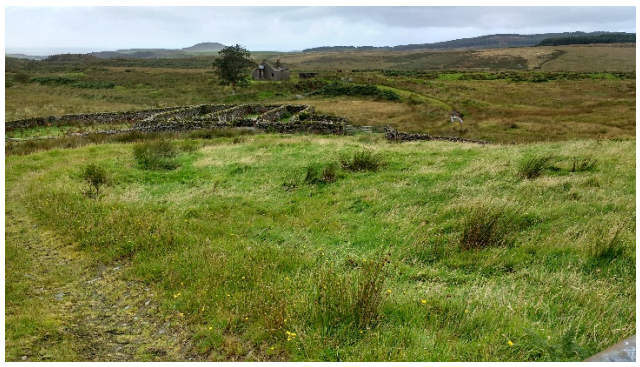
Watercourse Crossing: WX10 Status: Existing NGR: NR 79434 56358 Watercourse Width: 1 m Watercourse Depth: 0.1 m Notes: Ford crossing minor watercourse from small catchment as overland flow. Watercourse spreads at ford and becomes more confined downstream.
