Technical Appendix 9.1: Photographs

Natural Drainage Channels & Evidence of Erosion

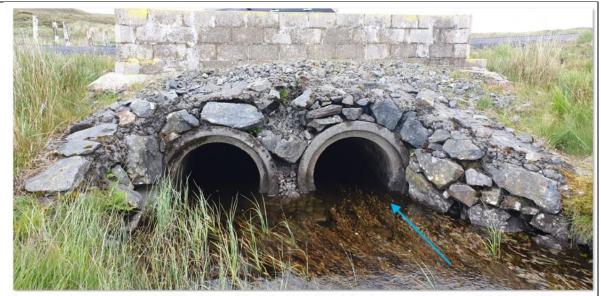
Baseline Sampling Location SW1 – 09/04/19

Example of natural drainage channel which has been modified by the introduction of this watercourse crossing (associated with the existing Barnesmore Windfarm). Lough Golagh discharges into receiving surface water system at this location i.e. baseline sampling location SW1. Photo taken during site survey carried out 09/04/19.

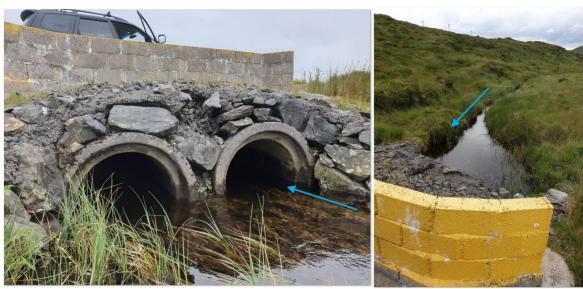
Baseline Sampling Location SW1 - 25/07/19

Baseline sampling location SW1. Photo taken during site survey carried out 25/07/19.

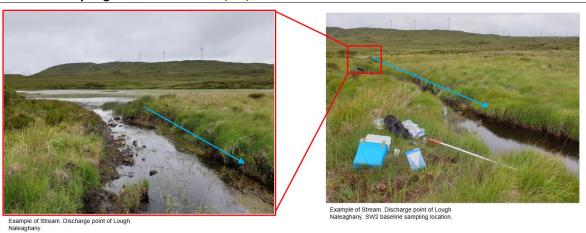
Baseline Sampling Locations SW3

Example of Stream. Lowerymore 030 and SW3
Baseline Sampling Location

Example of Stream. Lowerymore 030 and SW3-B and SW3-C Baseline Sampling Locations.

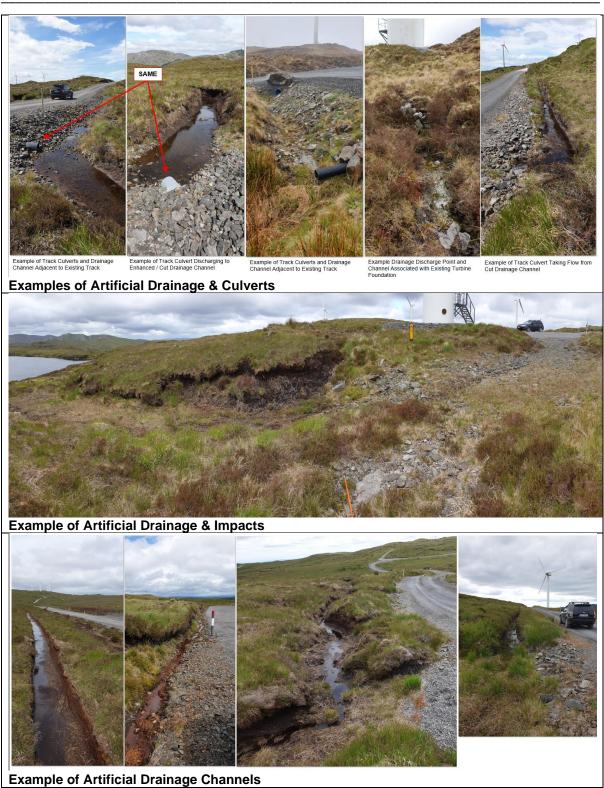
Example of Artificial Drainage & Culvert

Example of Track Culverts and Drainage. Receiving surface water runoff from enhanced natural drainage channels and discharging to natural drainage channels on the downgradient side of the existing trackway.
