Hare Hill Windfarm Repowering and Extension

**Environmental Impact Assessment
Report**

**Technical Appendix 9.1: Watercourse
Crossing Assessment**

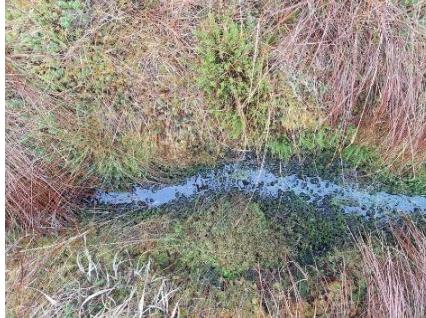
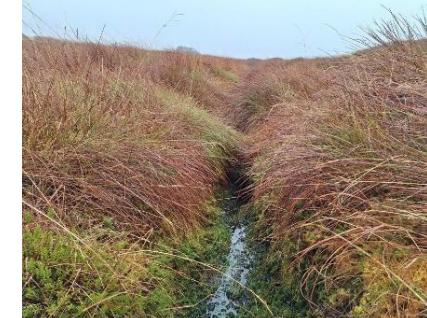
Table 4.1 WX1 Detailed Assessment

<ul style="list-style-type: none"> • Existing crossing: No • Channel Type: Artificial drainage channel • Gradient: Gentle • Valley form: No obvious valley sides • Bank condition: Undercut (no evidence of recent collapse) • Bed material: Vegetation, Peat • Riparian corridor: Moorland • Flow condition: Very slow <ul style="list-style-type: none"> • Water width (m): 0.11 • Water depth (m): 0.07 • Bankfull width (m): 0.32 • Bankfull height (m): 0.12 • Banktop height (m): 0.12 • Flooded Bankfull width (m): 0.44 • Flooded Bankfull height: 0.15 <p>Present on 1:50,000 scale OS map? No</p> <p>Note: None.</p> <p>EASR Auth Level: GBR</p> <p>Proposed Crossing Type: To accommodate flow, a circular culvert is proposed.</p>
<h3>Crossing Photographs</h3> <p>Upstream</p>

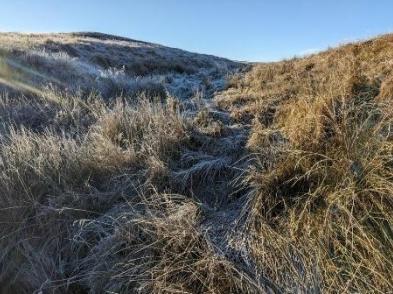
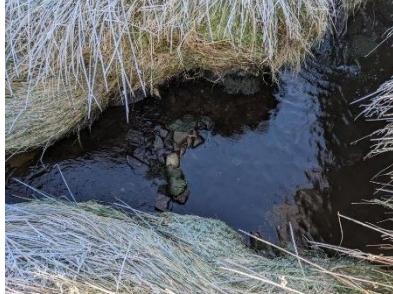
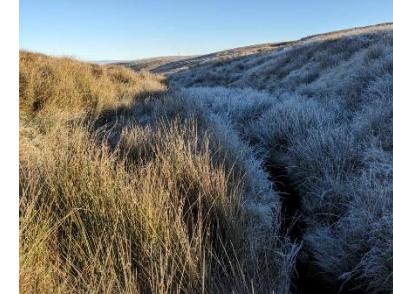
Table 4.2 WX2 Detailed Assessment

<small>© Crown Copyright 2025. All rights reserved. Ordnance Survey Licence 0100031673.</small>	<ul style="list-style-type: none"> • Existing crossing: No • Channel Type: Incised • Gradient: Moderate • Valley form: Deep vee • Bank condition: Stable • Bed material: Coarse gravel, Rounded pebbles, Boulders • Riparian corridor: Moorland • Flow condition: Moderate • Water width (m): 0.50 • Water depth (m): 0.20 • Bankfull width (m): 0.80 • Bankfull height (m): 0.40 • Banktop height (m): 2.50 • Flooded Bankfull width (m): 2.00 • Flooded Bankfull height: 1.00 <p>Present on 1:50,000 scale OS map? Yes</p> <p>Note: Substantial channel, may require a bridge or track relocation</p> <p>EASR Auth Level: Registration</p> <p>Proposed Crossing Type: The stream is located within a deep valley, where a small conventional bridge could provide the most effective watercourse crossing.</p>

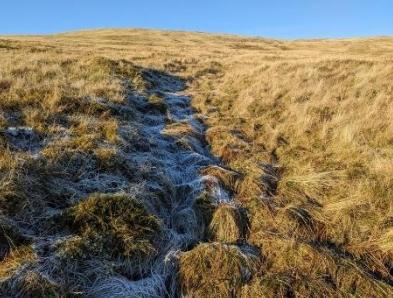
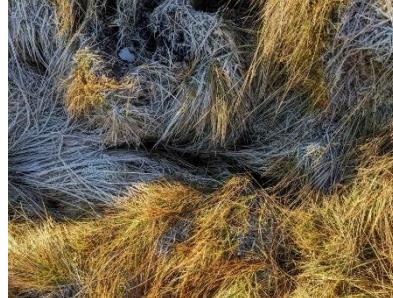
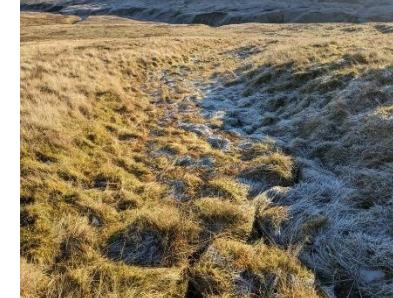
Table 4.3 WX3 Detailed Assessment

<ul style="list-style-type: none"> • Existing crossing: No • Channel Type: Poorly defined • Gradient: Moderate • Valley form: Shallow vee • Bank condition: N/A • Bed material: Vegetation • Riparian corridor: Moorland • Flow condition: Stagnant <p>• Water width (m): 0.10</p> <p>• Water depth (m): 0.10</p> <p>• Bankfull width (m): 0.30</p> <p>• Bankfull height (m): 0.15</p> <p>• Banktop height (m): -</p> <p>• Flooded Bankfull width (m): 0.50-1.00</p> <p>• Flooded Bankfull height: 0.25</p> <p>Present on 1:50,000 scale OS map? No</p> <p>Note: Vegetated channel with some stagnant water but no flow. On day of survey this is not a watercourse but during wet conditions there could be some surface run off flow</p> <p>EASR Auth Level: GBR</p> <p>Proposed Crossing Type: To accommodate flow, a circular culvert is proposed.</p>
Crossing Photographs

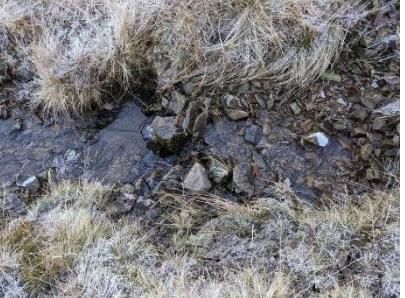
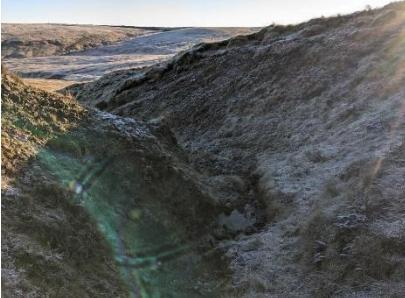
Table 4.4 WX4 Detailed Assessment

<p>© Crown Copyright 2025. All rights reserved. Ordnance Survey Licence 0100031673.</p>	<p>Crossing Description</p> <ul style="list-style-type: none"> • Existing crossing: No • Channel Type: Incised • Gradient: Steep • Valley form: Gorge • Bank condition: Stable • Bed material: Rounded pebbles, Coarse gravel, Boulders, Bedrock • Riparian corridor: Moorland • Flow condition: Moderate <ul style="list-style-type: none"> • Water width (m): 0.80 • Water depth (m): 0.10 • Bankfull width (m): 1.20 • Bankfull height (m): 0.30 • Banktop height (m): 3.00-4.00 • Flooded Bankfull width (m): 1.50-2.00 • Flooded Bankfull height: 1.00 <p>Present on 1:50,000 scale OS map? Yes</p> <p>Note: Substantial Gorge</p> <p>EASR Auth Level: Registration</p> <p>Proposed Crossing Type: The surveyor noted that there is a substantial gorge at this location which will require a bridge crossing or track relocation.</p>

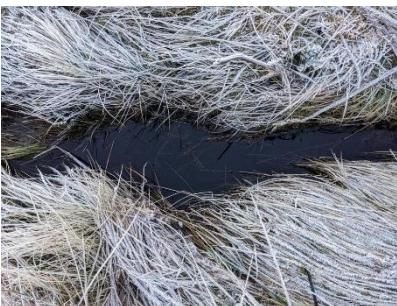
Table 4.5 WX5 Detailed Assessment

<p>© Crown Copyright 2025. All rights reserved. Ordnance Survey Licence 0100031673.</p>	<ul style="list-style-type: none"> • Existing crossing: No • Channel Type: Incised • Gradient: Steep • Valley form: Deep vee • Bank condition: Stable • Bed material: Coarse gravel, Vegetation • Riparian corridor: Moorland • Flow condition: Moderate <p>• Water width (m): 0.20</p> <p>• Water depth (m): 0.20</p> <p>• Bankfull width (m): 0.30</p> <p>• Bankfull height (m): 0.25</p> <p>• Banktop height (m): -</p> <p>• Flooded Bankfull width (m): 0.50-1.00</p> <p>• Flooded Bankfull height: 0.30-0.40</p> <p>Present on 1:50,000 scale OS map? No</p> <p>Note: Watercourse contained in a small gully.</p> <p>EASR Auth Level: GBR</p> <p>Proposed Crossing Type: To accommodate flow, a circular culvert is proposed.</p>
Crossing Photographs	
<p>Upstream</p>

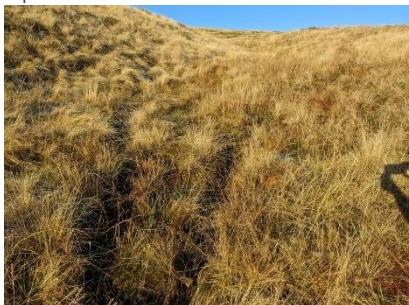
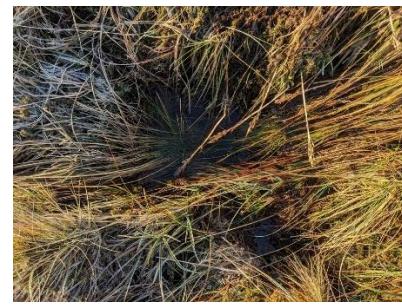
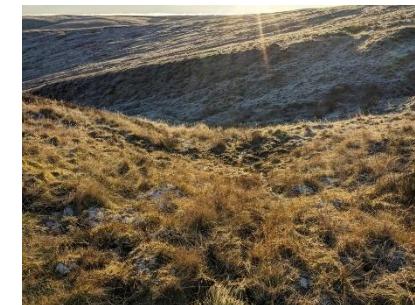
Table 4.6 WX6 Detailed Assessment

WX6 (265439, 607015)	
Crossing Location	Crossing Description
	<p>Crossing Description</p> <ul style="list-style-type: none"> • Existing crossing: No • Channel Type: Poorly defined • Gradient: Moderate • Valley form: Shallow vee • Bank condition: • Bed material: Vegetation • Riparian corridor: Moorland • Flow condition: Stagnant <p>• Water width (m): 0.10</p> <p>• Water depth (m): 0.10</p> <p>• Bankfull width (m): 0.30</p> <p>• Bankfull height (m): 0.15</p> <p>• Banktop height (m): -</p> <p>• Flooded Bankfull width (m): 0.50-1.00</p> <p>• Flooded Bankfull height: 0.25</p> <p>Present on 1:50,000 scale OS map? No</p> <p>Note: Small watercourse, mostly vegetated.</p> <p>EASR Auth Level: GBR</p> <p>Proposed Crossing Type: To accommodate flow, a circular culvert is proposed.</p>

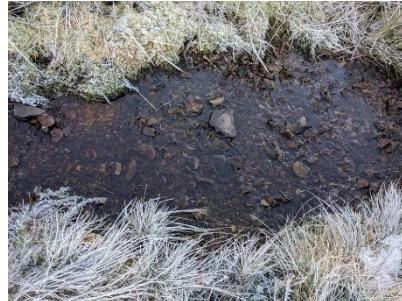
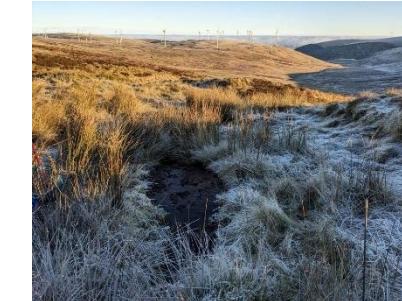
Table 4.7 WX7 Detailed Assessment

<p>© Crown Copyright 2025. All rights reserved. Ordnance Survey Licence 0100031673.</p>	<ul style="list-style-type: none"> • Existing crossing: No • Channel Type: Incised • Gradient: Steep • Valley form: Deep vee • Bank condition: Stable • Bed material: Coarse gravel, Vegetation • Riparian corridor: Moorland • Flow condition: Moderate • Water width (m): 0.30 • Water depth (m): 0.08 • Bankfull width (m): 0.80 • Bankfull height (m): 0.20 • Banktop height (m): - • Flooded Bankfull width (m): 1.00-2.00 • Flooded Bankfull height: 0.30 <p>Present on 1:50,000 scale OS map? No</p> <p>Note: Watercourse contained in gully, with eroded banks 25 m upstream showing evidence of frequent flooding.</p> <p>EASR Auth Level: GBR</p> <p>Proposed Crossing Type: To accommodate flow, a circular culvert is proposed.</p>
<p>Crossing Photographs</p> <p>Upstream

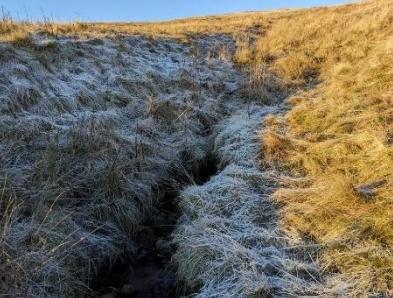
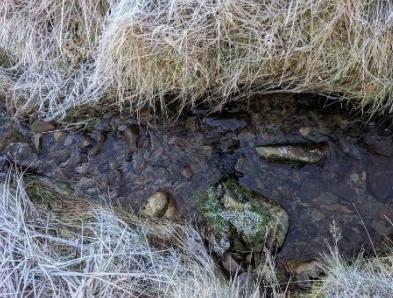
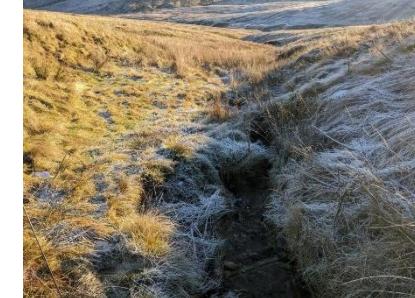
Table 4.8 WX8 Detailed Assessment

<p>© Crown Copyright 2025. All rights reserved. Ordnance Survey Licence 0100031673.</p>	<p>Crossing Description</p> <ul style="list-style-type: none"> • Existing crossing: No • Channel Type: Incised • Gradient: Moderate • Valley form: Deep vee, Gorge • Bank condition: Stable • Bed material: Fine sand/silt, Rounded pebbles, Coarse gravel, Boulders, Vegetation • Riparian corridor: Moorland • Flow condition: Moderate <p>• Water width (m): 0.80 • Water depth (m): 0.20 • Bankfull width (m): 1.00 • Bankfull height (m): 0.40 • Banktop height (m): 2.50 • Flooded Bankfull width (m): 1.50 • Flooded Bankfull height: 0.50</p> <p>Present on 1:50,000 scale OS map? Yes</p> <p>Note: Watercourse within small gully channel, may require a small bridge or track relocation 30 m upstream.</p> <p>EASR Auth Level: Registration</p> <p>Proposed Crossing Type: The stream is located within a deep valley, where a small conventional bridge could provide the most effective watercourse crossing.</p>

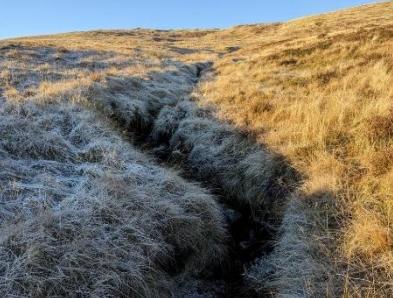
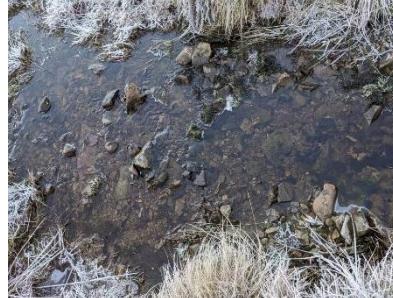
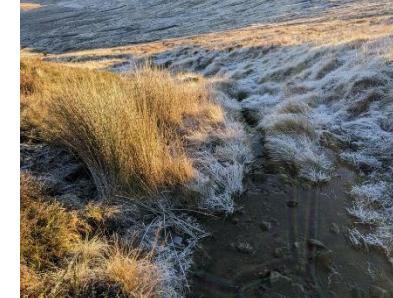
Table 4.9 WX9 Detailed Assessment

<p>Crossing Description</p> <ul style="list-style-type: none"> • Existing crossing: No • Channel Type: Incised • Gradient: Steep • Valley form: Shallow vee, Deep vee • Bank condition: Stable • Bed material: Fine sand/silt, Rounded pebbles, Coarse gravel, Boulders, Vegetation • Riparian corridor: Moorland • Flow condition: Moderate <p>• Water width (m): 0.80</p> <p>• Water depth (m): 0.10</p> <p>• Bankfull width (m): 1.20</p> <p>• Bankfull height (m): 0.20</p> <p>• Banktop height (m):</p> <p>• Flooded Bankfull width (m): 1.50-2.00</p> <p>• Flooded Bankfull height: 0.30</p> <p>Present on 1:50,000 scale OS map? Yes</p> <p>Note: None</p> <p>EASR Auth Level: Registration</p> <p>Proposed Crossing Type: To accommodate flow, a circular culvert is proposed.</p>
<p>Crossing Photographs</p> <p>Upstream

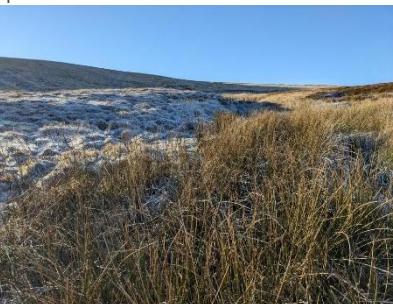
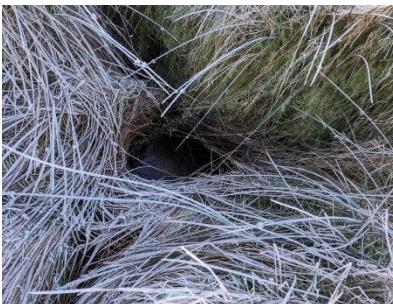
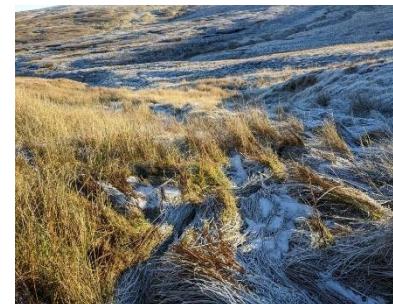
Table 4.10 WX10 Detailed Assessment

<p>© Crown Copyright 2025. All rights reserved. Ordnance Survey Licence 0100031673.</p>	<p>Crossing Description</p> <ul style="list-style-type: none"> • Existing crossing: No • Channel Type: Incised • Gradient: Moderate • Valley form: Shallow vee, Deep vee • Bank condition: Stable • Bed material: Vegetation • Riparian corridor: Moorland • Flow condition: Moderate <p>• Water width (m): 0.10 • Water depth (m): 0.05 • Bankfull width (m): 0.30 • Bankfull height (m): 0.20 • Banktop height (m): 2.00 • Flooded Bankfull width (m): 1.50-2.00 • Flooded Bankfull height: 0.30</p> <p>Present on 1:50,000 scale OS map? No Note: Channel mostly obscured by vegetation but can hear the water flow. EASR Auth Level: GBR Proposed Crossing Type: To accommodate flow, a circular culvert is proposed.</p>
Crossing Photographs	
<p>Upstream</p>

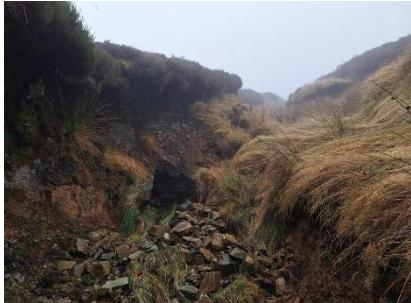
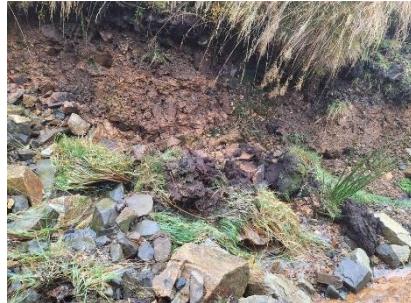
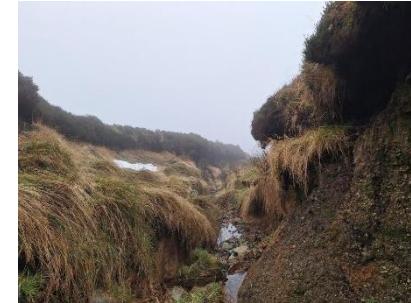
Table 4.11 WX11 Detailed Assessment

- **Existing crossing:** No
- **Channel Type:** Poorly defined, Artificial drainage channel
- **Gradient:** Steep
- **Valley form:** No obvious valley sides
- **Bank condition:** Unstable (potential recent collapse)
- **Bed material:** Rounded pebbles, Coarse gravel, Boulders, Vegetation, Peat, Soil
- **Riparian corridor:** Moorland
- **Flow condition:** Slow
- **Water width (m):** 0.11
- **Water depth (m):** 0.04
- **Bankfull width (m):** 0.81
- **Bankfull height (m):** 0.22
- **Banktop height (m):** 0.22
- **Flooded Bankfull width (m):** 1.24
- **Flooded Bankfull height:** 0.31

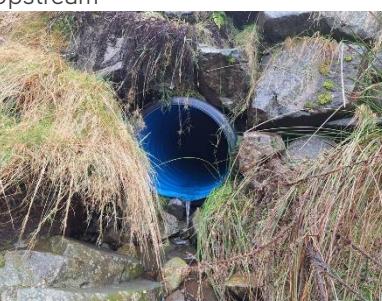
Table 4.12 WX12 Detailed Assessment

<p>© Crown Copyright 2025. All rights reserved. Ordnance Survey Licence 0100031673.</p>	<ul style="list-style-type: none"> Existing Crossing: Yes Crossing Type (existing): Circular Culvert Crossing Material (existing): Plastic Crossing Condition (existing): Good Channel Type: Artificial drainage channel Gradient: Moderate Valley form: Gorge Bank condition: Undercut (no evidence of recent collapse) Bed material: Boulders, Coarse gravel, Rounded pebbles, Vegetation Riparian corridor: Moorland Flow condition: Moderate 	<ul style="list-style-type: none"> Culvert Dimensions (m): 0.59 Water width (m): 0.42 Water depth (m): 0.06 Bankfull width (m): 0.86 Bankfull height (m): 0.19 Banktop height (m): 0.19 Flooded Bankfull width (m): 1.09 Flooded Bankfull height: 0.25 	
<p>Present on 1:50,000 scale OS map? No</p> <p>Note: Culvert slightly bent on the bottom at the exit end</p> <p>EASR Auth Level: GBR</p> <p>Proposed Crossing Type: To accommodate flow, a circular culvert is proposed.</p>

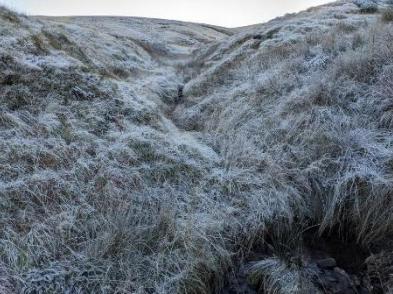
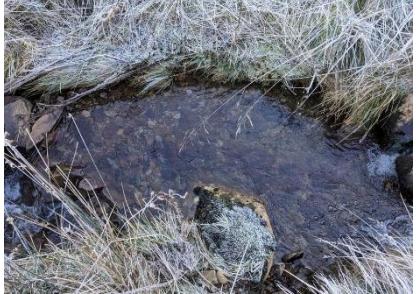
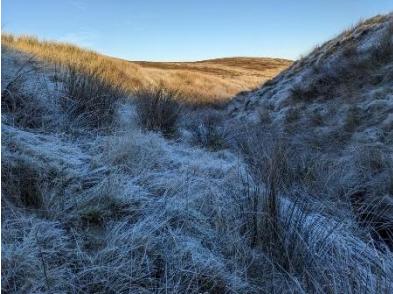
Table 4.13 WX13 Detailed Assessment

<p>© Crown Copyright 2025. All rights reserved. Ordnance Survey Licence 0100031673.</p>	<p>Crossing Description</p> <ul style="list-style-type: none"> • Existing crossing: No • Channel Type: Incised • Gradient: Moderate • Valley form: Gorge, Deep vee • Bank condition: Stable • Bed material: Rounded pebbles, Coarse gravel, Boulders • Riparian corridor: Moorland • Flow condition: Moderate <p>• Water width (m): 1.00 • Water depth (m): 0.25 • Bankfull width (m): 1.30 • Bankfull height (m): 0.35 • Banktop height (m): 4.00 • Flooded Bankfull width (m): 1.50 • Flooded Bankfull height: 0.50</p> <p>Present on 1:50,000 scale OS map? Yes Note: Substantial channel may require a bridge or relocate track. EASR Auth Level: Registration Proposed Crossing Type: The stream is located within a deeply incised valley, where a conventional bridge could provide the most effective watercourse crossing.</p>

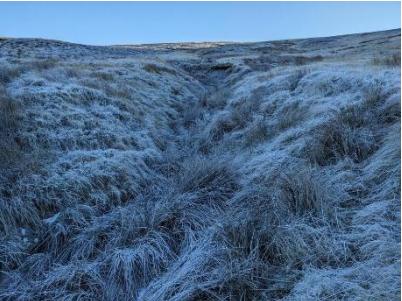
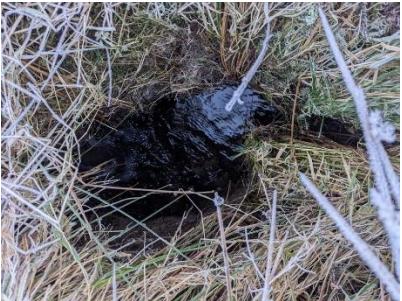
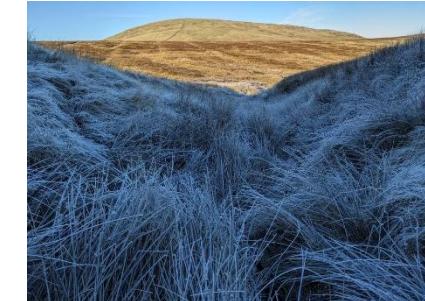
Table 4.14 WX14 Detailed Assessment

<ul style="list-style-type: none"> • Existing crossing: No • Channel Type: Incised • Gradient: Moderate • Valley form: Deep vee • Bank condition: Stable • Bed material: Rounded pebbles, Coarse gravel, Vegetation • Riparian corridor: Moorland • Flow condition: Moderate <p>• Water width (m): 0.30</p> <p>• Water depth (m): 0.10</p> <p>• Bankfull width (m): 0.40</p> <p>• Bankfull height (m): 0.20</p> <p>• Banktop height (m): 2.50</p> <p>• Flooded Bankfull width (m): 1.50-2.00</p> <p>• Flooded Bankfull height: 0.50</p> <p>Present on 1:50,000 scale OS map? Yes</p> <p>Note: Deep Channel</p> <p>EASR Auth Level: Registration</p> <p>Proposed Crossing Type: To accommodate flow, a circular culvert is proposed.</p>
<p>Crossing Photographs</p> <p>Upstream

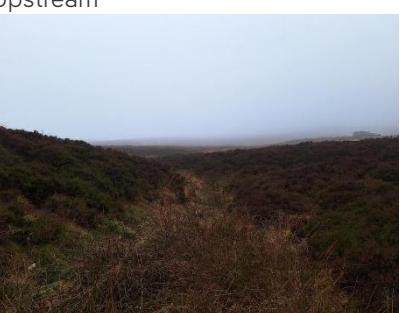
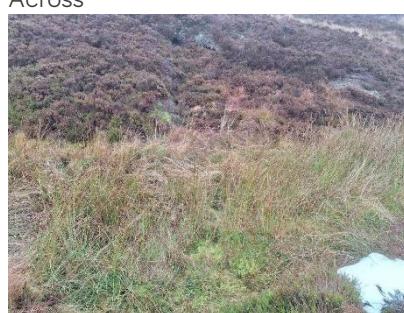
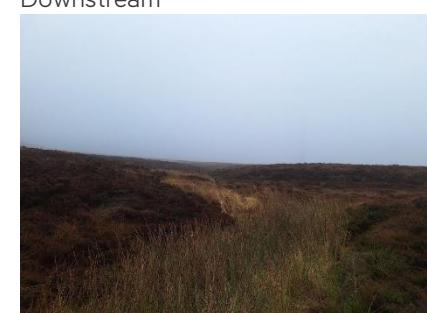
Table 4.15 WX15 Detailed Assessment

<p>© Crown Copyright 2025. All rights reserved. Ordnance Survey Licence 0100031673.</p>	<ul style="list-style-type: none"> • Existing crossing: No • Channel Type: None evident • Gradient: Gentle • Valley form: No obvious valley sides • Bank condition: Undercut (no evidence of recent collapse) • Bed material: Vegetation • Riparian corridor: Heavily Vegetated (e.g. gorse, bramble) • Flow condition: N/A <ul style="list-style-type: none"> • Water width (m): 1.59 • Water depth (m): N/A • Bankfull width (m): N/A • Bankfull height (m): N/A • Banktop height (m): N/A • Flooded Bankfull width (m): N/A • Flooded Bankfull height: N/A <p>Present on 1:50,000 scale OS map? No</p> <p>Note: No flow evident during site visit. Heavily vegetated. Possible artificial ditch</p> <p>EASR Auth Level: GBR</p> <p>Proposed Crossing Type: To accommodate flow, a circular culvert is proposed.</p>

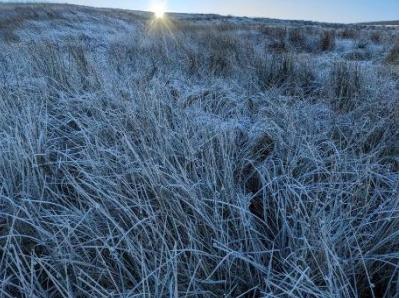
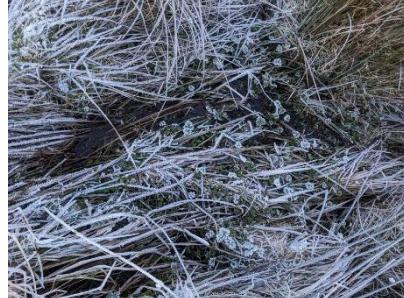
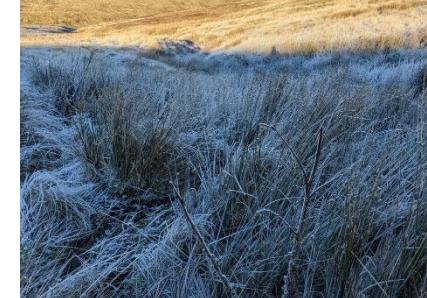
Table 4.16 WX16 Detailed Assessment

<p>© Crown Copyright 2025. All rights reserved. Ordnance Survey Licence 0100031673.</p>	<p>Crossing Description</p> <ul style="list-style-type: none"> • Existing crossing: No • Channel Type: Surface run-off/wetlands only, Poorly defined • Gradient: Moderate • Valley form: Shallow vee, No obvious valley sides • Bank condition: Stable • Bed material: Vegetation • Riparian corridor: Moorland • Flow condition: Very slow <p>• Water width (m): 0.50 • Water depth (m): 0.05 • Bankfull width (m): 0.80 • Bankfull height (m): 0.20 • Banktop height (m): - • Flooded Bankfull width (m): 1.00-2.00 • Flooded Bankfull height: 0.30</p> <p>Present on 1:50,000 scale OS map? Yes Note: Wet flush, no real channel or flow, but could have in wet conditions EASR Auth Level: GBR Proposed Crossing Type: To accommodate flow, a circular culvert is proposed.</p>

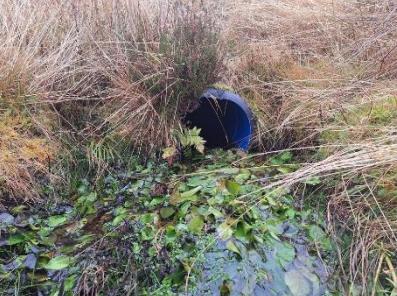
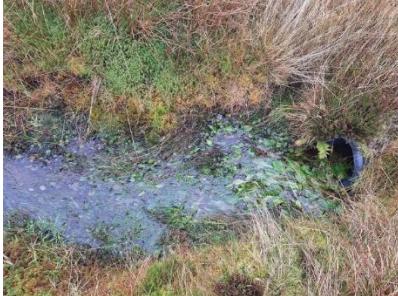
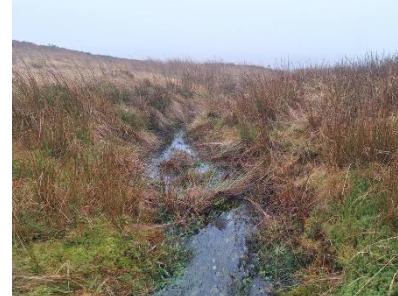
Table 4.17 WX17 Detailed Assessment

<p>© Crown Copyright 2025. All rights reserved. Ordnance Survey Licence 0100031673.</p>	<ul style="list-style-type: none"> Existing Crossing: Yes Crossing Type (existing): Circular Culvert Crossing Material (existing): Plastic Crossing Condition (existing): Average Channel Type: Poorly defined, Incised Gradient: Gentle Valley form: No obvious valley sides Bank condition: Stable Bed material: Vegetation Riparian corridor: Heavily Vegetated (e.g. gorse, bramble), Moorland Flow condition: Slow <p>Present on 1:50,000 scale OS map? No Note: Heavily vegetated upstream. EASR Auth Level: GBR Proposed Crossing Type: To accommodate flow, an upgraded circular culvert is recommended.</p>
<h3>Crossing Photographs</h3> <p>Upstream</p>

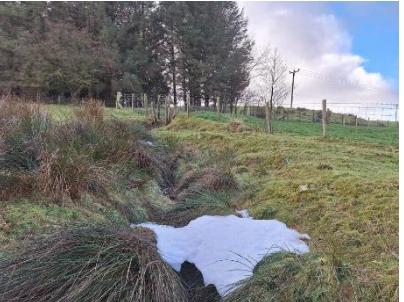
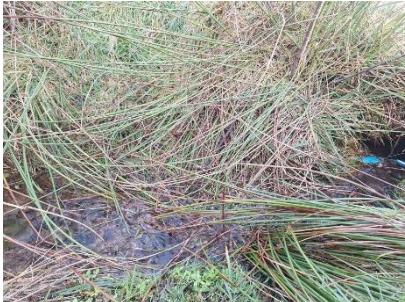
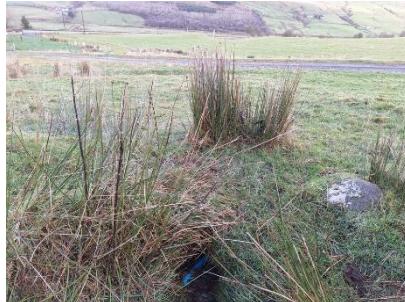
Table 4.18 WX18 Detailed Assessment

<small>© Crown Copyright 2025. All rights reserved. Ordnance Survey Licence 0100031673.</small>	<ul style="list-style-type: none"> • Existing Crossing: Yes • Crossing Type (existing): Circular Culvert • Crossing Material (existing): Plastic • Crossing Condition (existing): Poor • Channel Type: Poorly defined, Incised • Gradient: Moderate • Valley form: Shallow vee • Bank condition: Undercut (no evidence of recent collapse) • Bed material: Rounded pebbles, Coarse gravel, Vegetation • Riparian corridor: Heavily Vegetated (e.g. gorse, bramble), Moorland, Agricultural Grazing • Flow condition: Moderate <p>Culvert Dimensions (m): 0.34 Water width (m): 0.17 Water depth (m): 0.08 Bankfull width (m): 0.65 Bankfull height (m): 0.13 Banktop height (m): 0.13 Flooded Bankfull width (m): 0.72 Flooded Bankfull height: 0.19</p> <p>Present on 1:50,000 scale OS map? No Note: Large hydraulic drop down of the channel flow upon exit of the culvert. EASR Auth Level: GBR Proposed Crossing Type: To accommodate flow, a circular culvert is proposed.</p>

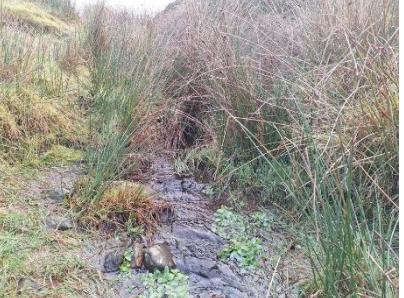
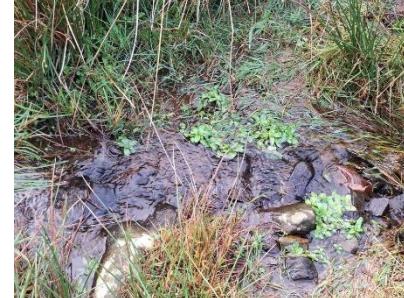
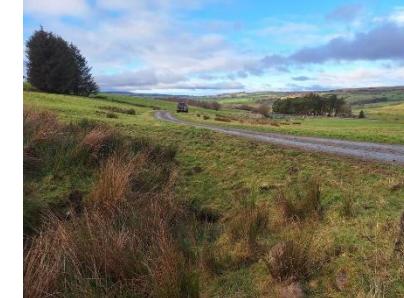
Table 4.19 WX19 Detailed Assessment

<p>© Crown Copyright 2025. All rights reserved. Ordnance Survey Licence 0100031673.</p>	<ul style="list-style-type: none"> • Existing Crossing: Yes • Crossing Type (existing): Circular Culvert • Crossing Material (existing): Plastic • Crossing Condition (existing): Average • Channel Type: Poorly defined, Incised • Gradient: Moderate • Valley form: Shallow vee • Bank condition: Stable • Bed material: Rounded pebbles, Coarse gravel, Boulders, Vegetation • Riparian corridor: Moorland, Agricultural Grazing • Flow condition: Moderate 	<ul style="list-style-type: none"> • Culvert Dimensions (m): 0.45 • Water width (m): 0.30 • Water depth (m): 0.08 • Bankfull width (m): 0.55 • Bankfull height (m): 0.13 • Banktop height (m): 0.13 • Flooded Bankfull width (m): 1.3 • Flooded Bankfull height: 0.20
<p>Present on 1:50,000 scale OS map? Yes</p> <p>Note: Culvert is topped by vegetation seems to be a concrete trough on exit of the culvert.</p> <p>EASR Auth Level: Registration</p> <p>Proposed Crossing Type: To accommodate flow, a circular culvert is proposed.</p>

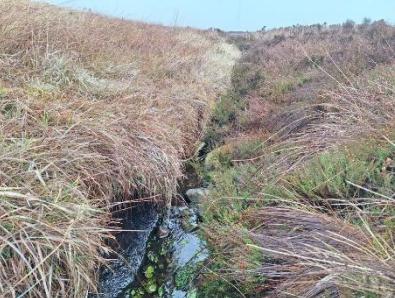
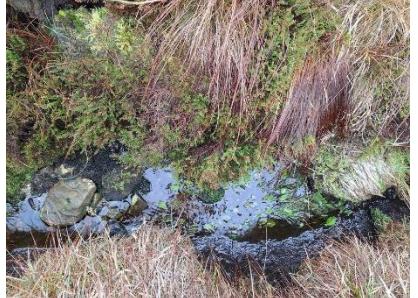
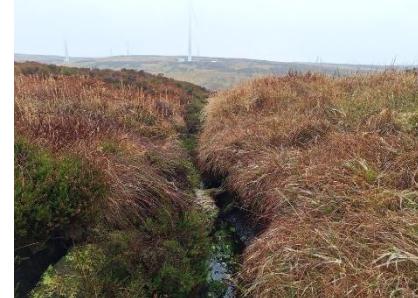
Table 4.20 WX20 Detailed Assessment

<p>© Crown Copyright 2025. All rights reserved. Ordnance Survey Licence 0100031673.</p>	<ul style="list-style-type: none"> Existing Crossing: No Channel Type: Poorly defined Gradient: Gentle Valley form: Shallow vee Bank condition: Undercut (no evidence of recent collapse) Bed material: Rounded pebbles, Vegetation, Peat Riparian corridor: Moorland Flow condition: Slow 	<ul style="list-style-type: none"> Water width (m): 0.21 Water depth (m): 0.03 Bankfull width (m): 0.39 Bankfull height (m): 0.11 Banktop height (m): 0.11 Flooded Bankfull width (m): 0.57 Flooded Bankfull height: 0.17 <p>Present on 1:50,000 scale OS map? No</p> <p>Note: Indicative of an artificially drained channel.</p> <p>EASR Auth Level: GBR</p> <p>Proposed Crossing Type: To accommodate flow, a circular culvert is proposed.</p>
<p>Crossing Photographs</p> <p>Upstream

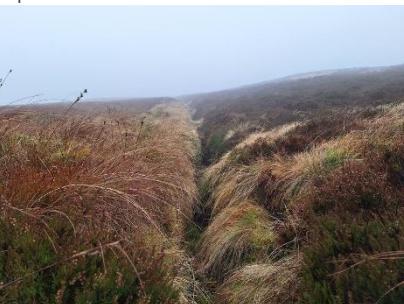
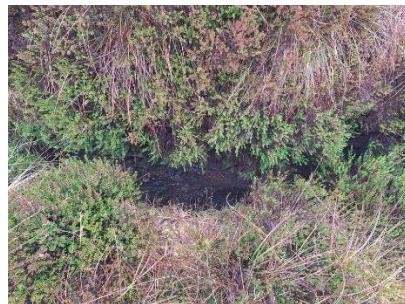
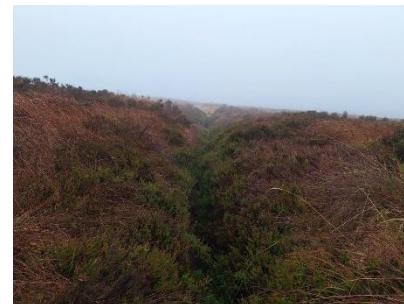
Table 4.21 WX21 Detailed Assessment

<p>© Crown Copyright 2025. All rights reserved. Ordnance Survey Licence 0100031673.</p>	<p>Crossing Description</p> <ul style="list-style-type: none"> • Existing crossing: No • Channel Type: Artificial drainage channel • Gradient: Moderate • Valley form: Asymmetrical • Bank condition: Undercut (no evidence of recent collapse) • Bed material: Rounded pebbles, Coarse gravel, Soil, Peat • Riparian corridor: Moorland • Flow condition: Dry <p>Present on 1:50,000 scale OS map? No</p> <p>Note: No flow identified; indicative of an artificially drained channel.</p> <p>EASR Auth Level: GBR</p> <p>Proposed Crossing Type: To accommodate flow, a circular culvert is proposed.</p>
<p>Crossing Photographs</p> <p>Upstream</p>

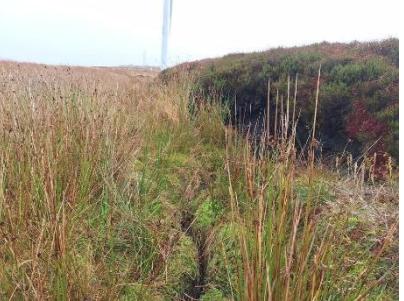
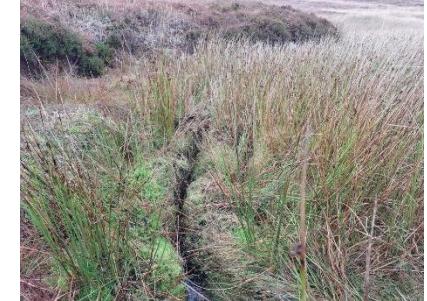
Table 4.23 WX23 Detailed Assessment

Crossing Description <ul style="list-style-type: none"> • Existing crossing: No • Channel Type: Poorly defined • Gradient: Gentle • Valley form: No obvious valley sides • Bank condition: Undercut (no evidence of recent collapse) • Bed material: Rounded pebbles, Vegetation, Peat • Riparian corridor: Moorland • Flow condition: Slow 	<ul style="list-style-type: none"> • Water width (m): 0.12 • Water depth (m): 0.09 • Bankfull width (m): 0.18 • Bankfull height (m): 0.13 • Banktop height (m): 0.13 • Flooded Bankfull width (m): 0.26 • Flooded Bankfull height: 0.18 	
Present on 1:50,000 scale OS map? No			
Note: Channel is flowing through vegetation.			
EASR Auth Level: GBR			
Proposed Crossing Type: To accommodate flow, a circular culvert is proposed.			
Crossing Photographs			
Upstream

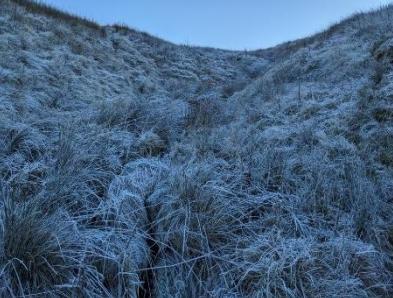
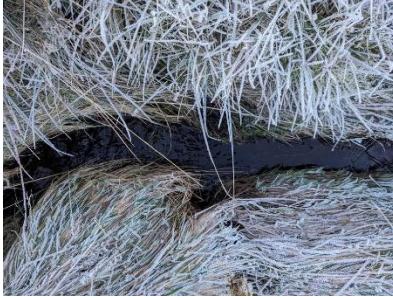
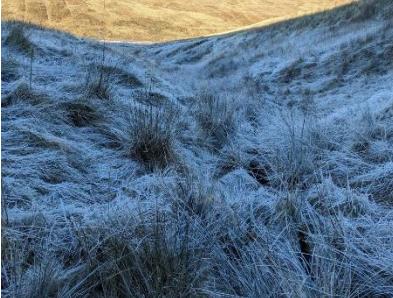
Table 4.24 WX24 Detailed Assessment

<small>© Crown Copyright 2025. All rights reserved. Ordnance Survey Licence 0100031673.</small>	<ul style="list-style-type: none"> • Existing crossing: No • Channel Type: Incised • Gradient: Moderate • Valley form: Deep vee • Bank condition: Stable • Bed material: Vegetation, Coarse gravel • Riparian corridor: Moorland • Flow condition: Moderate <p>• Water width (m): 0.20</p> <p>• Water depth (m): 0.15</p> <p>• Bankfull width (m): 0.30</p> <p>• Bankfull height (m): 0.25</p> <p>• Banktop height (m): 3.00</p> <p>• Flooded Bankfull width (m): 1.00</p> <p>• Flooded Bankfull height: 0.50</p> <p>Present on 1:50,000 scale OS map? Yes</p> <p>Note: Substantial channel to cross with track.</p> <p>EASR Auth Level: Registration</p> <p>Proposed Crossing Type: To accommodate flow, a circular culvert is proposed</p>
<h3>Crossing Photographs</h3> <p>Upstream</p>

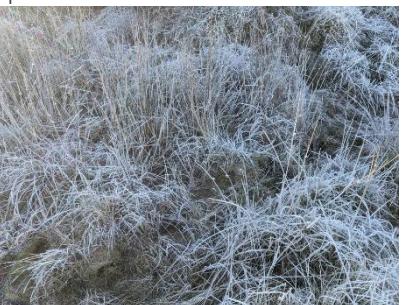
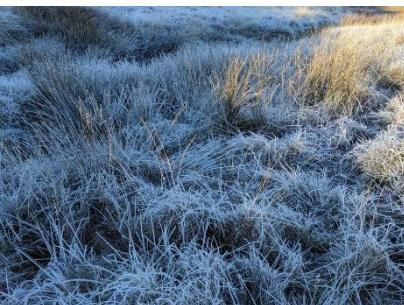
Table 4.25 WX25 Detailed Assessment

<p>© Crown Copyright 2025. All rights reserved. Ordnance Survey Licence 0100031673.</p>	<ul style="list-style-type: none"> Existing crossing: No Channel Type: None evident Gradient: Gentle Valley form: No obvious valley sides Bank condition: Bed material: Riparian corridor: Moorland Flow condition: Dry 	<ul style="list-style-type: none"> Water width (m): 0 Water depth (m): 0 Bankfull width (m): 0 Bankfull height (m): 0 Banktop height (m): 0 Flooded Bankfull width (m): 0 Flooded Bankfull height: 0 <p>Present on 1:50,000 scale OS map? No – above mapped watercourse.</p> <p>Note: Not a watercourse. Just above headwaters.</p> <p>EASR Auth Level: N/A</p> <p>Proposed Crossing Type: N/A</p>
Crossing Photographs		Upstream	Across
<p>Upstream</p>

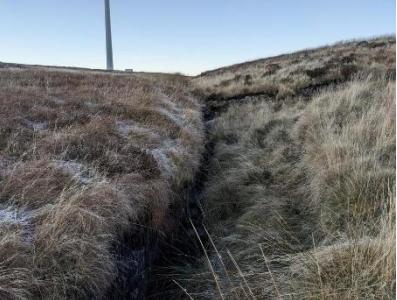
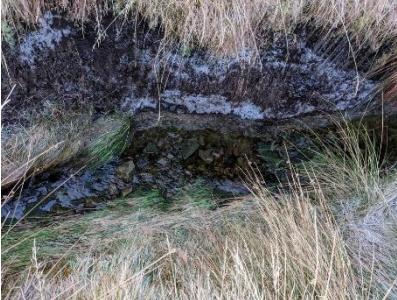
Table 4.26 WX26 Detailed Assessment

<p>WX26 (266352, 607812)</p> <p>Map showing the location of WX26. The map includes contour lines, a north arrow, and a scale bar (0-500m). Key features labeled include T22, WX26, Watercourse crossing location (yellow diamond), Site boundary (red box), Proposed turbine (blue circle), Watercourse (blue line), 50m watercourse buffer (light blue shaded area), Proposed hardstanding (brown shaded area), and Proposed new track (green line). The watercourse is labeled 'March Burn'.</p> <p>© Crown Copyright 2025. All rights reserved. Ordnance Survey Licence 0100031673.</p>	<p>Crossing Description</p> <ul style="list-style-type: none"> • Existing crossing: No • Channel Type: Incised • Gradient: Gentle • Valley form: Shallow vee • Bank condition: Stable • Bed material: Coarse gravel, Vegetation, Boulders • Riparian corridor: Moorland • Flow condition: Moderate <ul style="list-style-type: none"> • Water width (m): 0.25 • Water depth (m): 0.10 • Bankfull width (m): 0.40 • Bankfull height (m): 0.20 • Banktop height (m): 2.00 • Flooded Bankfull width (m): 1-1.25 • Flooded Bankfull height: 0.50 <p>Present on 1:50,000 scale OS map? Yes</p> <p>Note: Deep cut of approx. 2m</p> <p>EASR Auth Level: Registration</p> <p>Proposed Crossing Type: To accommodate flow, a circular culvert is proposed.</p>

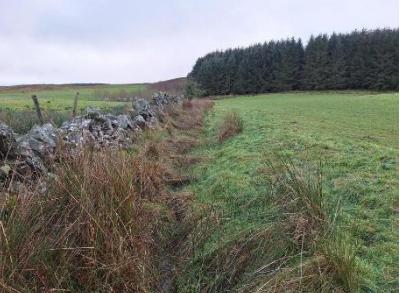
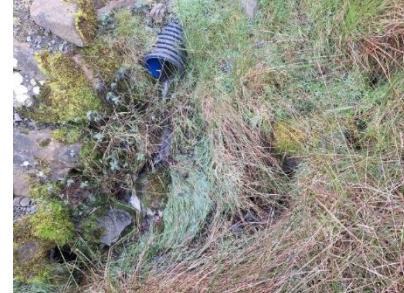
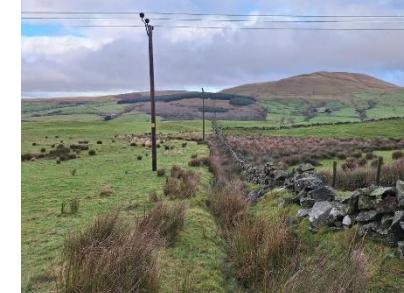
Table 4.27 WX27 Detailed Assessment

<p>© Crown Copyright 2025. All rights reserved. Ordnance Survey Licence 0100031673.</p>	<ul style="list-style-type: none"> Existing Crossing: Yes Crossing Type (existing): Circular Culvert Crossing Material (existing): Plastic Crossing Condition (existing): Average Channel Type: Poorly defined Gradient: Moderate Valley form: Shallow vee Bank condition: Undercut (no evidence of recent collapse) Bed material: Vegetation Riparian corridor: Heavily Vegetated (e.g. gorse, bramble), Agricultural Grazing, Moorland Flow condition: Moderate <p>Culvert Dimensions (m): 0.34 Water width (m): 0.12 Water depth (m): 0.05 Bankfull width (m): 0.38 Bankfull height (m): 0.09 Banktop height (m): 0.09 Flooded Bankfull width (m): 0.79 Flooded Bankfull height: 0.18</p> <p>Present on 1:50,000 scale OS map? No Note: Heavily vegetated channel. EASR Auth Level: GBR Proposed Crossing Type: To accommodate flow, an upgraded circular culvert is recommended.</p>

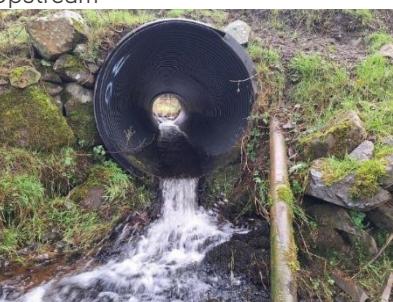
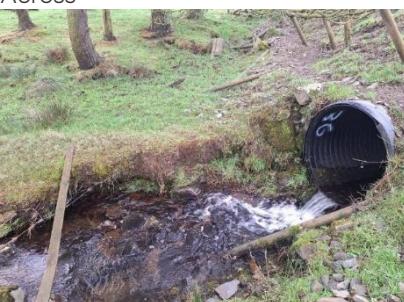
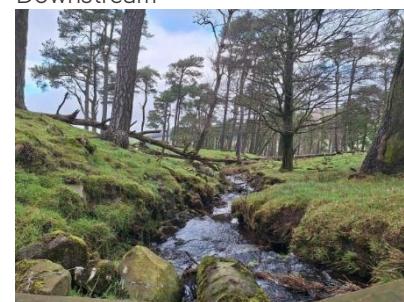
Table 4.28 WX28 Detailed Assessment

<p>© Crown Copyright 2025. All rights reserved. Ordnance Survey Licence 0100031673.</p>	<ul style="list-style-type: none"> • Existing Crossing: Yes • Crossing Type (existing): Circular Culvert • Crossing Material (existing): Plastic • Crossing Condition (existing): Good • Channel Type: Incised, Meandering • Gradient: Moderate • Valley form: Shallow vee • Bank condition: Undercut (no evidence of recent collapse) • Bed material: Boulders, Coarse gravel, Rounded pebbles • Riparian corridor: Moorland, Agricultural Grazing • Flow condition: Moderate <p>Present on 1:50,000 scale OS map? Yes Note: Large hydraulic drop upon exit of the culvert. EASR Auth Level: Registration Proposed Crossing Type: To accommodate flow, aid fish passage and mitigate hydraulic drop an upgraded oversized bottomless arch culvert which contains natural bed material is recommended.</p>

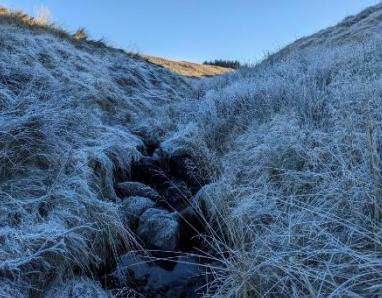
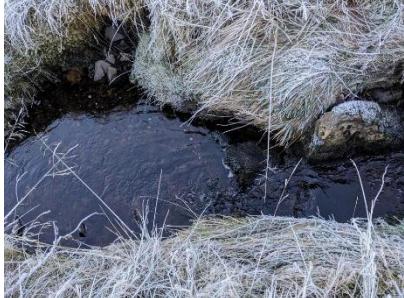
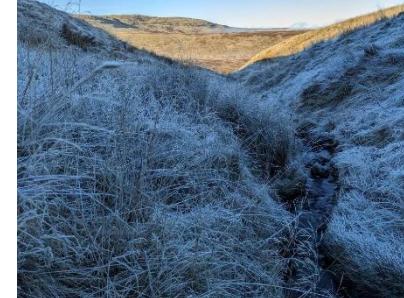
Table 4.29 WX29 Detailed Assessment

<p>© Crown Copyright 2019. All rights reserved. Ordnance Survey Licence 0100031673.</p>	<p>Existing Crossing: No</p> <ul style="list-style-type: none"> Crossing Type (existing): Crossing Material (existing): Crossing Condition (existing): Channel Type: Incised Gradient: Moderate Valley form: Deep vee, Gorge Bank condition: Stable Bed material: Fine sand/silt, Rounded pebbles, Coarse gravel, Boulders Riparian corridor: Moorland Flow condition: Moderate • <p>Water width (m): 0.80 Water depth (m): 0.25 Bankfull width (m): 1.20 Bankfull height (m): 0.40 Banktop height (m): 5.00 Flooded Bankfull width (m): 1.50-2.00 Flooded Bankfull height: 0.80</p> <p>Present on 1:50,000 scale OS map? Yes Note: Deep channel to cross, will probably need a bridge or relocate track at least 150m upstream. EASR Auth Level: Registration Proposed Crossing Type: The stream is located within a deeply incised gorge valley, where a conventional bridge could provide the most effective watercourse crossing.</p>

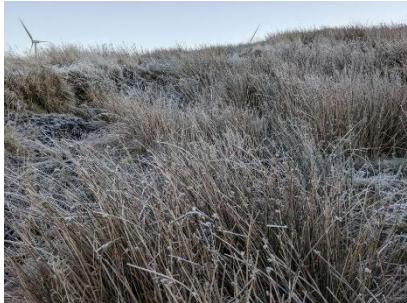
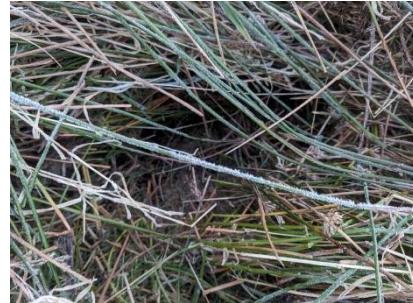
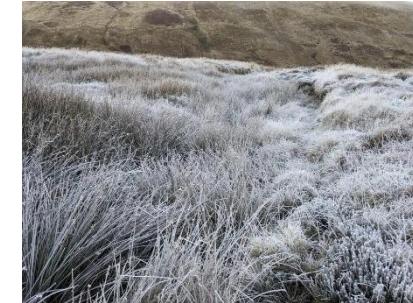
Table 4.30 WX30 Detailed Assessment

- **Existing crossing:** No
- **Channel Type:** Poorly defined
- **Gradient:** Moderate
- **Valley form:** No obvious valley sides, Shallow vee
- **Bank condition:** Stable
- **Bed material:** Vegetation, Coarse gravel
- **Riparian corridor:** Moorland
- **Flow condition:** Moderate
- **Water width (m):** 0.15
- **Water depth (m):** 0.05
- **Bankfull width (m):** 0.25
- **Bankfull height (m):** 0.15
- **Banktop height (m):** -
- **Flooded Bankfull width (m):** 0.30-0.80
- **Flooded Bankfull height:** 0.30

Note: Watercourse contained obscured by vegetation but can hear it.

Proposed Crossing Type: To accommodate flow, a circular culvert is recommended.

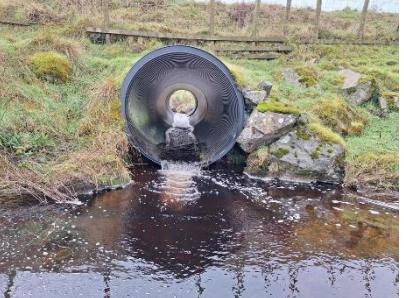
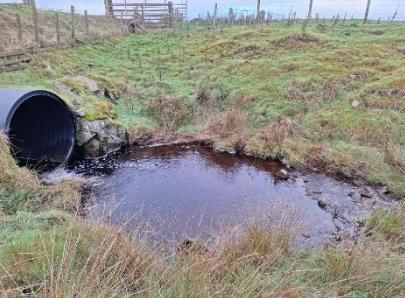
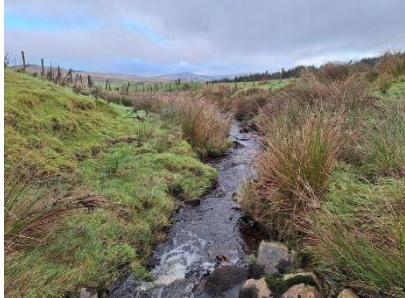
Table 4.31 WX31 Detailed Assessment

<p>© Crown Copyright 2025. All rights reserved. Ordnance Survey Licence 0100031673.</p>	<ul style="list-style-type: none"> Existing Crossing: Yes Crossing Type (existing): Circular Culvert Crossing Material (existing): Plastic Crossing Condition (existing): Good Channel Type: Meandering Gradient: Gentle Valley form: Shallow vee Bank condition: Undercut (no evidence of recent collapse) Bed material: Boulders, Coarse gravel, Rounded pebbles Riparian corridor: Agricultural Grazing, Moorland Flow condition: Moderate <p>Culvert Dimensions (m): 1.48 Water width (m): 0.85 Water depth (m): 0.14 Bankfull width (m): 1.24 Bankfull height (m): 0.23 Banktop height (m): 0.23 Flooded Bankfull width (m): 1.31 Flooded Bankfull height: 0.29</p> <p>Present on 1:50,000 scale OS map? Yes Note: Large pool at exit of culvert and slight drop on exit. EASR Auth Level: Registration Proposed Crossing Type: To accommodate flow, aid fish passage and mitigate hydraulic drop, an upgraded oversized bottomless arch culvert which contains natural bed material is recommended.</p>

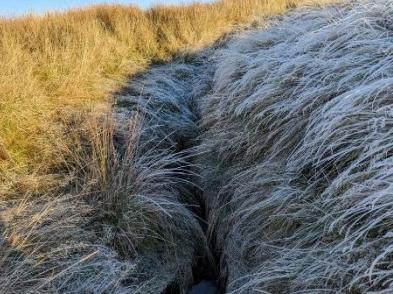
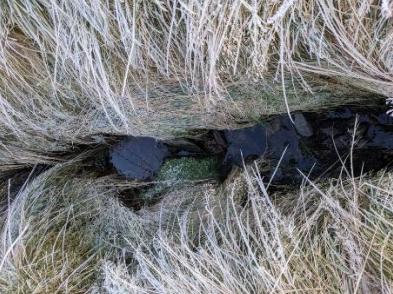
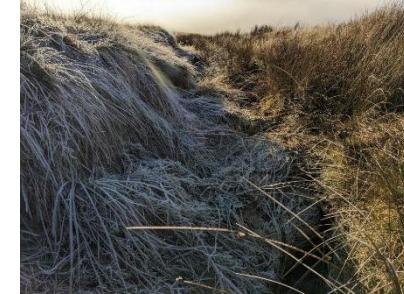
Table 4.33 WX33 Detailed Assessment

<ul style="list-style-type: none"> • Existing crossing: No • Channel Type: Incised • Gradient: Moderate • Valley form: Shallow vee, Deep vee • Bank condition: Stable • Bed material: Coarse gravel, Boulders, Vegetation • Riparian corridor: Moorland • Flow condition: Slow <p>• Water width (m): 0.20</p> <p>• Water depth (m): 0.05</p> <p>• Bankfull width (m): 0.35</p> <p>• Bankfull height (m): 0.20</p> <p>• Banktop height (m): 2.00</p> <p>• Flooded Bankfull width (m): 0.80</p> <p>• Flooded Bankfull height: 0.50</p> <p>Present on 1:50,000 scale OS map? No</p> <p>Note: Small incised channel, 2m deep.</p> <p>EASR Auth Level: GBR</p> <p>Proposed Crossing Type: To accommodate flow, a circular culvert is proposed.</p>
Crossing Photographs	
<p>Upstream</p>

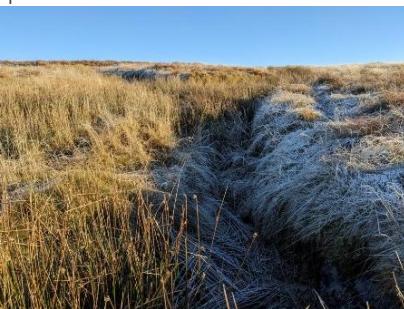
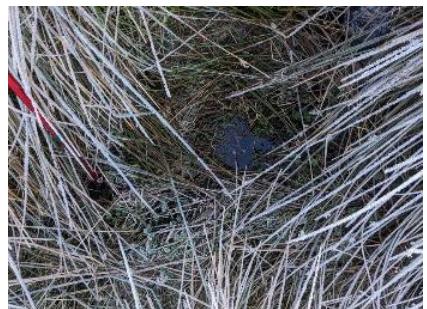
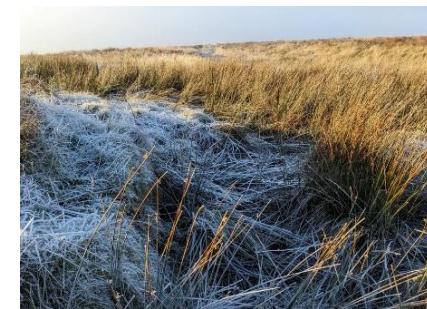
Table 4.34 WX34 Detailed Assessment

<p>© Crown Copyright 2025. All rights reserved. Ordnance Survey Licence 0100031673.</p>	<ul style="list-style-type: none"> • Existing crossing: No • Channel Type: Poorly defined • Gradient: Moderate • Valley form: Shallow vee, No obvious valley sides • Bank condition: Stable • Bed material: Vegetation • Riparian corridor: Moorland • Flow condition: Stagnant <p>Present on 1:50,000 scale OS map? No Note: Wet flush, with stagnant water, but could flow in wet conditions. EASR Auth Level: GBR Proposed Crossing Type: To accommodate flow, a circular culvert is proposed.</p>
Crossing Photographs	
<p>Upstream</p>

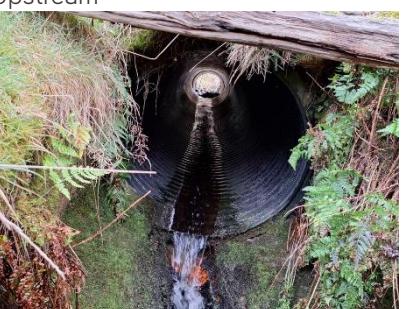
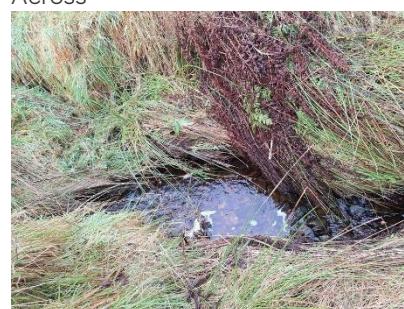
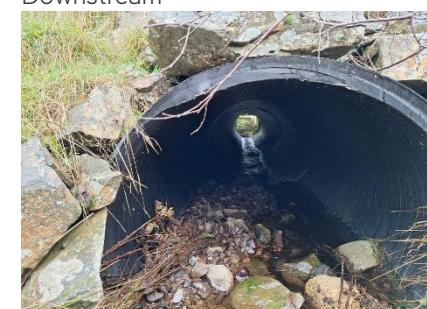
Crossing Location	WX35 (267063, 612443) Crossing Description

<p>© Crown Copyright 2025. All rights reserved. Ordnance Survey Licence 0100031673.</p>	<ul style="list-style-type: none"> Existing crossing: Yes Crossing Type (existing): Circular Culvert Crossing Material (existing): Plastic Crossing Condition (existing): Good Channel Type: Incised, Poorly defined Gradient: Gentle Valley form: Gorge Bank condition: Undercut (no evidence of recent collapse) Bed material: Rounded pebbles, Coarse gravel Riparian corridor: Moorland, Agricultural Grazing Flow condition: Moderate <p>Present on 1:50,000 scale OS map? Yes</p> <p>Note: Build-up of material at the entrance of existing culvert as well as hydraulic drop at the exit of culvert</p> <p>EASR Auth Level: Registration</p> <p>Proposed Crossing Type: To accommodate flow and mitigate hydraulic drop, an upgraded oversized bottomless arch culvert which contains natural bed material is recommended.</p>

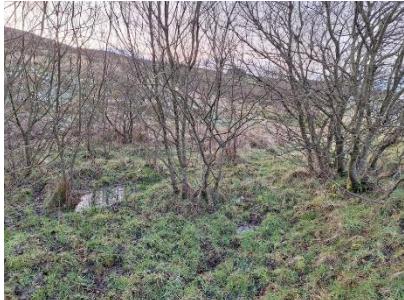
Crossing Location	WX36 (267094, 612437) Crossing Description

<ul style="list-style-type: none"> • Existing crossing: No • Channel Type: None evident • Gradient: Gentle • Valley form: Gorge • Bank condition: None evident • Bed material: None evident • Riparian corridor: Moorland, Agricultural Grazing • Flow condition: Stagnant pool <p>Present on 1:50,000 scale OS map? No Note: Stagnant pool present no evidence of a watercourse. EASR Auth Level: N/A Proposed Crossing Type: N/A</p>
<h3>Crossing Photographs</h3> <p>Upstream</p>	<p>Across</p>

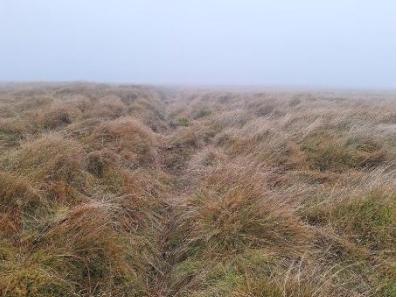
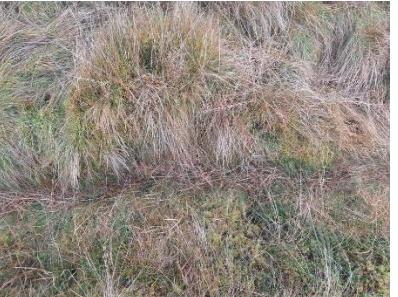
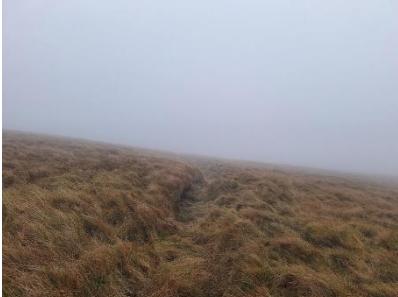
Crossing Location	WX37 (267197, 609685) Crossing Description

<small>© Crown Copyright 2025. All rights reserved. Ordnance Survey Licence 0100031673.</small>	<ul style="list-style-type: none"> • Existing crossing: No • Channel Type: None evident • Gradient: Gentle • Valley form: No obvious valley sides • Bank condition: None evident • Bed material: Vegetation • Riparian corridor: Moorland, Agricultural Grazing • Flow condition: N/A • Water width (m): N/A • Water depth (m): N/A • Bankfull width (m): N/A • Bankfull height (m): N/A • Banktop height (m): N/A • Flooded Bankfull width (m): N/A • Flooded Bankfull height: N/A <p>Present on 1:50,000 scale OS map? No</p> <p>Note: No flow evident. Fully vegetated. Indicative of an artificial ditch with no flow.</p> <p>EASR Auth Level: N/A</p> <p>Proposed Crossing Type: N/A</p>

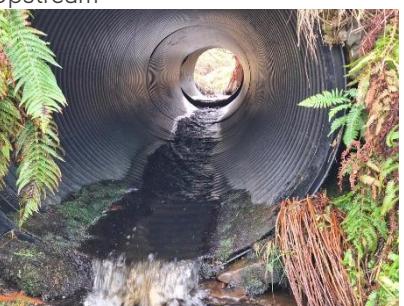
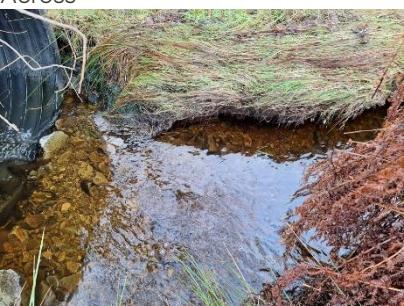
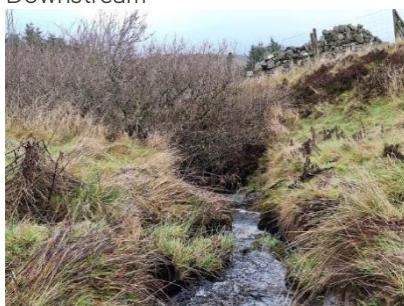
Crossing Location	WX38 (267204, 612397) Crossing Description

<p>© Crown Copyright 2025. All rights reserved. Ordnance Survey Licence 0100031673.</p>	<p>Crossing Description:</p> <ul style="list-style-type: none"> • Existing Crossing: Yes • Crossing Type (existing): Circular Culvert • Crossing Material (existing): Plastic • Crossing Condition (existing): Good • Channel Type: Incised, Meandering • Gradient: Gentle • Valley form: Shallow vee • Bank condition: Undercut (no evidence of recent collapse) • Bed material: Rounded pebbles, Bedrock • Riparian corridor: Moorland, Agricultural Grazing • Flow condition: Moderate <p>• Culvert Dimensions (m): 1.38</p> <p>• Water width (m): 0.96</p> <p>• Water depth (m): 0.16</p> <p>• Bankfull width (m): 1.49</p> <p>• Bankfull height (m): 0.22</p> <p>• Banktop height (m): 0.22</p> <p>• Flooded Bankfull width (m): 1.31</p> <p>• Flooded Bankfull height: 0.27</p> <p>Present on 1:50,000 scale OS map? Yes</p> <p>Note: Slight drop down within the culvert with hydraulic drop increasing erosion.</p> <p>EASR Auth Level: Registration</p> <p>Proposed Crossing Type: To accommodate flow, aid fish passage and mitigate hydraulic drop an upgraded oversized bottomless arch culvert which contains natural bed material is recommended.</p>

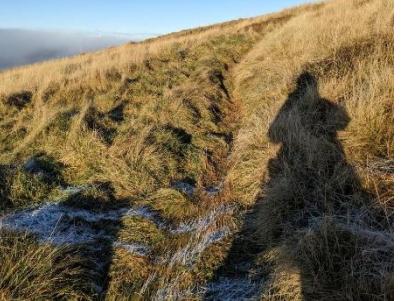
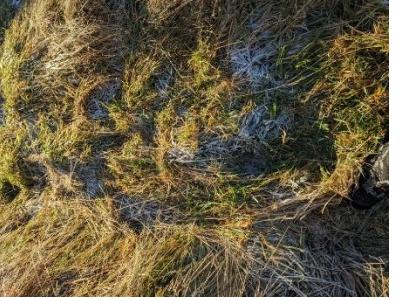
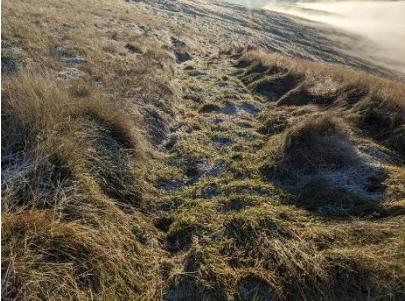
Crossing Location	WX39 (267212, 606854) Crossing Description

© Crown Copyright 2025. All rights reserved. Ordnance Survey Licence 0100031673.	<ul style="list-style-type: none"> Existing crossing: No Channel Type: N/A Gradient: N/A Valley form: N/A Bank condition: N/A Bed material: N/A Riparian corridor: N/A Flow condition: N/A Water width (m): N/A Water depth (m): N/A Bankfull width (m): N/A Bankfull height (m): N/A Banktop height (m): N/A Flooded Bankfull width (m): N/A Flooded Bankfull height: N/A <p>Present on 1:50,000 scale OS map? Yes Note: No watercourse evident during site visit. EASR Auth Level: N/A Proposed Crossing Type: N/A</p>
Crossing Photographs	
Upstream

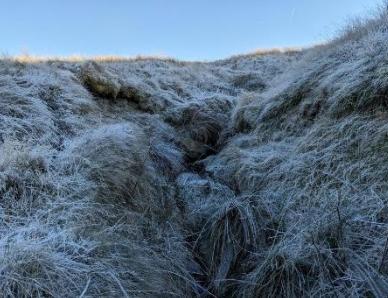
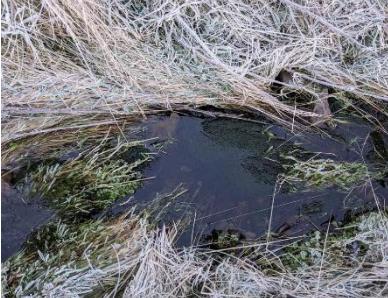
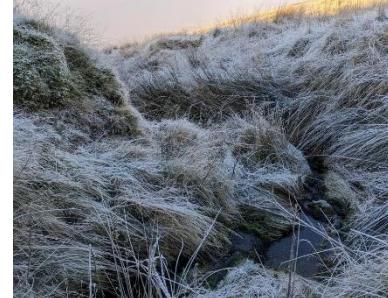
Crossing Location	WX40 (267291, 607070) Crossing Description

<p>© Crown Copyright 2025. All rights reserved. Ordnance Survey Licence 0100031673.</p>	<p>Crossing Description</p> <ul style="list-style-type: none"> • Existing crossing: No • Channel Type: Incised • Gradient: Moderate • Valley form: Deep vee, Shallow vee • Bank condition: Unstable (potential recent collapse) • Bed material: Rounded pebbles, Coarse gravel, Vegetation • Riparian corridor: Moorland • Flow condition: Moderate <p>• Water width (m): 0.20</p> <p>• Water depth (m): 0.15</p> <p>• Bankfull width (m): 0.40</p> <p>• Bankfull height (m): 0.25</p> <p>• Banktop height (m): 3.00</p> <p>• Flooded Bankfull width (m): 0.60-1.00</p> <p>• Flooded Bankfull height: 0.45</p> <p>Present on 1:50,000 scale OS map? Yes</p> <p>Note: Fairly deep channel, consider moving track up or downstream.</p> <p>EASR Auth Level: Registration</p> <p>Proposed Crossing Type: Relatively deep channel which is located within a deep valley, therefore a small conventional bridge could provide the most effective watercourse crossing.</p>
