Hare Hill Windfarm Repowering and Extension

**Environmental Impact Assessment
Report**

**Technical Appendix 9.1: Watercourse
Crossing Assessment**

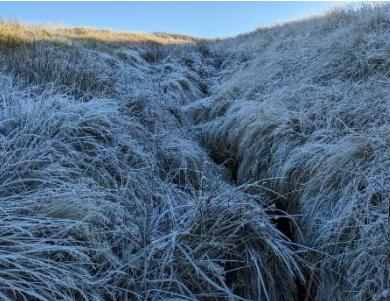
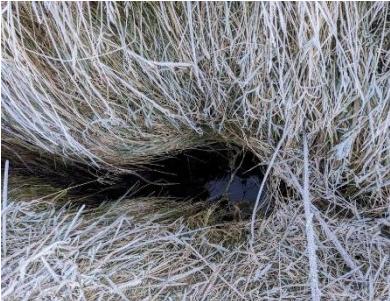
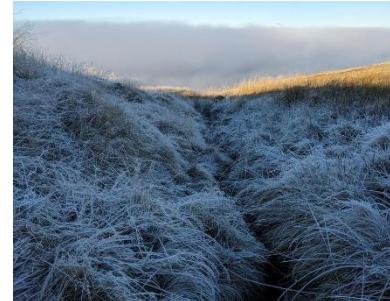
Crossing Location	Crossing Description

<p>WX41 (267331, 607000)</p> <ul style="list-style-type: none"> • Existing crossing: No • Channel Type: Incised • Gradient: Moderate • Valley form: Shallow vee • Bank condition: Stable • Bed material: Coarse gravel, Boulders, Vegetation • Riparian corridor: Moorland • Flow condition: Moderate <ul style="list-style-type: none"> • Water width (m): 0.16 • Water depth (m): 0.08 • Bankfull width (m): 0.25 • Bankfull height (m): 0.40 • Banktop height (m): 2.00 • Flooded Bankfull width (m): 0.70-1.00 • Flooded Bankfull height: 0.60 <p>Present on 1:50,000 scale OS map? Yes</p> <p>Note: None</p> <p>EASR Auth Level: Registration</p> <p>Proposed Crossing Type: To accommodate flow, a circular culvert is proposed.</p>
<p>Crossing Photographs</p>	
<p>Upstream</p>

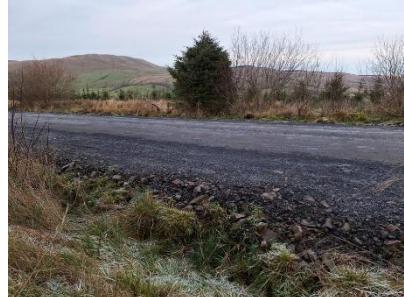
Crossing Location	WX42 (267525, 611855) Crossing Description

<p>© Crown Copyright 2025. All rights reserved. Ordnance Survey Licence 0100031673.</p>	<ul style="list-style-type: none"> • Existing crossing: No • Channel Type: N/A • Gradient: N/A • Valley form: N/A • Bank condition: N/A • Bed material: N/A • Riparian corridor: N/A • Flow condition: N/A • Water width (m): N/A • Water depth (m): N/A • Bankfull width (m): N/A • Bankfull height (m): N/A • Banktop height (m): N/A • Flooded Bankfull width (m): N/A • Flooded Bankfull height: N/A <p>Present on 1:50,000 scale OS map? No Note: No watercourse identified. EASR Auth Level: N/A Proposed Crossing Type: N/A</p>

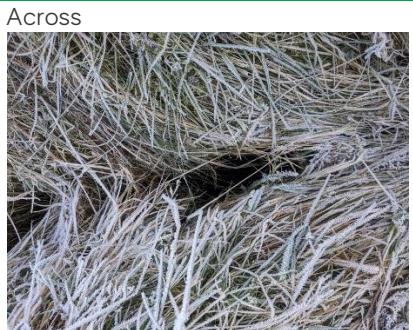
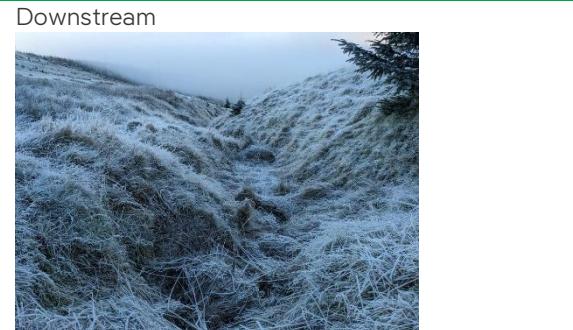
Crossing Location	WX43 (267717, 607281)	Crossing Description

<p>WX43 (267717, 607281)</p> <ul style="list-style-type: none"> • Existing crossing: No • Channel Type: Incised • Gradient: Moderate • Valley form: Deep vee, Shallow vee • Bank condition: Stable • Bed material: Rounded pebbles, Coarse gravel, Vegetation • Riparian corridor: Moorland • Flow condition: Slow 	<ul style="list-style-type: none"> • Water width (m): 0.10 • Water depth (m): 0.05 • Bankfull width (m): 0.20 • Bankfull height (m): 0.20 • Banktop height (m): 1.50 • Flooded Bankfull width (m): 0.50-1.00 • Flooded Bankfull height: 0.60-1.00 			
<p>Present on 1:50,000 scale OS map? Yes</p> <p>Note: Watercourse mostly obscured by vegetation but could have increased flow in wet conditions.</p> <p>EASR Auth Level: Registration</p> <p>Proposed Crossing Type: To accommodate flow, a circular culvert is proposed.</p>					
Crossing Photographs	Upstream	Across

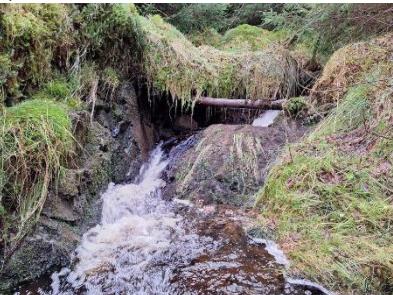
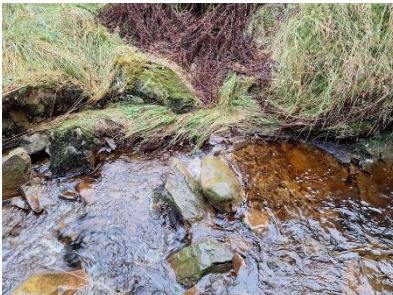
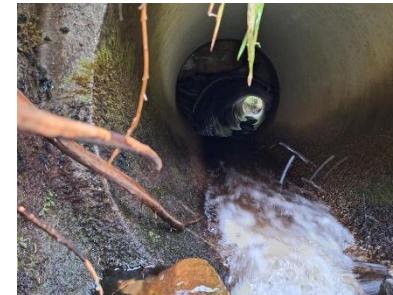
Crossing Location	WX44 (267934, 611594) Crossing Description

<p>© Crown Copyright 2025. All rights reserved. Ordnance Survey Licence 0100031673.</p>	<ul style="list-style-type: none"> Existing Crossing: Yes Crossing Type (existing): Circular Culvert Crossing Material (existing): Concrete Crossing Condition (existing): Good Channel Type: Incised, Meandering Gradient: Moderate Valley form: Gorge Bank condition: Undercut (no evidence of recent collapse) Bed material: Boulders, Rounded pebbles, Coarse gravel Riparian corridor: Commercial Forestry, Heavily Vegetated (e.g. gorse, bramble) Flow condition: Moderate <p>Culvert Dimensions (m): 1.00 Water width (m): 1.47 Water depth (m): 0.15 Bankfull width (m): 1.52 Bankfull height (m): 0.25 Banktop height (m): 0.25 Flooded Bankfull width (m): 1.68 Flooded Bankfull height: 0.38</p> <p>Present on 1:50,000 scale OS map? Yes Note: Culvert is made of concrete and plastic (inner section seems to be plastic) Drop at the exit of the culvert generating fast flow. EASR Auth Level: Registration Proposed Crossing Type: To accommodate flow, aid fish passage and mitigate hydraulic drop an upgraded oversized bottomless arch culvert which contains natural bed material is recommended.</p>

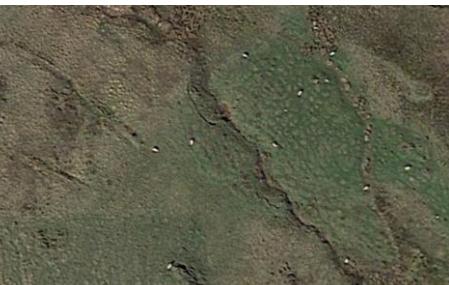
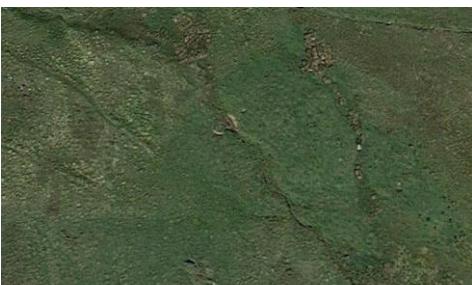
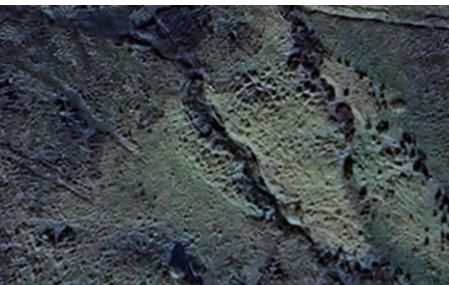
Crossing Location	WX45 (266133, 611782) Crossing Description

© Crown Copyright 2025. All rights reserved. Ordnance Survey Licence 0100031673.	<p>Crossing Description</p> <ul style="list-style-type: none"> • Existing crossing: No • Channel Type: Incised • Gradient: Moderate • Valley form: Shallow vee • Bank condition: Stable • Bed material: • Riparian corridor: Moorland • Flow condition: <p>• Water width (m): 0.5</p> <p>• Water depth (m): -</p> <p>• Bankfull width (m): 1.2</p> <p>• Bankfull height (m): -</p> <p>• Banktop height (m): -</p> <p>• Flooded Bankfull width (m): 1.3</p> <p>• Flooded Bankfull height: -</p> <p>Present on 1:50,000 scale OS map? Yes</p> <p>Note: Assessed using satellite imagery.</p> <p>EASR Auth Level: Registration</p> <p>Proposed Crossing Type: To accommodate flow, a circular culvert is proposed.</p>
