EUCHANHEAD RENEWABLE ENERGY DEVELOPMENT

Technical Appendix 10.5: Schedule of Watercourse Crossings
Prepared for: ScottishPower Renewables

SLR Ref: 405.00481.00052
Version 3
October 2020

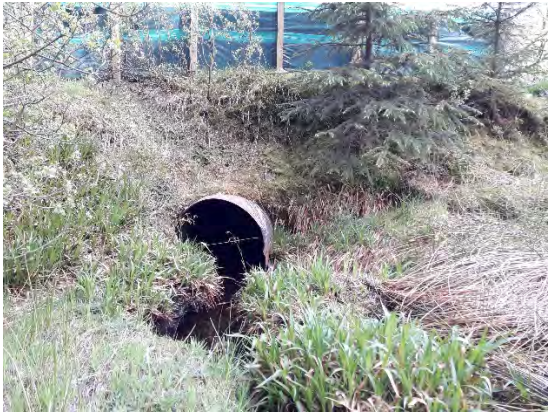
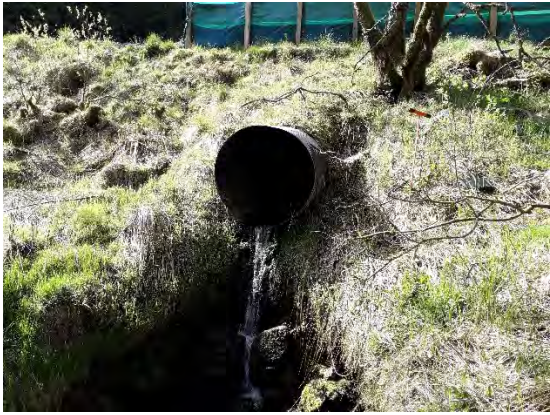
Watercourse Crossing: WX05 Status: Existing NGR: NS 68222 05782 Watercourse Width: 1.1 m Watercourse Depth: 0.2 m Notes: Large existing steel circular culvert which is approximately 0.9 m in diameter.	Existing

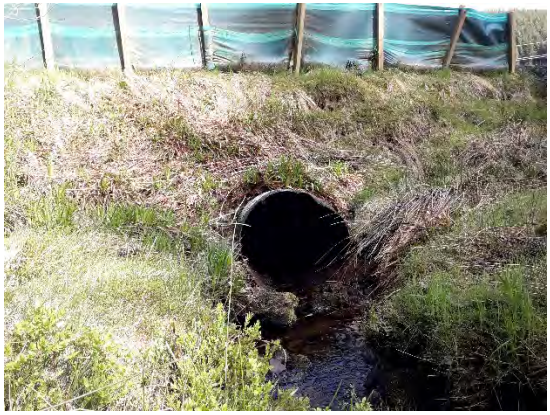
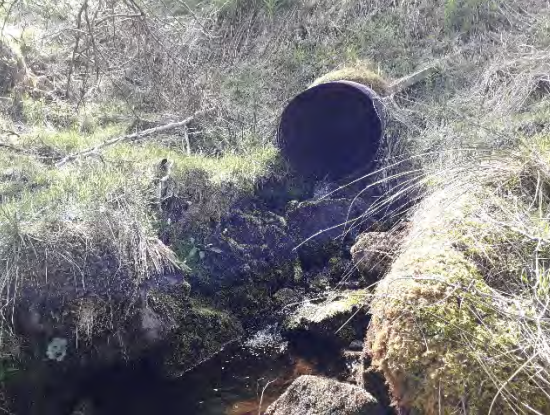
Watercourse Crossing: WX06 Status: Existing NGR: NS 68134 05632 Watercourse Width: 0.9 m Watercourse Depth: 0.2 m Notes: Large existing steel circular culvert which is approximately 0.8 m in diameter.	Existing

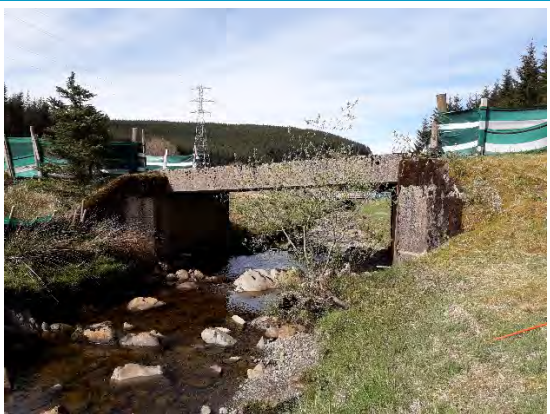
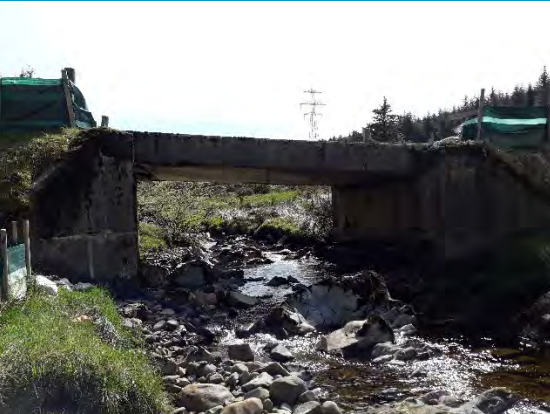
Watercourse Crossing: WX07 Status: Existing NGR: NS 68208 05331 Watercourse Width: 3 m Watercourse Depth: 0.4 m Notes: An existing bottomless single span bridge which has a span of approximately 4 m and is 2 m high.	Existing

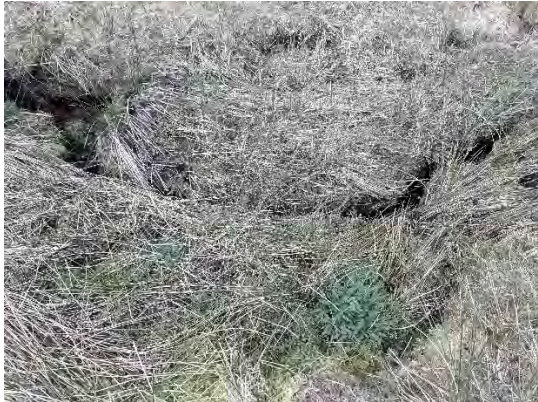
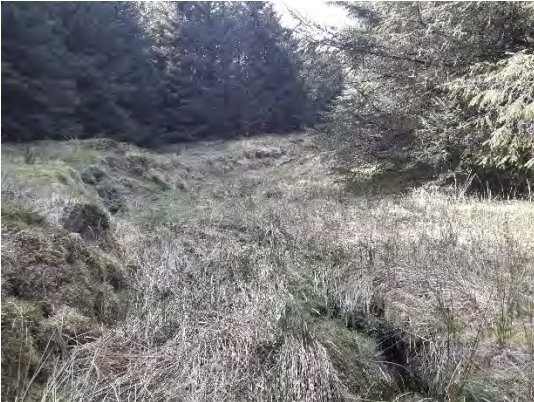
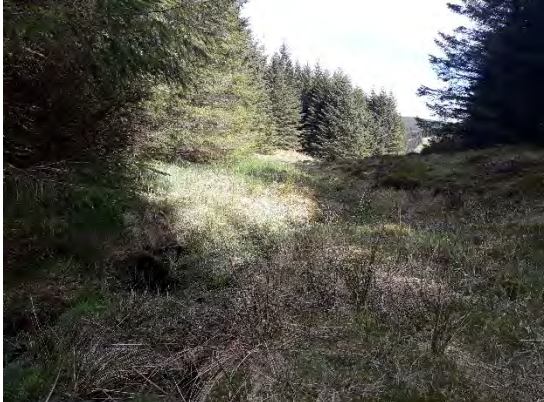
Watercourse Crossing: WX10 Status: New NGR: NS 67717 06025 Watercourse Width: 0.1 m Watercourse Depth: 0.4 m Notes: Minor watercourse located within a channel which extends to 1 m high and 1.5 m wide.

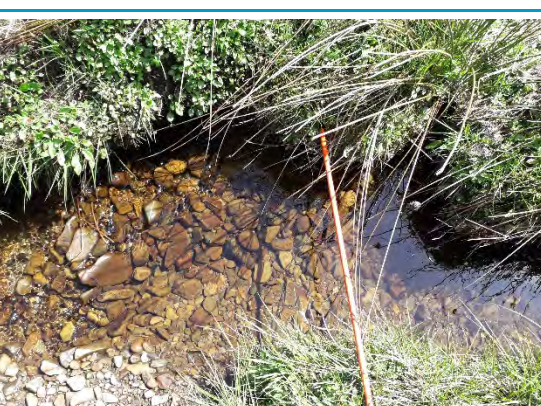
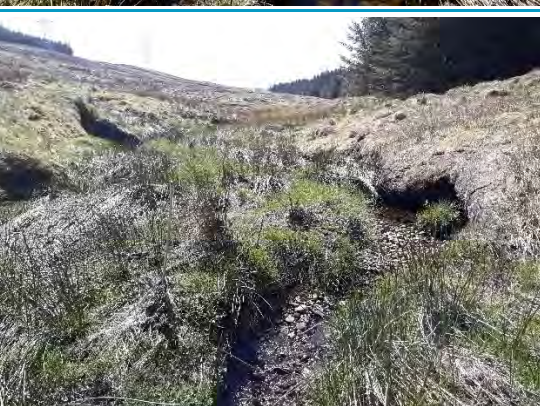
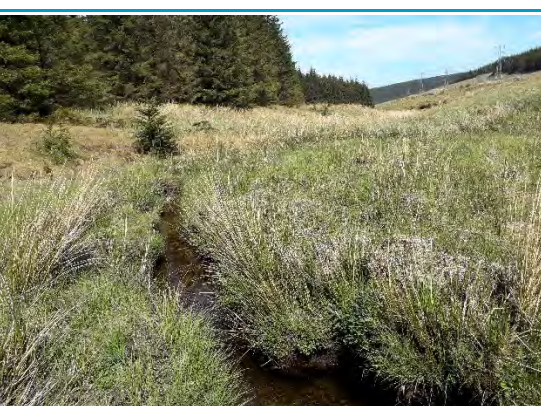
Watercourse Crossing: WX15 Status: New NGR: NS 66829 04102 Watercourse Width: 0.6 m Watercourse Depth: 0.1 m Notes: Minor meandering watercourse located in a fairly broad channel with a small floodplain located on the south western side.

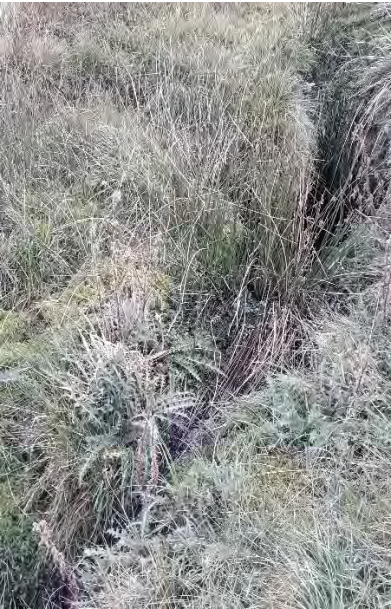
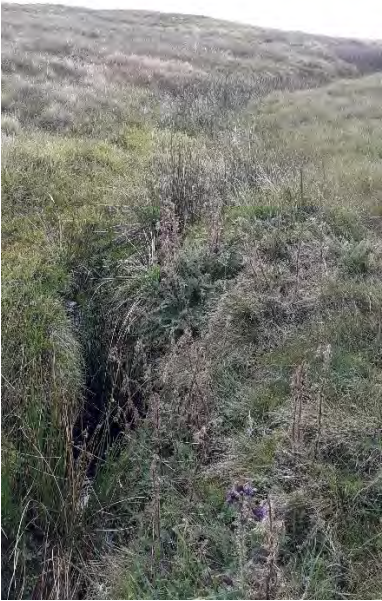
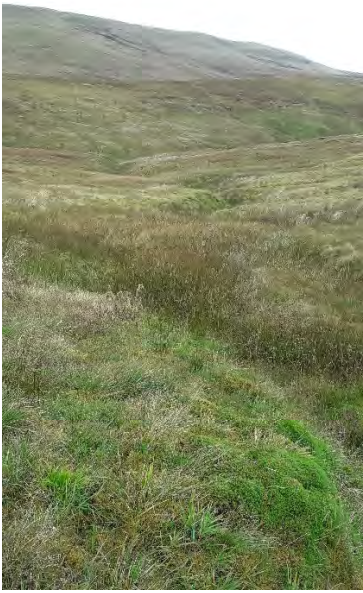
Watercourse Crossing: WX26 Status: New NGR: NS 65901 05082 Watercourse Width: 0.1 m Watercourse Depth: 0.2 m Notes: Minor watercourse located within a small channel comprising of long grasses and mosses.

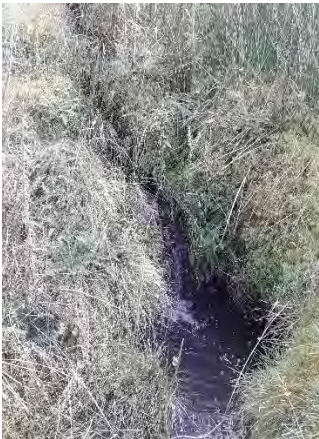
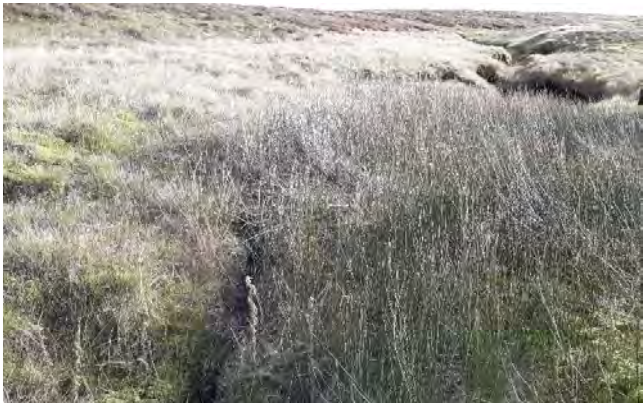
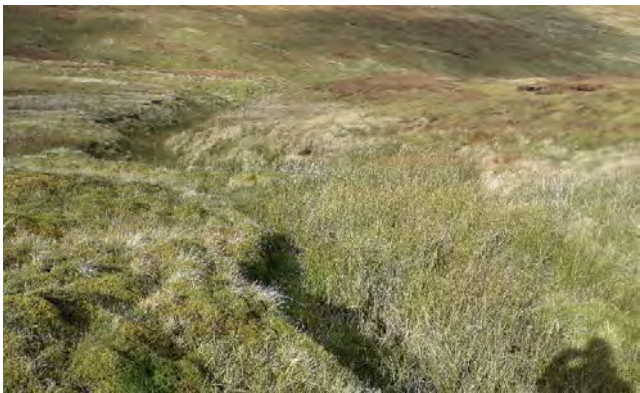
Watercourse Crossing Details	Photograph of New Watercourse Crossing Point		Photograph Looking Upstream of Watercourse Crossing	Photograph Looking Downstream of Watercourse Crossing
Watercourse Crossing: WX27 Status: New NGR: NS 65726 05018 Watercourse Width: 0.2 m Watercourse Depth: 0.2 m Notes: Minor watercourse located within a small channel comprising of long grasses and reeds.

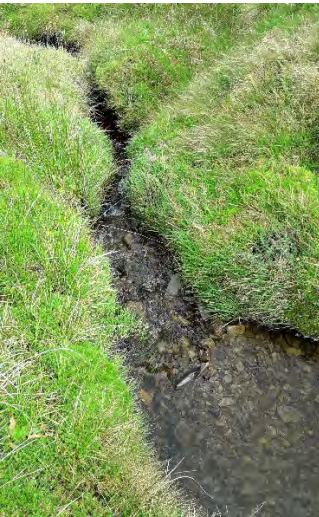
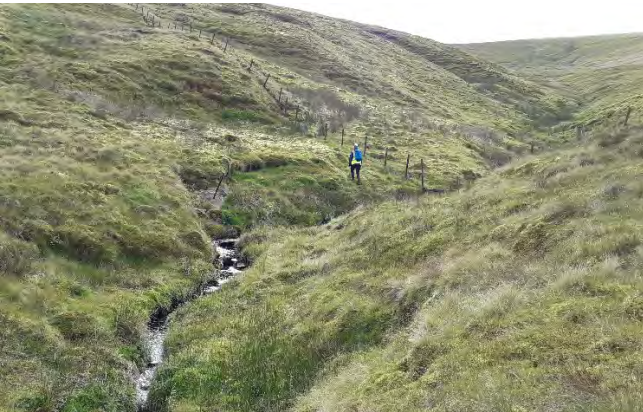
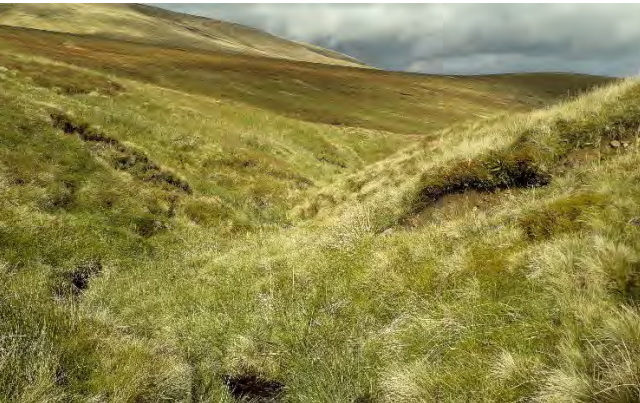
Watercourse Crossing: WX28 Status: New NGR: NS 65610 05036 Watercourse Width: 0.5 m Watercourse Depth: 0.3 m Notes: Incised channel with steep sided slopes. Channel is approximately 8 m wide and 8 m high.

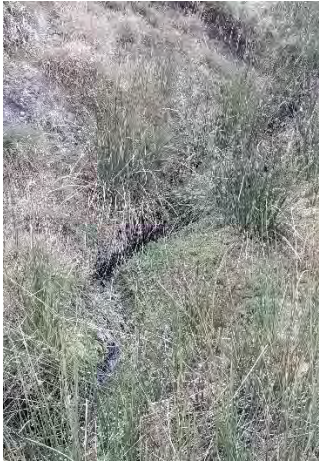
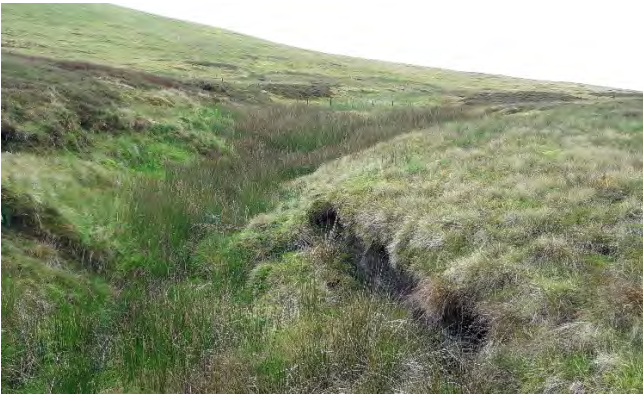
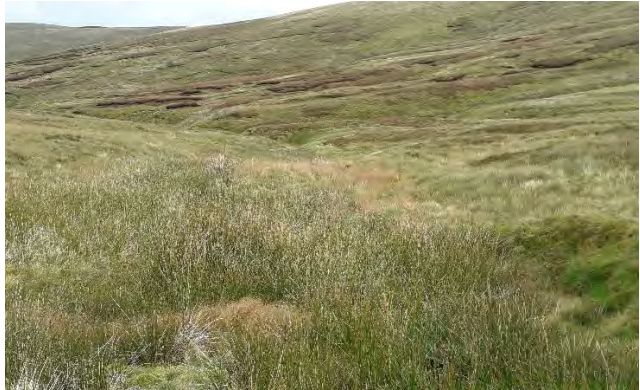
Watercourse Crossing: WX29 Status: New NGR: NS 65457 05121 Watercourse Width: 0.2 m Watercourse Depth: 0.2 m Notes: Minor watercourse within a wider channel which is approximately 4 m wide and 2 m deep.

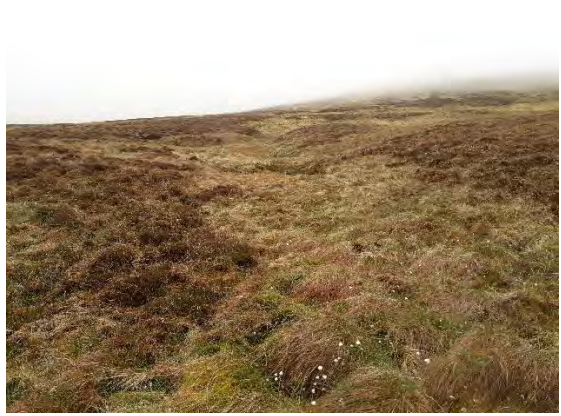
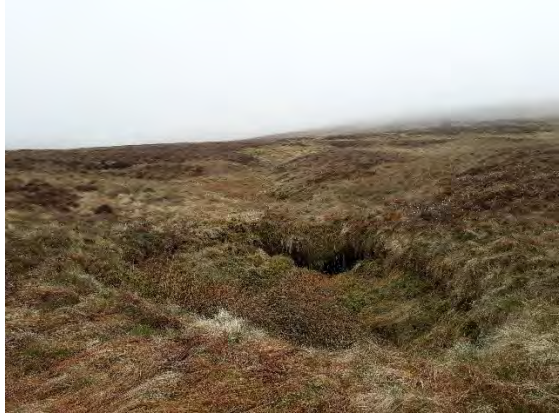
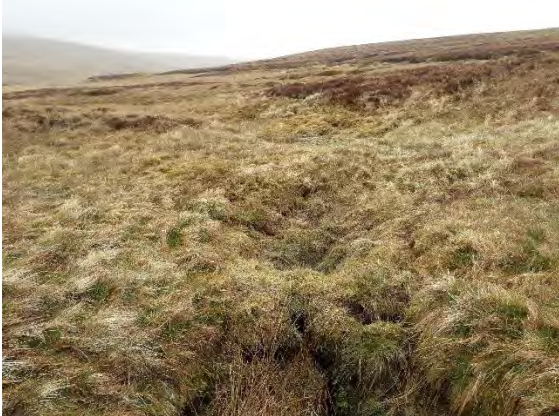
Watercourse Crossing Details	Photograph of New Watercourse Crossing Point	Photograph Looking Upstream of Watercourse Crossing	Photograph Looking Downstream of Watercourse Crossing
Watercourse Crossing: WX30 Status: New NGR: NS 65245 05353 Watercourse Width: 0.5 m Watercourse Depth: 0.5 m Notes: Minor watercourse which is located beneath peat at the crossing location.

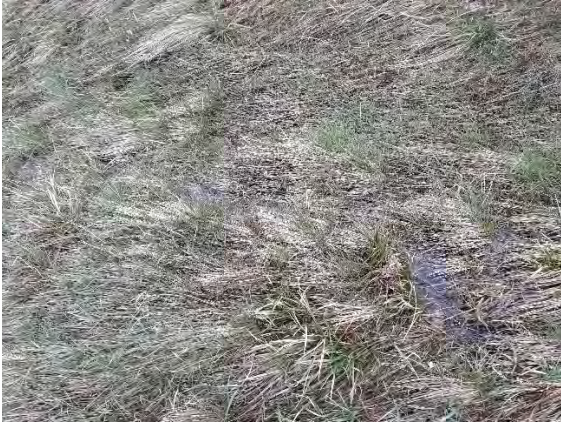
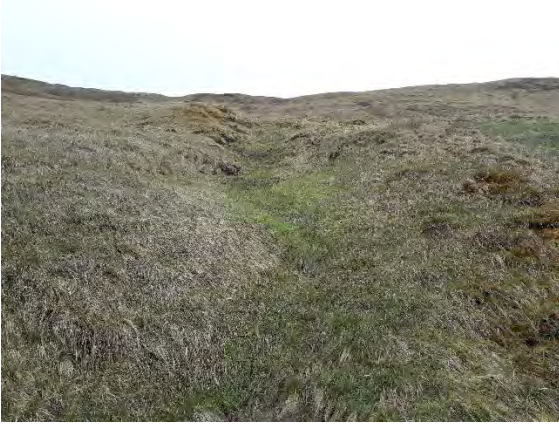
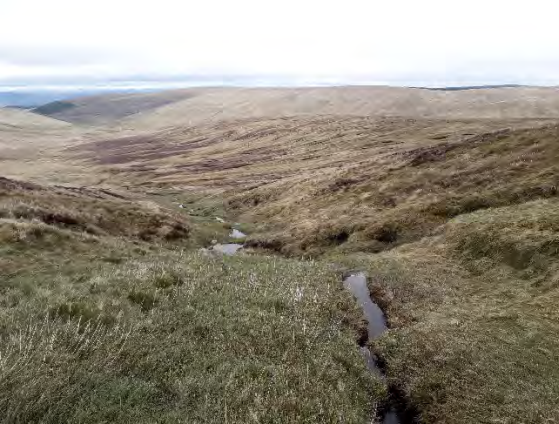
Watercourse Crossing: WX33 Status: New NGR: NS 65356 06900 Watercourse Width: 0.3 m Watercourse Depth: 0.1 m Notes: Minor watercourse located in a relatively broad shallow channel, which becomes more defined further downstream.
