Annex B. Detailed Assessment Datasheet Descriptions

Harestanes South Windfarm Extension Project Team

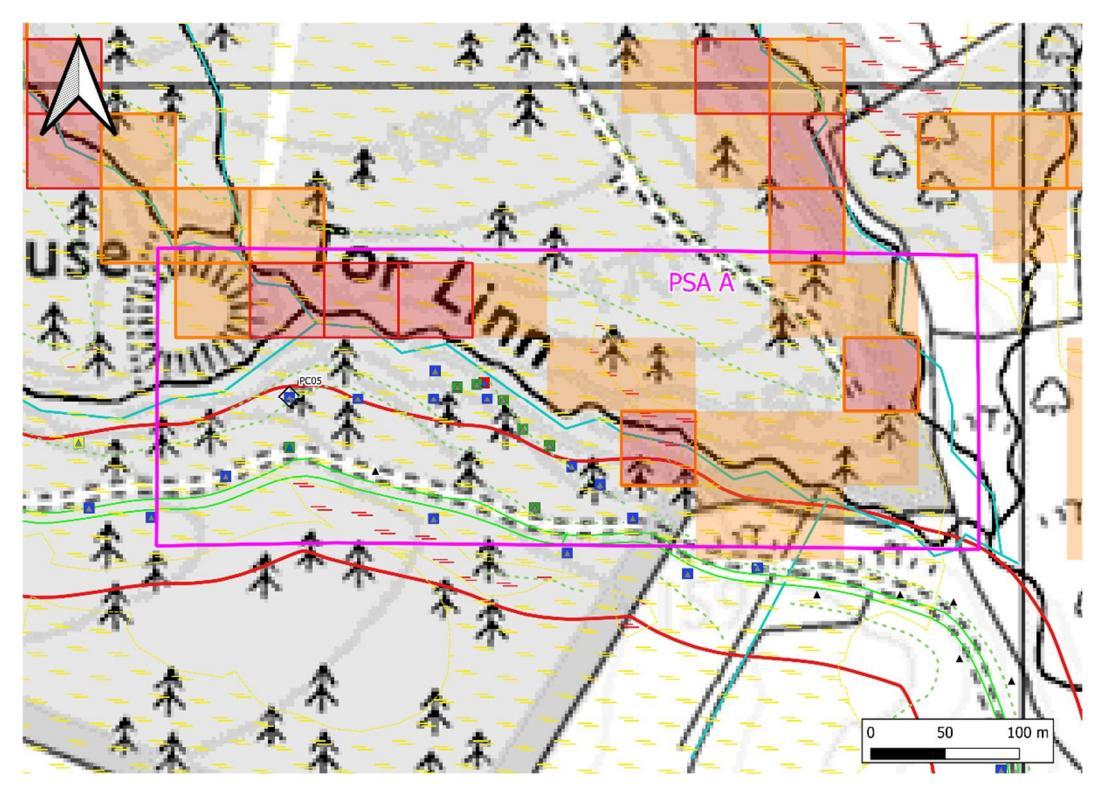
Illustration 6.7: OS overview of PSA Area A

Peat depths in PSA Area A are typically less than 0.5m, with some isolated results of up to 0.70m and a mean probing depth of 0.25m for PSA Area A. Peat depths were generally non-peat or shallow peat within 100m of planned infrastructure. Limited additional probing was collected within the Initial High and Moderate Risk cells due to survey safety concerns in relation to steep slopes combined with unstable fallen trees, with a further limitation applied to avoid potential probing damage to Wallace's House Scheduled Monument. Slope gradients are generally steeper in the area north of the planned track upgrade, with two distinct breaks of slope below the existing track noted, where slope angles ranging up to 47 degrees. Local slope angles are increased by the bankings immediately to the north of the existing track, presumably using material excavated during the original track construction (see **Photograph 6.9** in Site Reconnaissance section). From observation, this material appeared to be a mix of peaty soil, mineral soil and boulder clay, with no obvious bank instability. A peat core was initially planned to the north of the existing track, however due to locally shallow depths and visual evidence of non-peaty

Section 1.8 lists standard mitigation measures. Additional peat depth surveys shall enable a better understanding of the area to reduce the risk of any small-scale peat instability. This area is not considered at risk of mass peat instability as non-peaty soils are predominant, however, there is potential risk of non-peat instability and should be recorded in the Geotechnical Risk Register. Care should be taken to avoid increasing loading of slope to the north of the track upgrade, with slope support to be maintained for slopes to the south of the upgrade. Slope monitoring should be instigated preconstruction to both sides of this track section and additional slope management measures considered, which may lead to a requirement for slope support or erosion protection, such as use of gabion terraces/mattresses or other measures. Track drainage should avoid converging large or high velocity flows onto slopes to north in order to avoid scour and/or bank collapse.

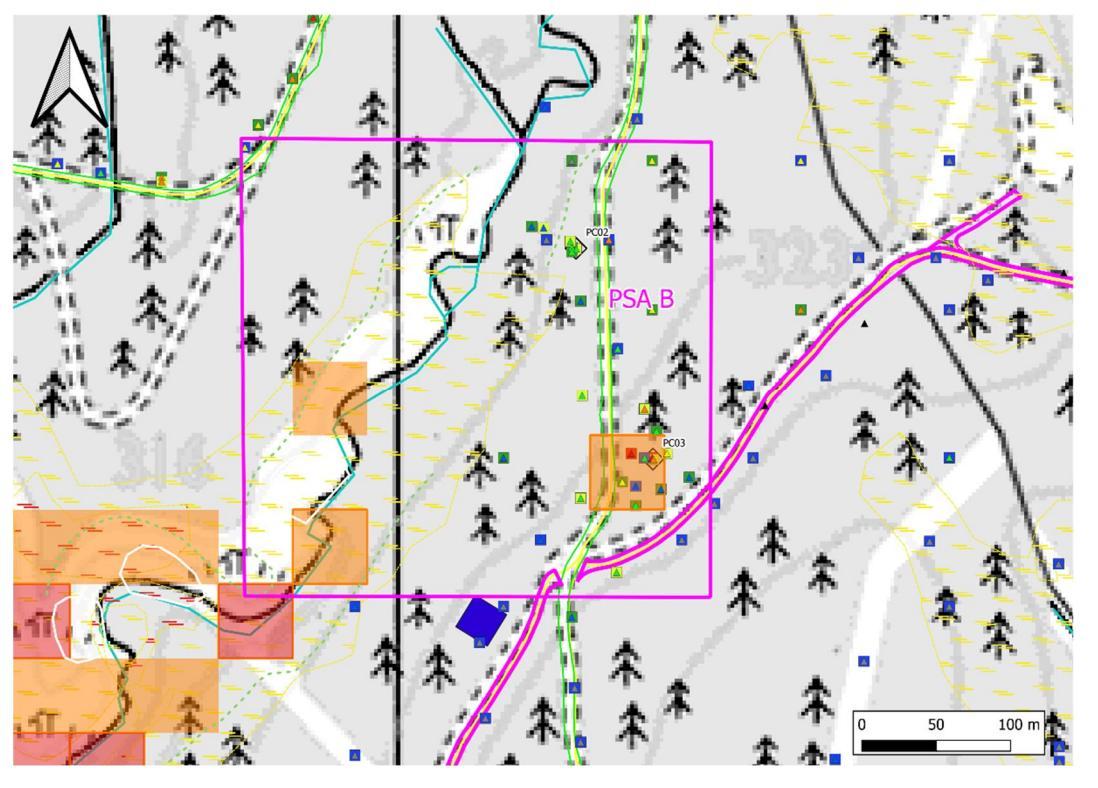
Illustration 6.9: OS overview of PSA Area B

Section 1.8 details standard good practice measures. The existing operational Harestanes Windfarm access track, planned for upgrade, passes through part of a single Initial Moderate Risk cell. The track to be upgraded is located immediately downslope of an area of level ground which includes a relatively small deposit of very deep peat. The existing track crosses the Glenkiln Burn in the north of PSA Area B and is within the watercourse's 50m buffer zone.

The existing track planned for upgrade retains 'High' consequence status. An isolated pocket of deep peat has been identified at the PC03 location, however, no peat instability evidence was observed at this location or identified on GeoSure data. The steep gradients and breaks of slope relating to the Glenkiln Burn are within the west of PSA Area B and identified as GeoSure Class C, however, all planned infrastructure avoids these fluvial erosion features. Taking account of the peatland morphology, existing drainage network, *in situ* retained tree roots, individual peat probe FoS, design and mitigation (including micrositing to avoid deeper peat), the Likelihood is reduced to Unlikely and the Revised Risk reduced to Low.

Section 1.8 lists standard mitigation measures. Additional peat data would be recommended, with peat characteristics recorded and micrositing considered to minimise peat disturbance. The upgrade of the existing track will require care to avoid removal of slope support to east or increased loading of slope to west. Slope monitoring should be undertaken of slopes close to the Initial Moderate Risk cell, which may lead to a requirement for slope support or erosion protection, such as use of gabion terraces/mattresses or other measures. Track drainage design should avoid converging flows into areas potentially prone to failure, such as the area adjacent to the Glenkiln Burn where active erosion and bank failure is evident. Blasting at BP01 to consider peat stability. This location should be recorded in the Geotechnical Risk Register. Although considered unlikely, should peatslide occur; approximated width 20m, length 20m, volume of peat 600m³; receptors being local hillside and/or access track.

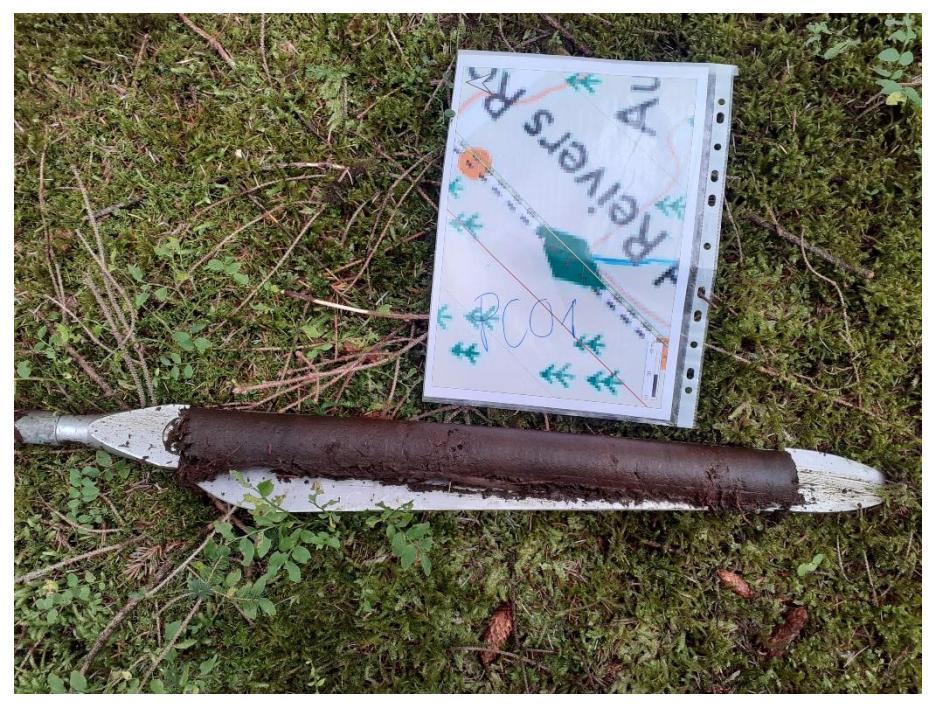
Photograph 6.14: Peat Core PC01b (deep), NGR 300492, 593418

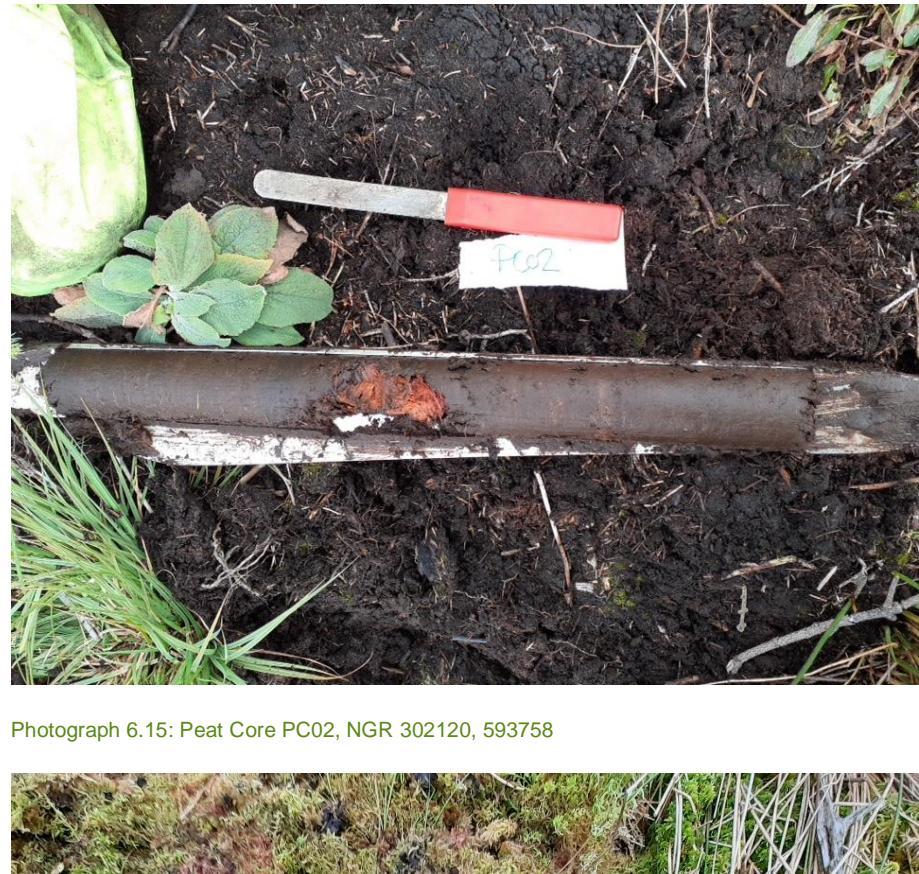
Peat core location PC03 had 2 cores taken (PC03a and PC03b) at a slope angle of 5 degrees, collected at depths of 1.5m and 3.0m, respectively, each recording Von Post humification class H4; Weakly Decomposed. This data suggests that amorphous catotelmic peat is not generally found at depths less than 3.0m locally. The hand shear vane's lowest recorded value, within a drainage channel at a depth of 1.0m, was 6kN/m². A peat core was also collected at PC02 on a 6 degree embankment slope below the existing track; H5 Von Post and lowest shear vane of 11kN/m².

Photograph 6.16: Peat Core PC03a (shallow), NGR 302172, 593616

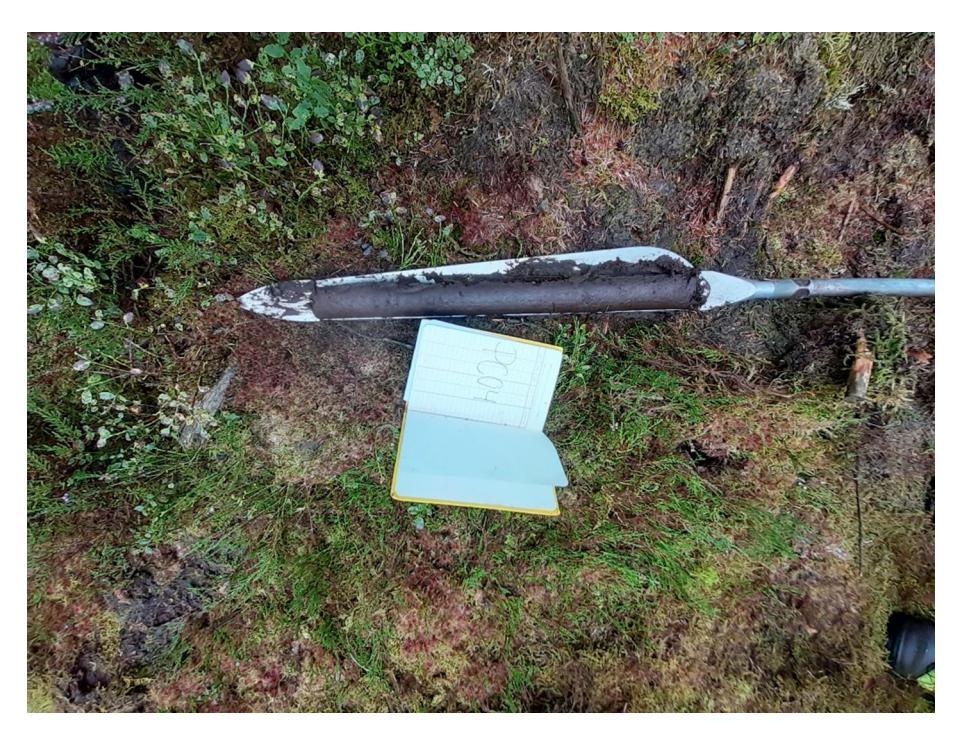
Photograph 6.17: Peat Core PC04, NGR 302338, 592685
