Rigged Hill Windfarm Repowering

Technical Appendix A12.1: Abnormal Load Assessment

RIGGED HILL WIND FARM REPOWERING

ABNORMAL LOAD ROUTE ASSESSMENT

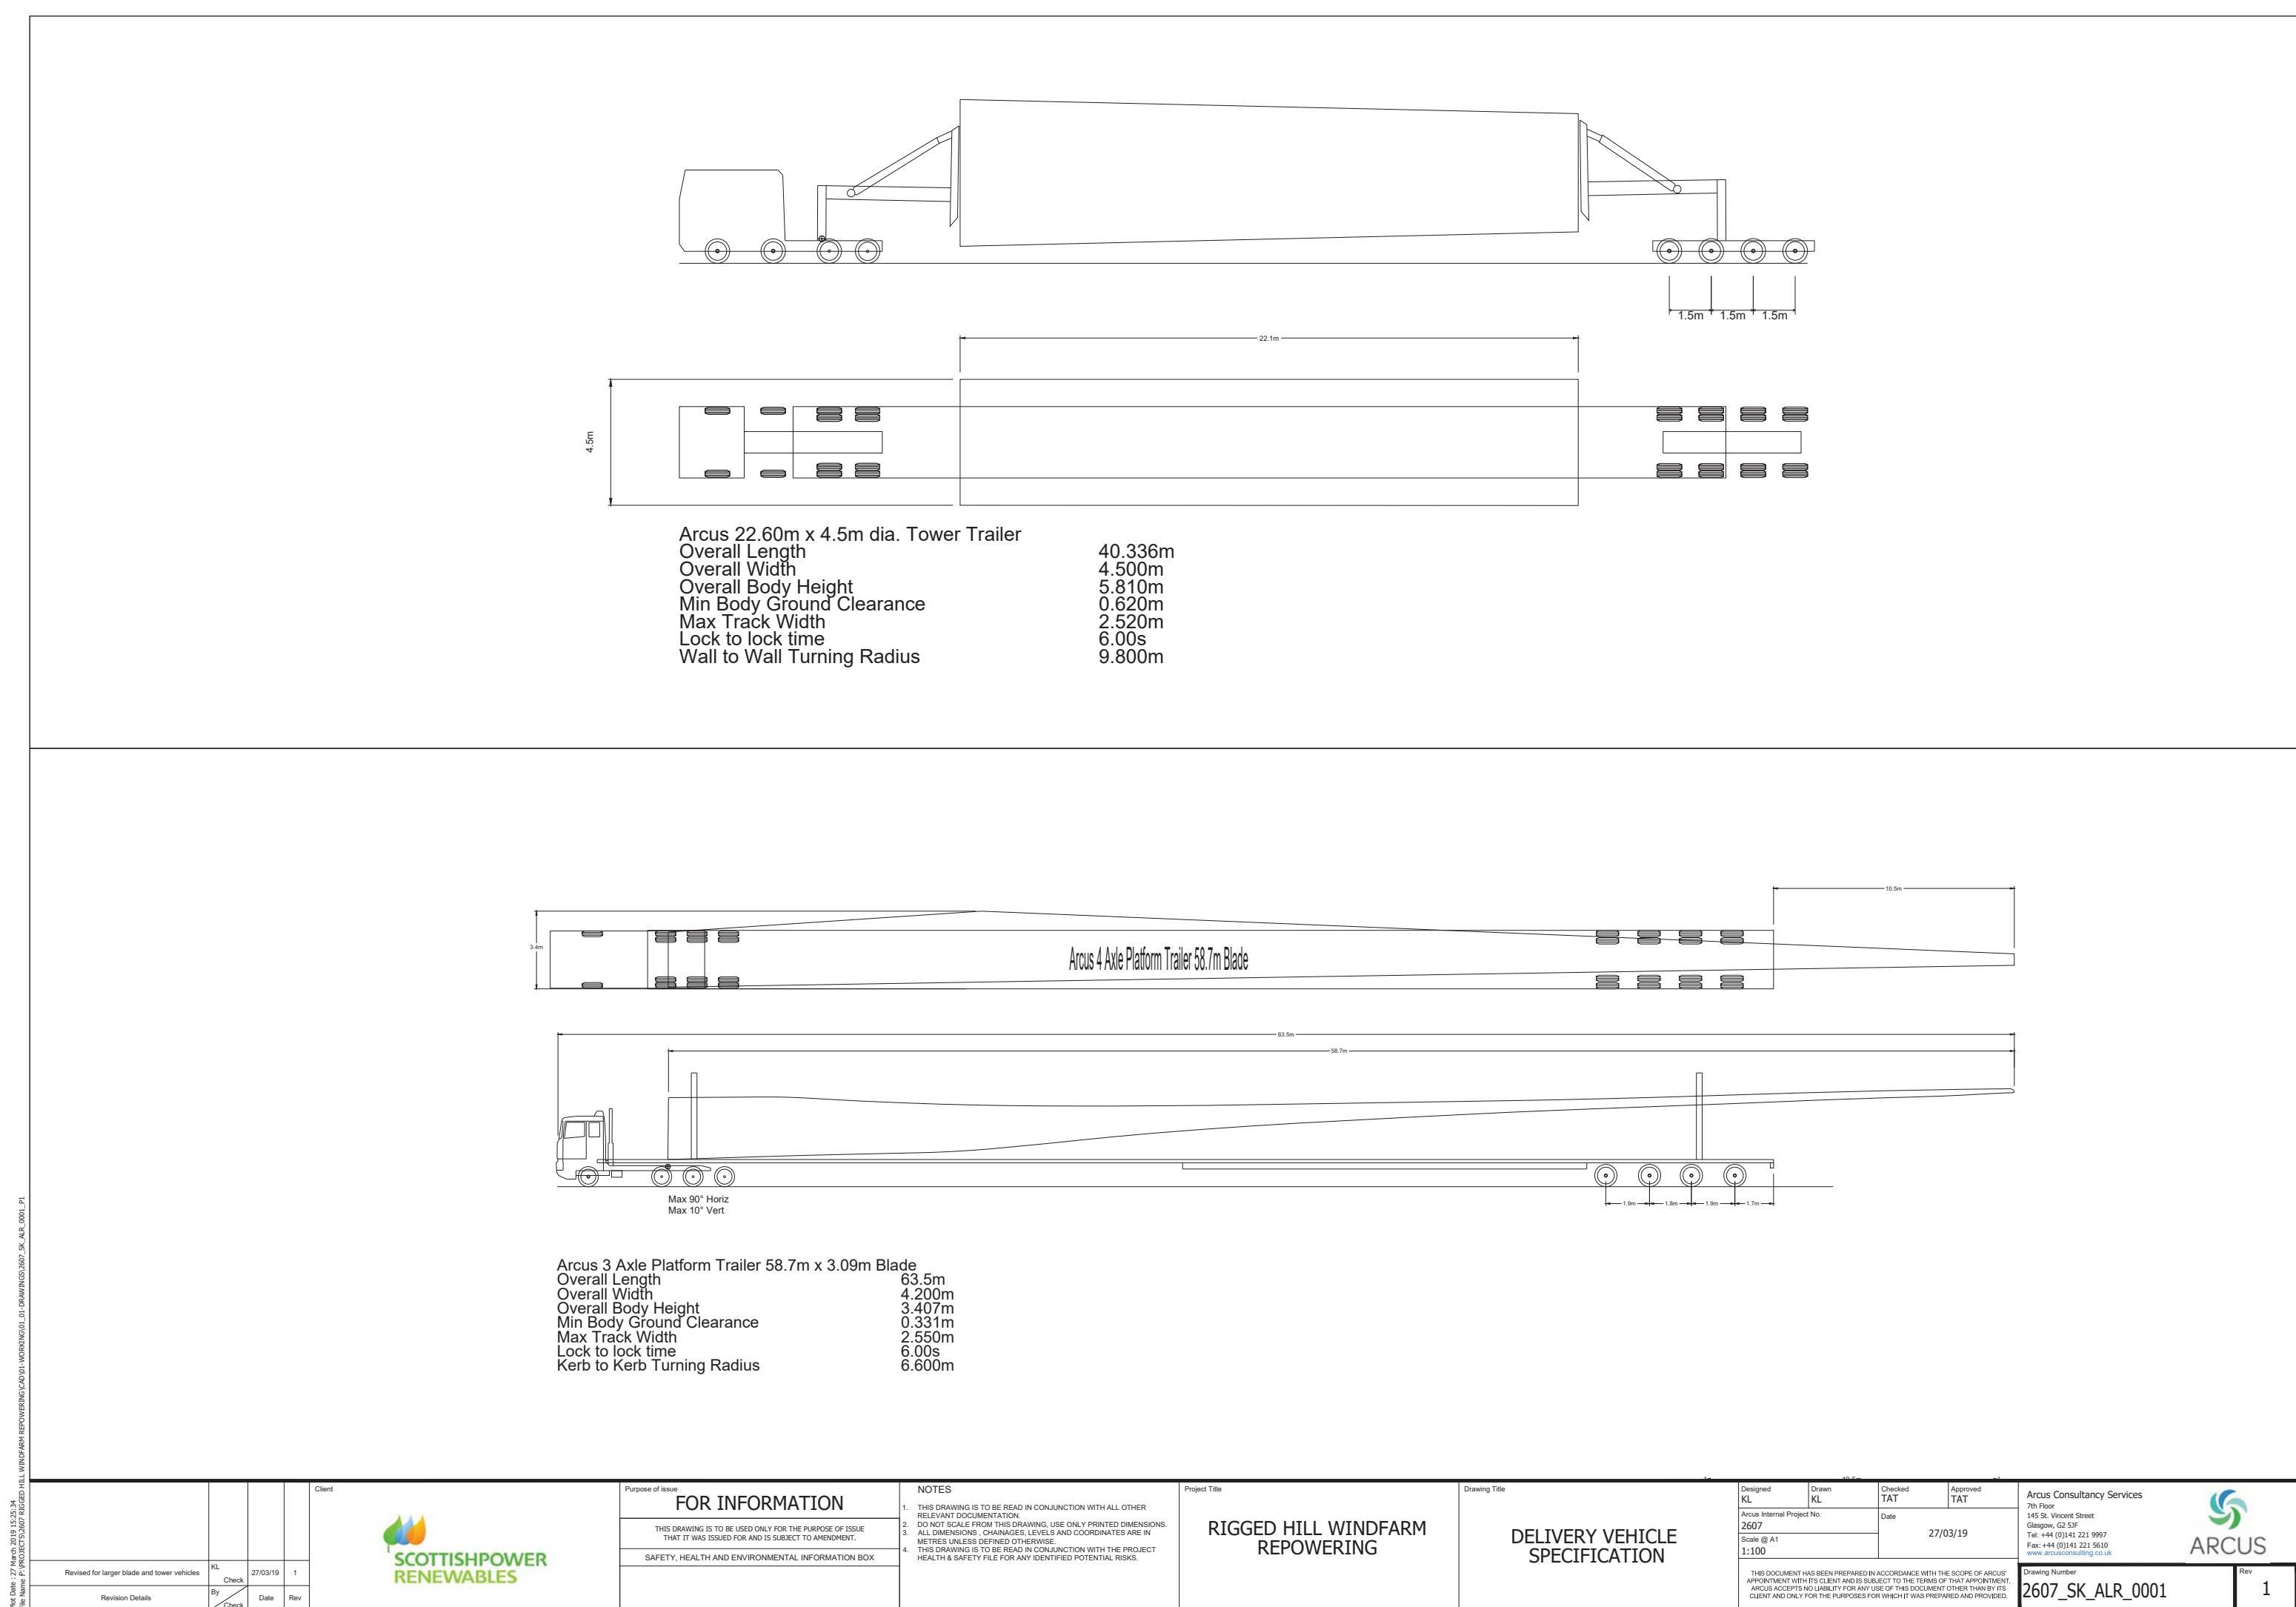
APPENDIX A – VEHICLE DATA SHEET

Vehicle data sheets are included in Appendix A. Dimensions of the worst case turbine components and corresponding delivery vehicle specifications are provided in the following tables.

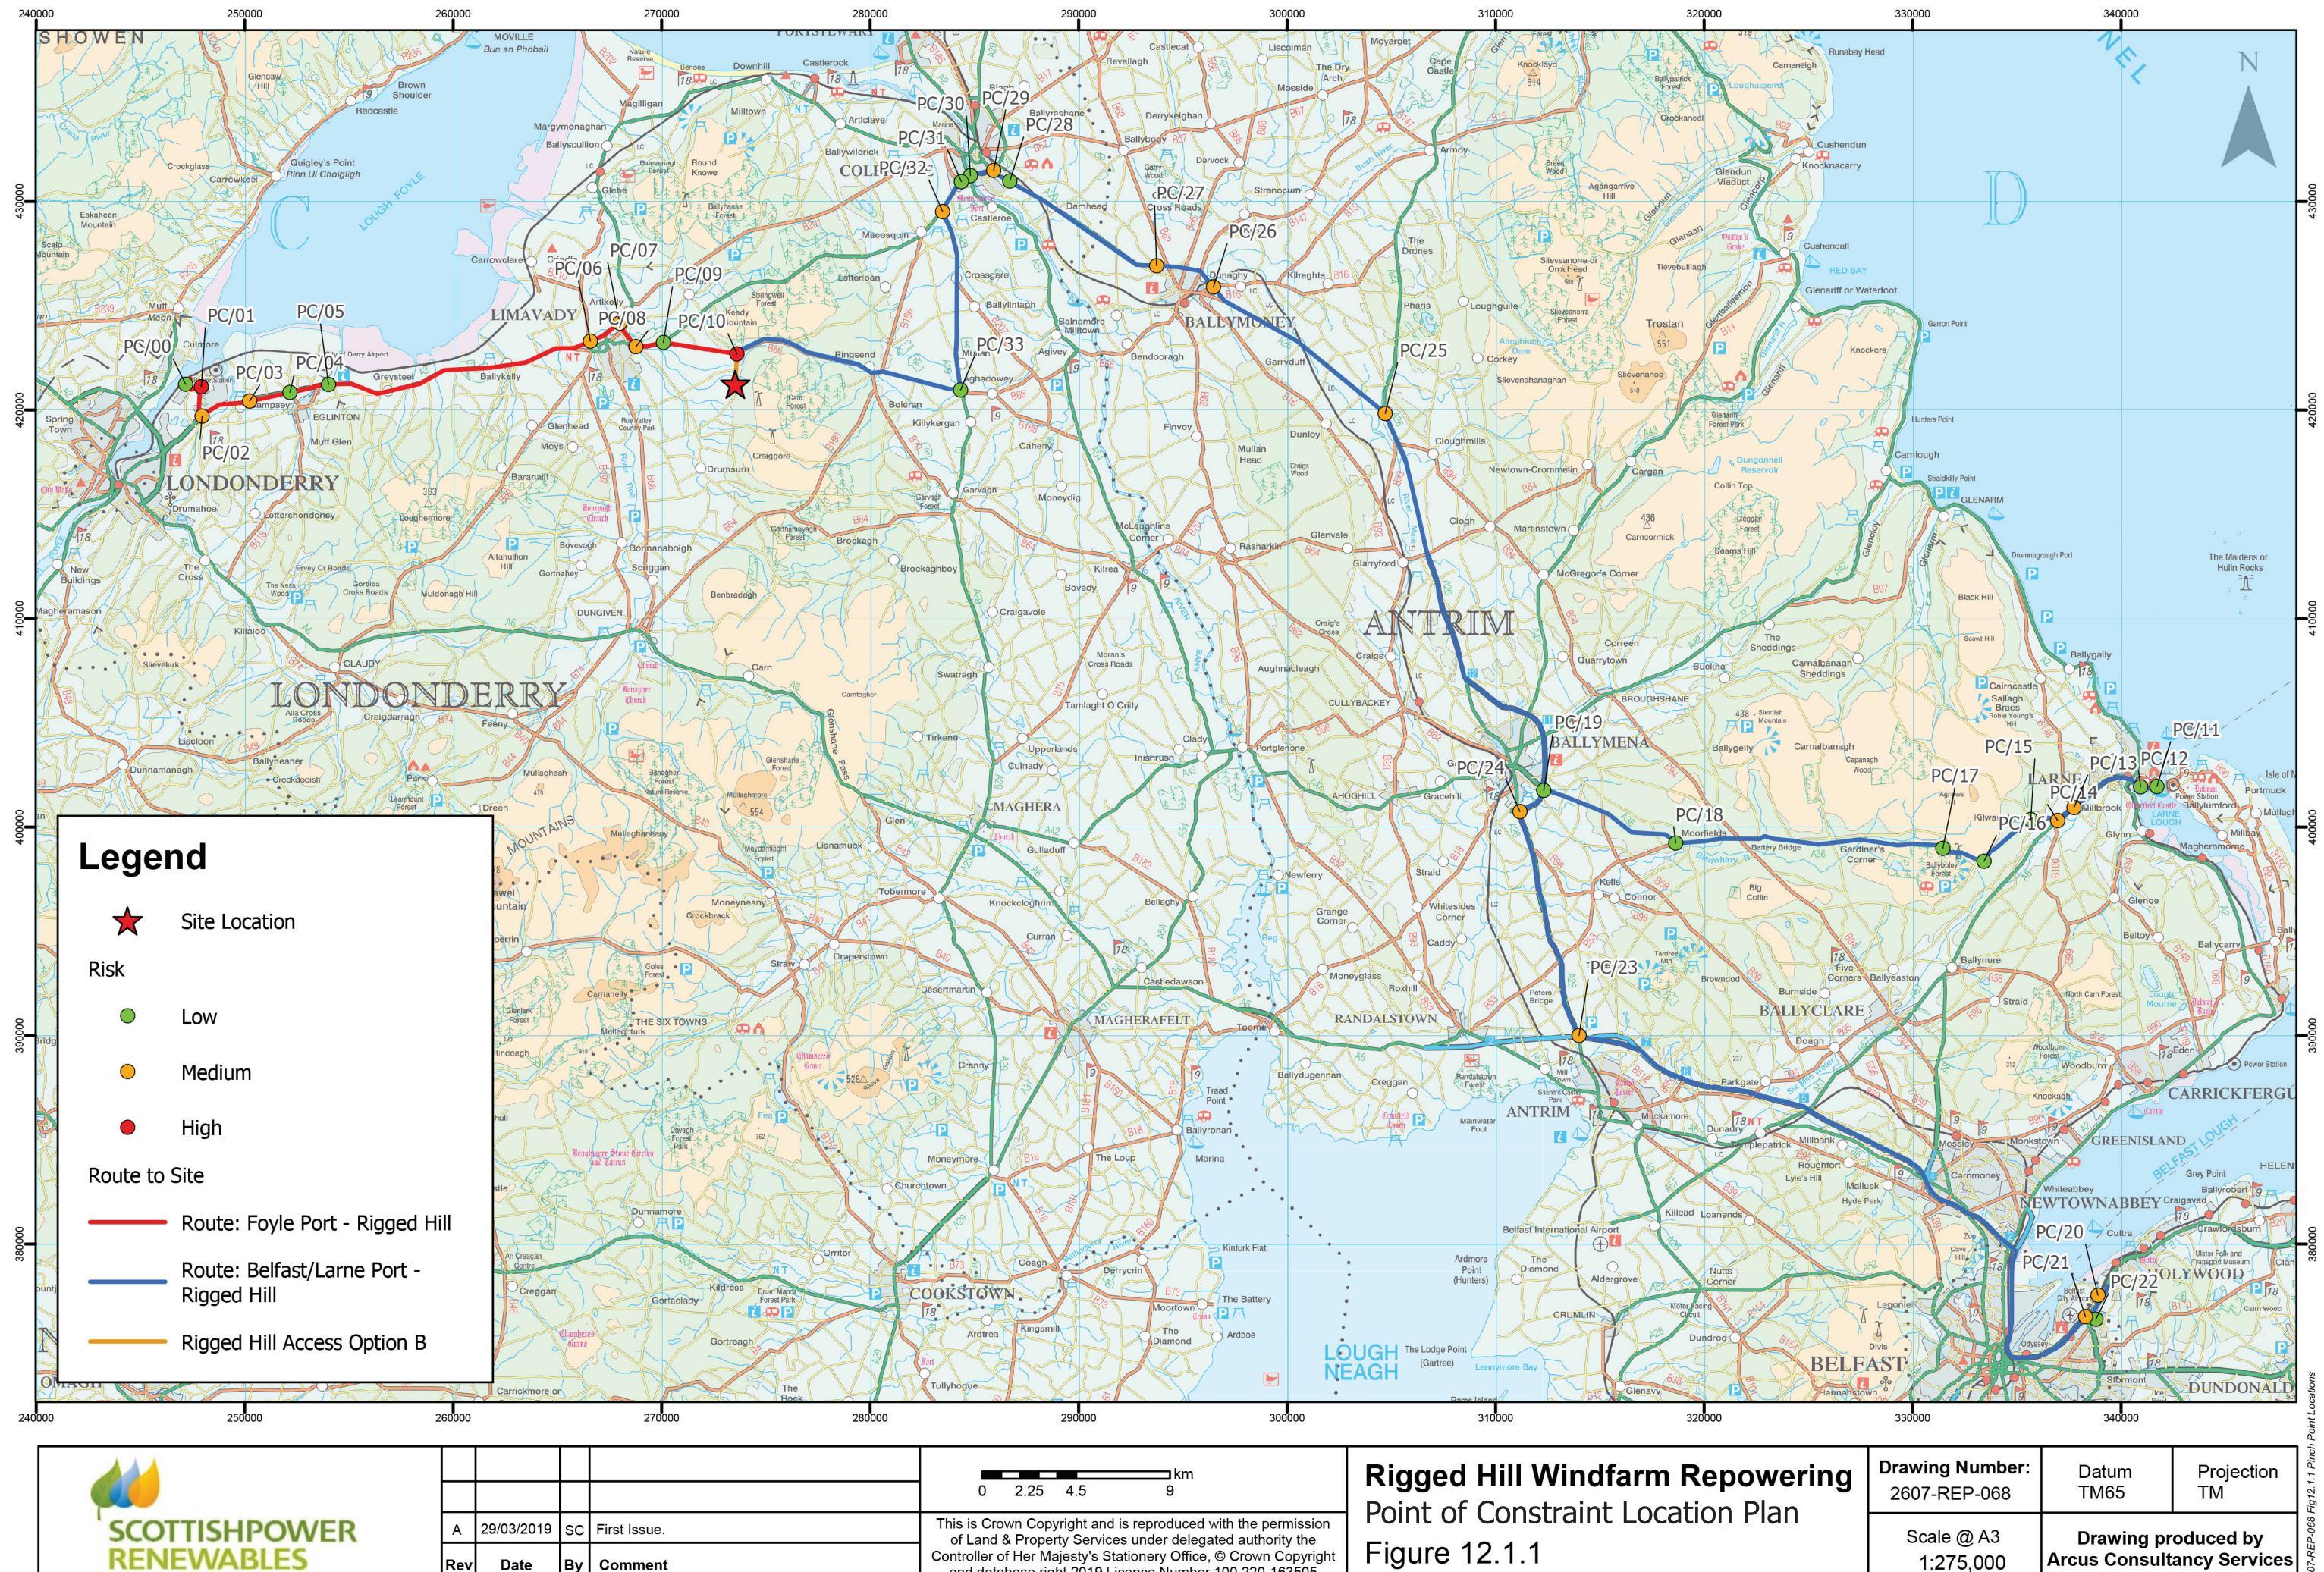
Figure 12.1.1

Routes to site were considered from Belfast and Larne in the east and from Foyle Port, Derry / Londonderry in the West. Figure 1 included in appendix B shows the assessed routes to site and location of PCs, and overview of each route is provided below.
