ARECLEOCH WINDFARM EXTENSION

Technical Appendix 10.5: Borrow Pit Screening Assessment Prepared for: ScottishPower Renewables

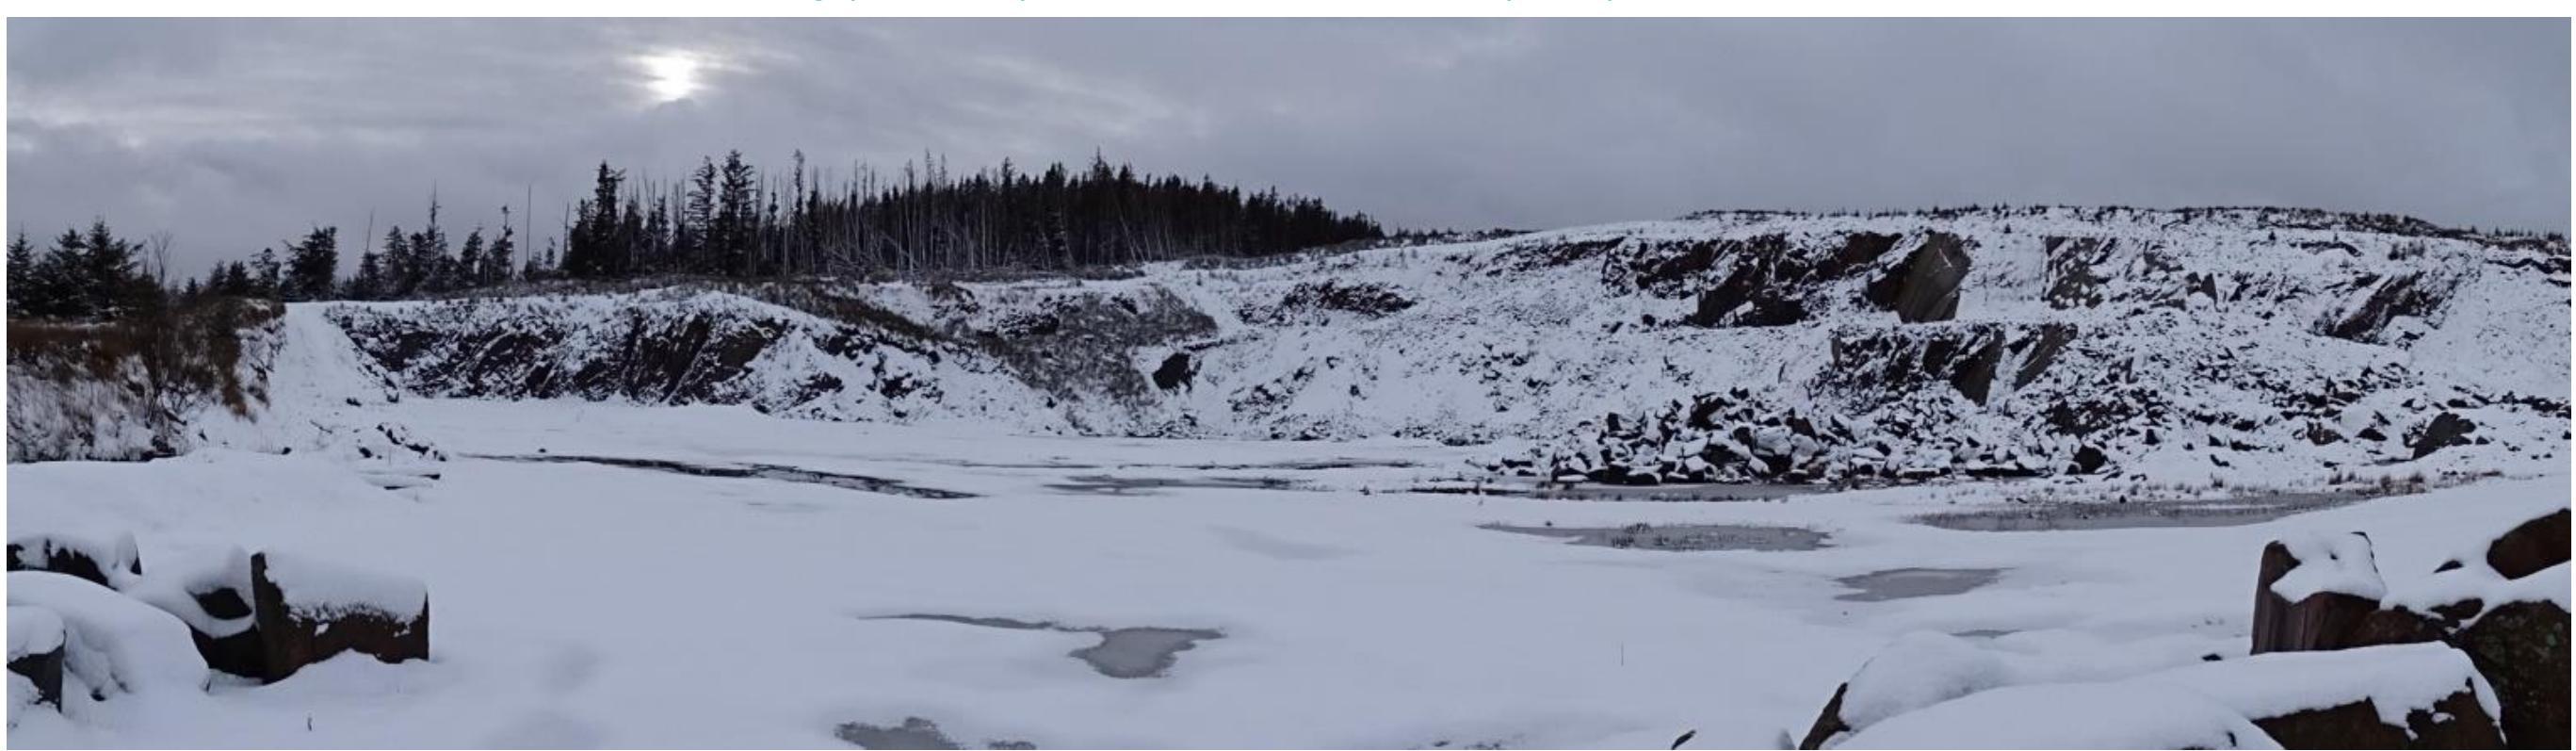
Photograph 4-1: Forestry Borrow Pit 6 (E 221550 N 571500) used by Forestry and Land Scotland

There has been no active mining or quarrying activities within the Site boundary (see Figure 10.5.1), though there has been borrow pit extraction within the forestry site and for the original Arecleoch Windfarm (Photograph 4-1). Large volumes of rock also appear to have been extracted from borrow pit BP4 which provides a guide to the extraction potential of adjacent sites.

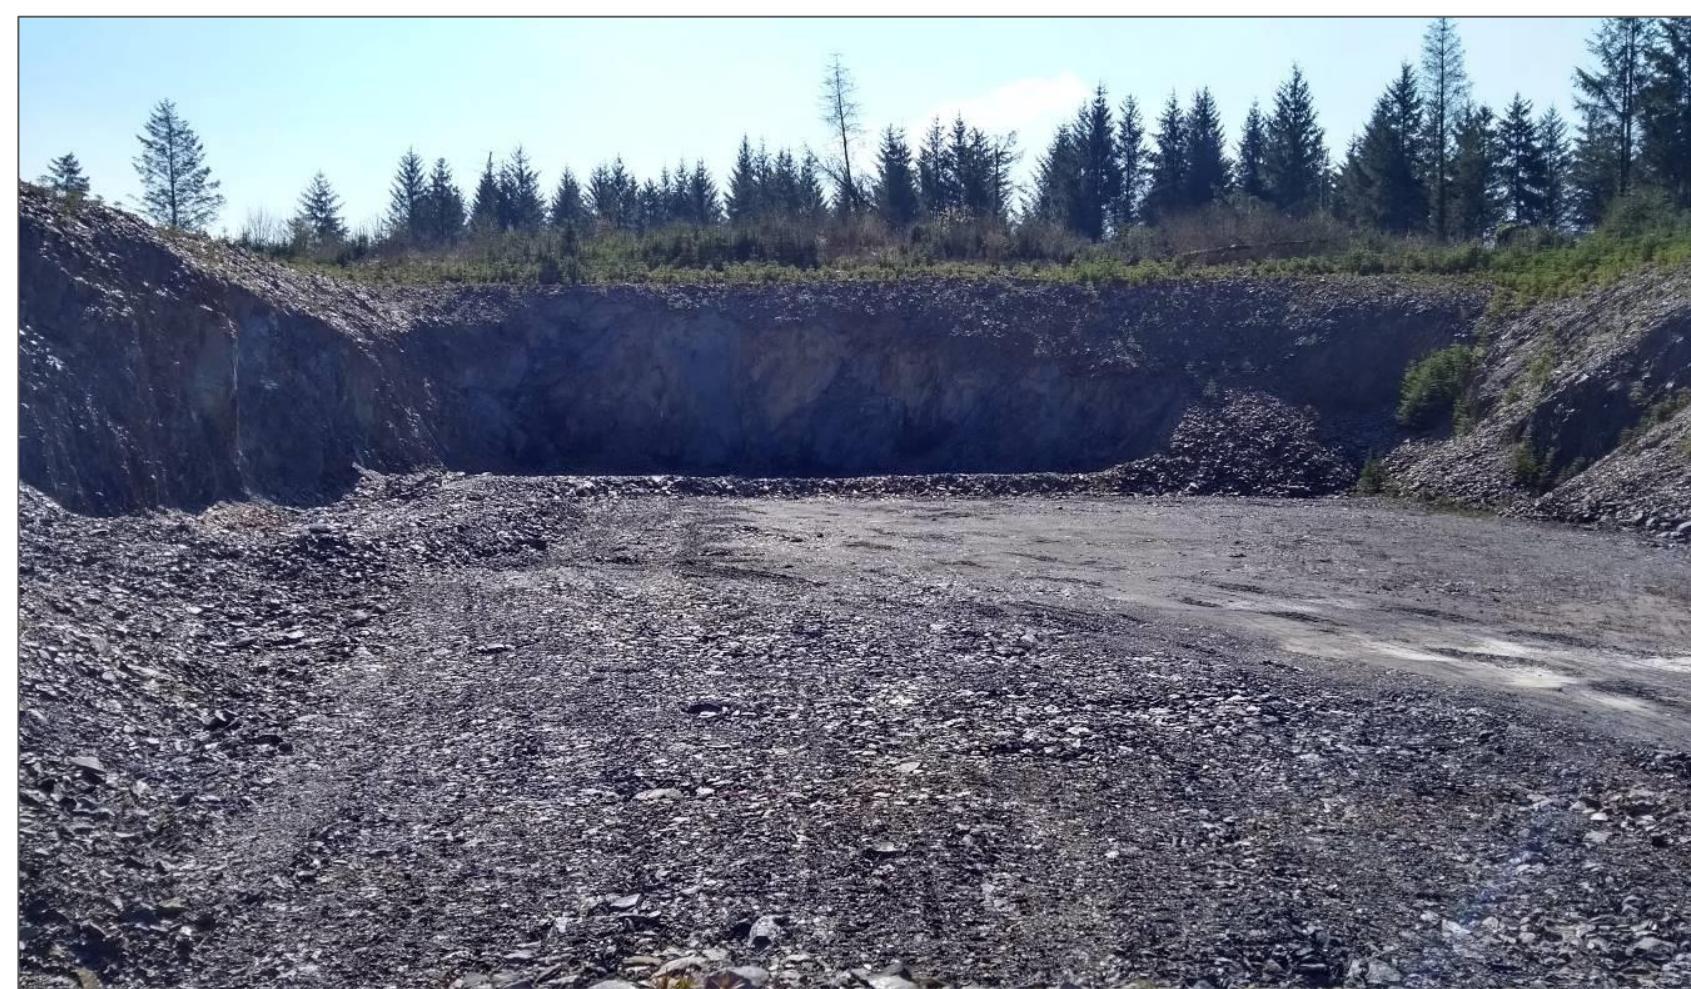
Photograph 4-2: Borrow Pit BP2 (Direction of View – south)

Borrow pit BP2 is located within the forested area to the south of the proposed access track at approximately NGR NH 226559, 577653 shown on **Figure 10.5.9b**. The potential borrow pit would be located a short distance from the existing access track.

The underlying geology in this area is the Kirkholm Formation, comprising massive wacke and siltsone turbidite sequences.

It is anticipated that the borrow pit would comprise a layer of weathered granular material, broken rock and rock close to the surface, which would offer a significant volume of material.

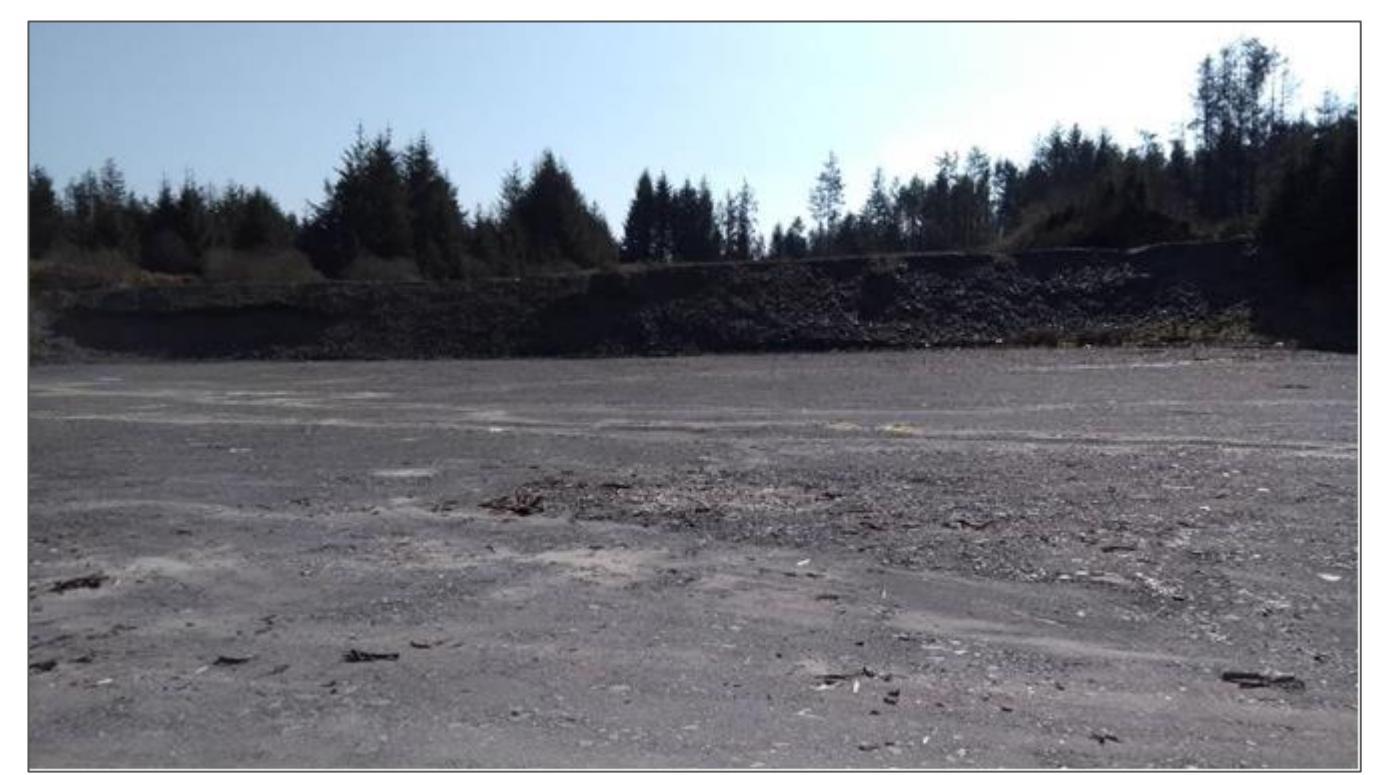
Photograph 4-4: Borrow Pit BP3 (Direction of View – east)

Borrow pit BP3 is located within the forested area to the south of the proposed access track at approximately NGR NH 224618, 577001 shown on Figure 10.5.9c. The potential borrow pit is an extension to an existing borrow pit and adjacent to the existing track that is to be used as part of the proposed Development.

The underlying geology in this area is the Kirkholm Formation, comprising massive wacke and siltsone turbidite sequences.

It is anticipated that the borrow pit would comprise a layer of weathered granular material, broken rock and rock close to the surface, which would offer a significant volume of material.

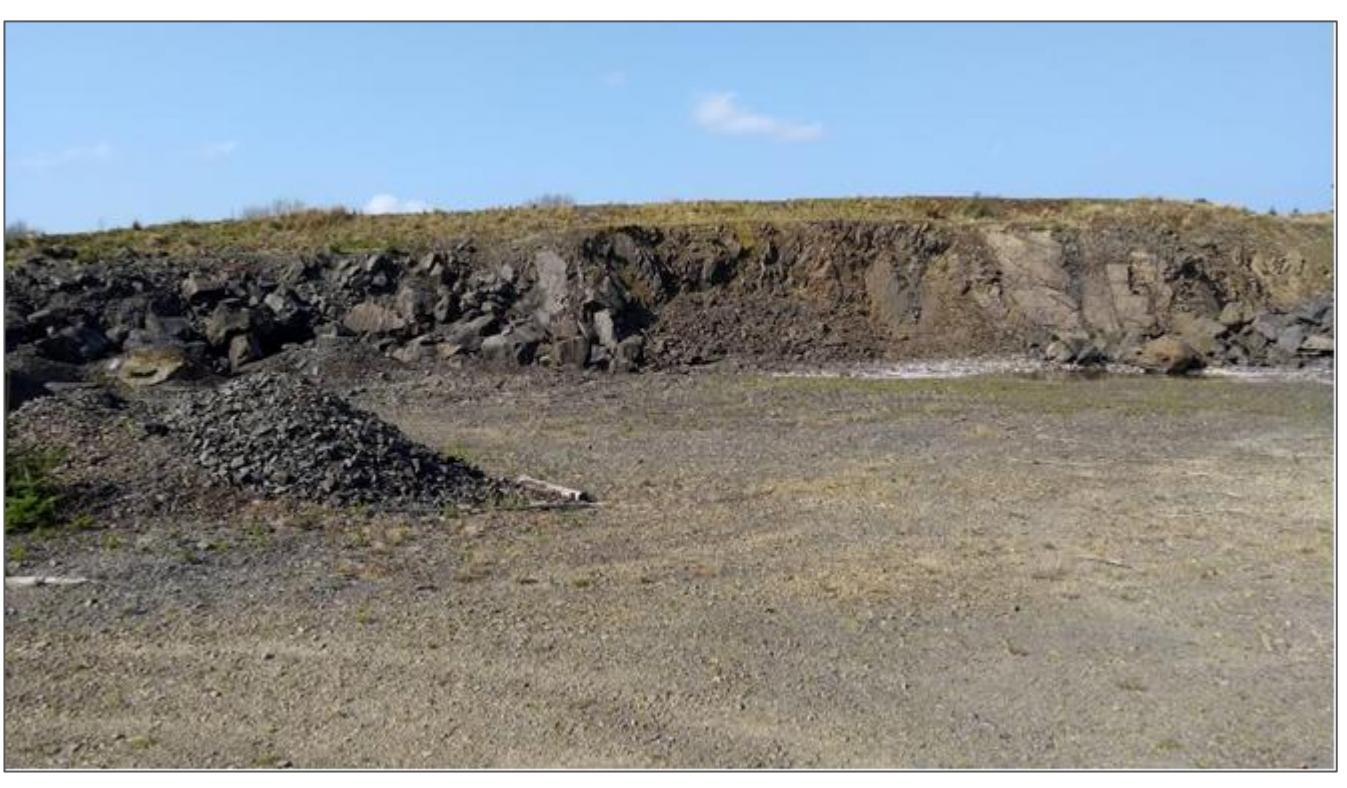
Photograph 4-6: Borrow Pit BP4 (Direction of View – North)

Borrow pit BP4 is located on the existing access track, within the forested area, at approximately NGR NH 220787, 580811 shown on Figure 10.5.9d. The proposed borrow pit is an extension to an existing borrow pit, immediately to the north of the proposed access track. Due to the anticipated high volumes of bedrock close to surface, it would be possible to extend this borrow pit in width and gain large volumes of aggregate.

The underlying geology in this area is the Kirkholm Formation, comprising massive wacke and siltsone turbidite sequences.

It is anticipated that the borrow pit would comprise a layer of weathered granular material, broken rock and rock close to the surface, which would offer a significant volume of material.

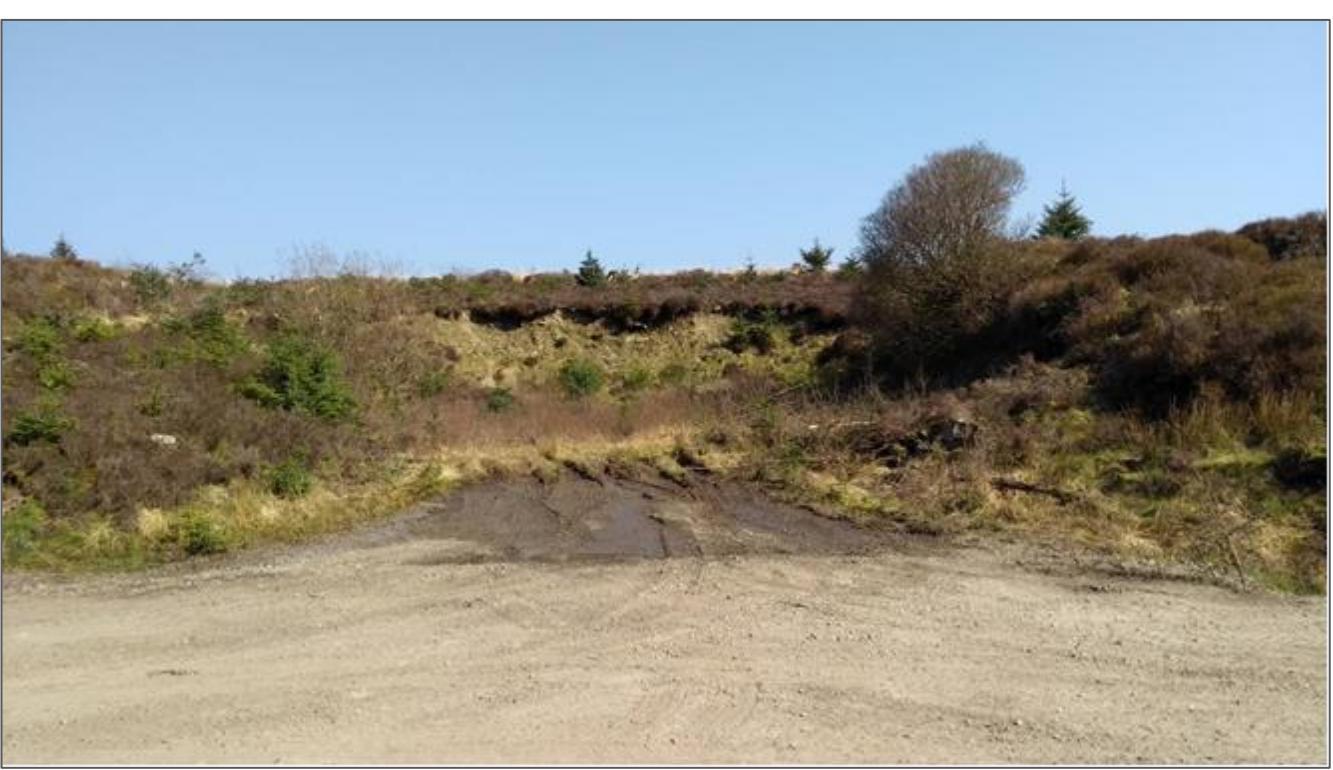
Photograph 4-8: Borrow Pit BP5 (Direction of View – north east)

Borrow pit BP5 is located within the forested area at the north of the proposed access track at approximately NGR NH 219901, 580861 shown on **Figure 10.5.9e**. The borrow pit would be located a short distance from the existing access track.

The underlying geology in this area is the Kirkholm Formation, comprising massive wacke and siltsone turbidite sequences.

It is anticipated that the borrow pit would comprise a layer of weathered granular material, broken rock and rock close to surface, which would offer a significant volume of material. Peat probing identified no significant peat.

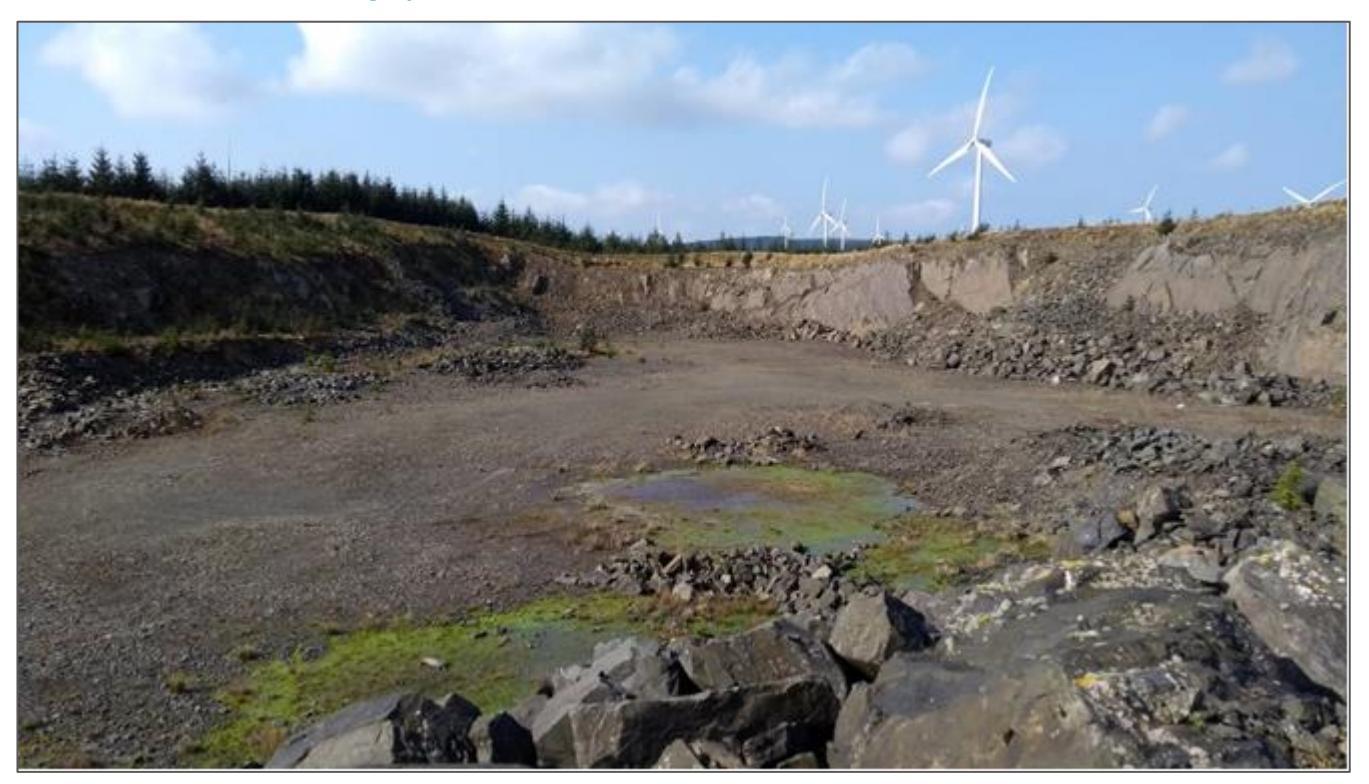
Photograph 4-9: Borrow Pit BP6 (Direction of View – north east)

Borrow pit BP6 is located on the existing access track, within the forested area, at approximately NGR NH 220787, 580811 shown on Figure 10.5.9f. The proposed borrow pit is an extension to an existing Wee Fell borrow pit, located on the Arecleoch Windfarm but accessible to the proposed Development. Due to the anticipated high volumes of bedrock close to surface, it would be possible to extend this borrow pit in width and gain large volumes of aggregate.

The underlying geology in this area is the Kirkholm Formation, comprising massive wacke and siltsone turbidite sequences.

It is anticipated that the borrow pit would comprise a layer of weathered granular material, broken rock and rock close to surface, which would offer a significant volume of material. Peat probing identified no significant peat and found bedrock close to surface.

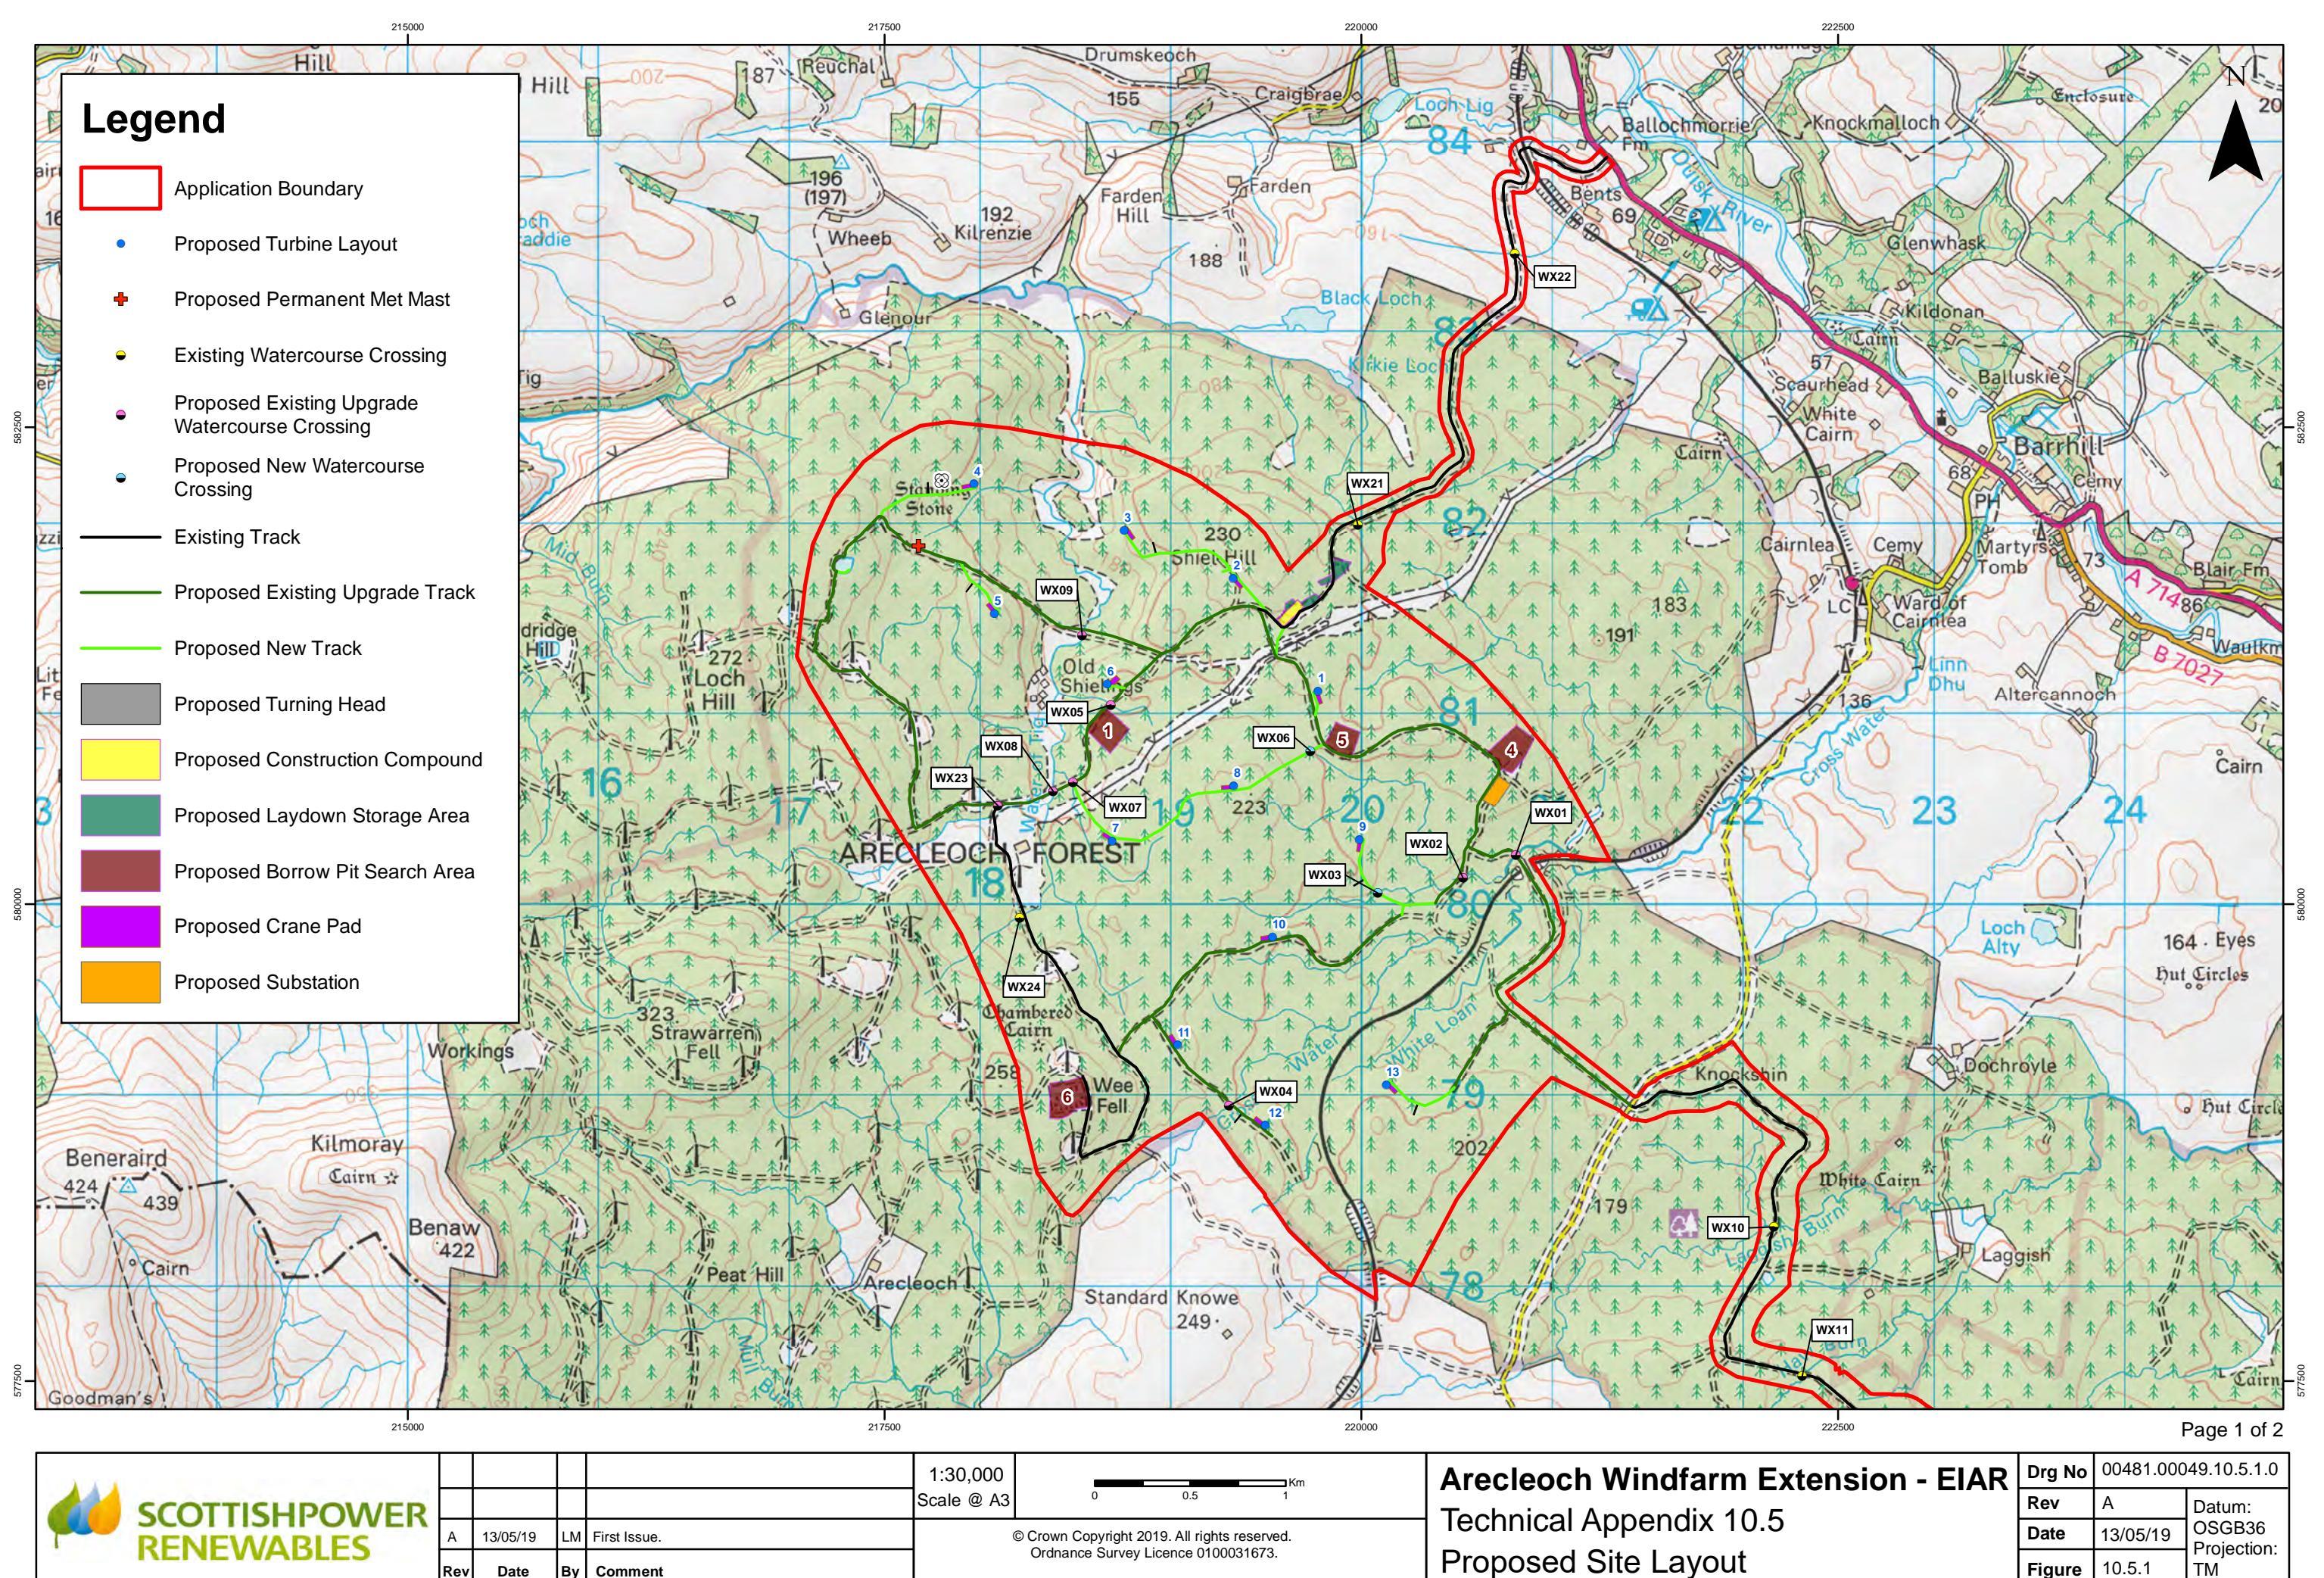
FIGURE 10.5.1: PROPOSED SITE LAYOUT

Access tracks would be required to facilitate access to the above ground components of the proposed Development, as shown on Figure 10.5.1. It is proposed that existing public roads and forestry tracks would be utilised where possible. However, there would be a requirement for some of these tracks to be upgraded, as well as the construction of new tracks. Borrow pits are required to provide aggregate to supply sufficient rock to construct suitable access tracks.

There have been several design iterations, a design freeze was agreed upon in April 2019. This assessment is based on the latest and final design iteration. A general view of the Site conditions are shown within Figure 10.5.1.

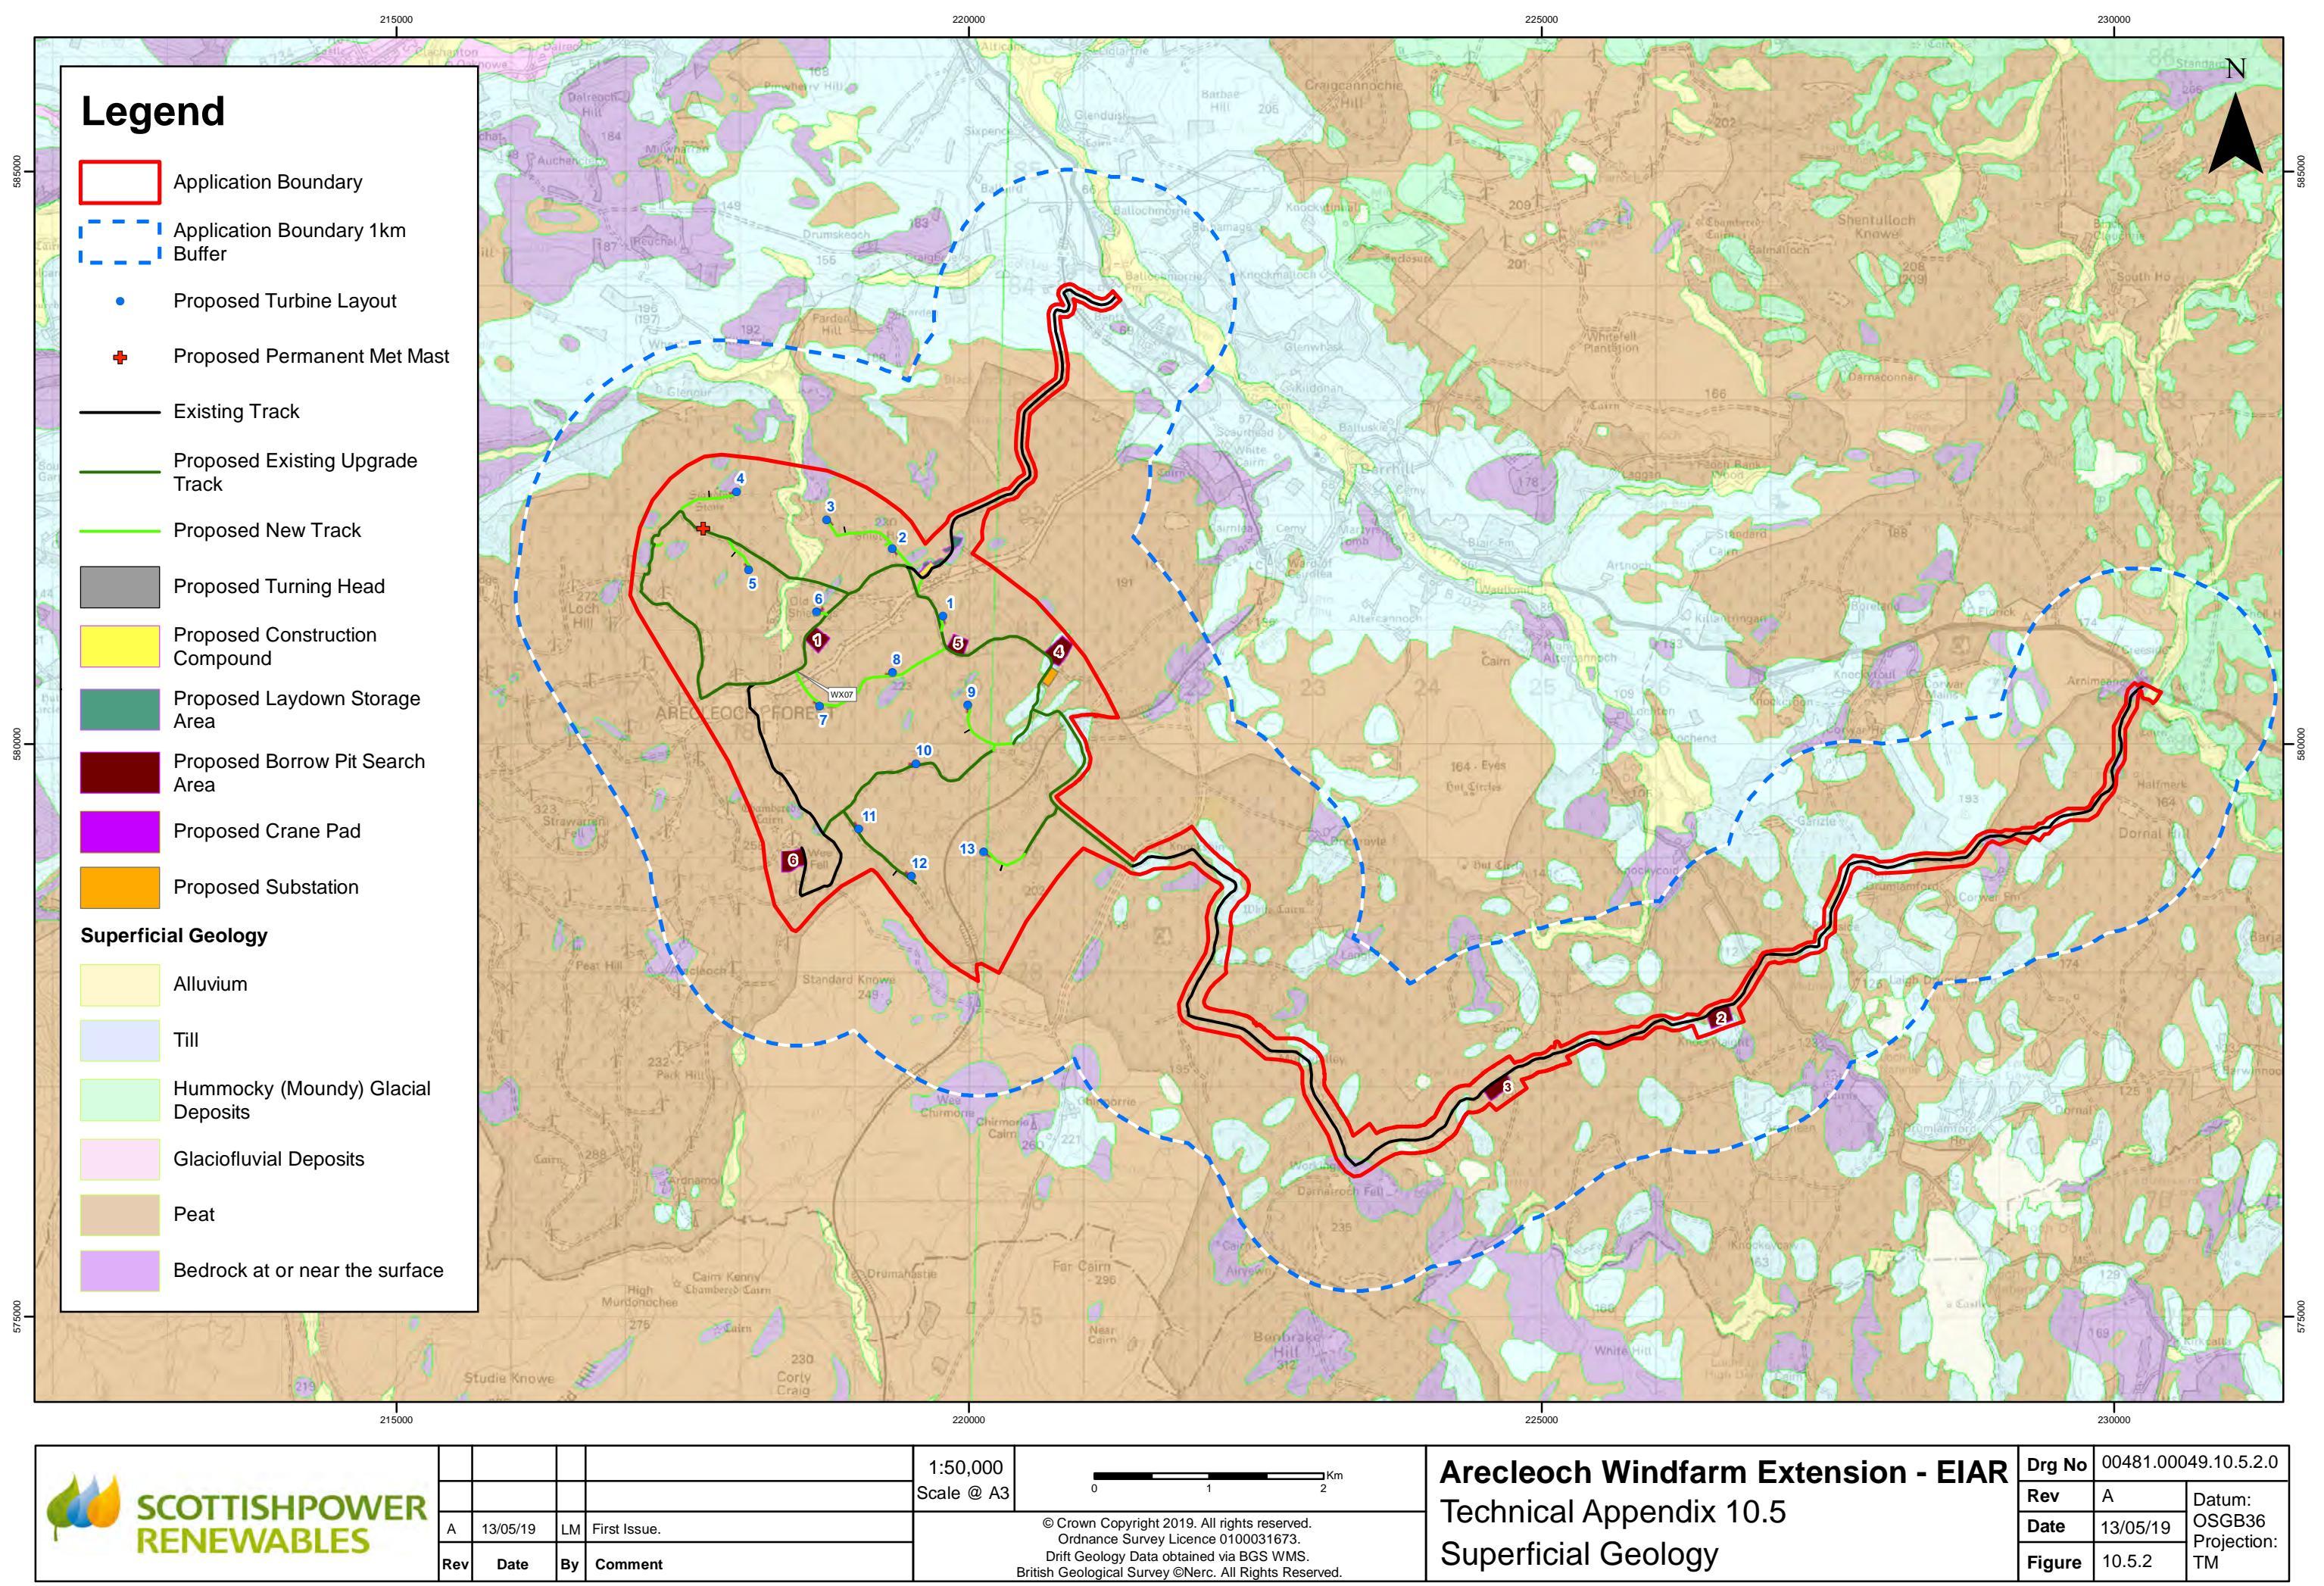
FIGURE 10.5.2: SUPERFICIAL GEOLOGY

The principal soil type underlying the Site is peat with areas of peaty gleys and brown soils along many of the watercourse valleys. Rare units of peaty gleyed podzols exist within the application boundary, most notably at the watercourse crossing of Cross Water (WX01). Mineral gleys and Brown soils have been recorded along the existing access track to the A714, west of Barrhill. Along the larger watercourses at lower altitudes (Water of Tig and River Cree) alluvial soils are observed within and along watercourses.

British Geological Survey mapping shows the Site to be almost entirely underlain by peat, with alluvium mapped around the Water of Tig, Pollingowan Burn and River Cree. Hummocky features are identified as glacial till with superficial deposits absent on some hill tops.

The Superficial geology of the Site is detailed in Figure 10.5.2.

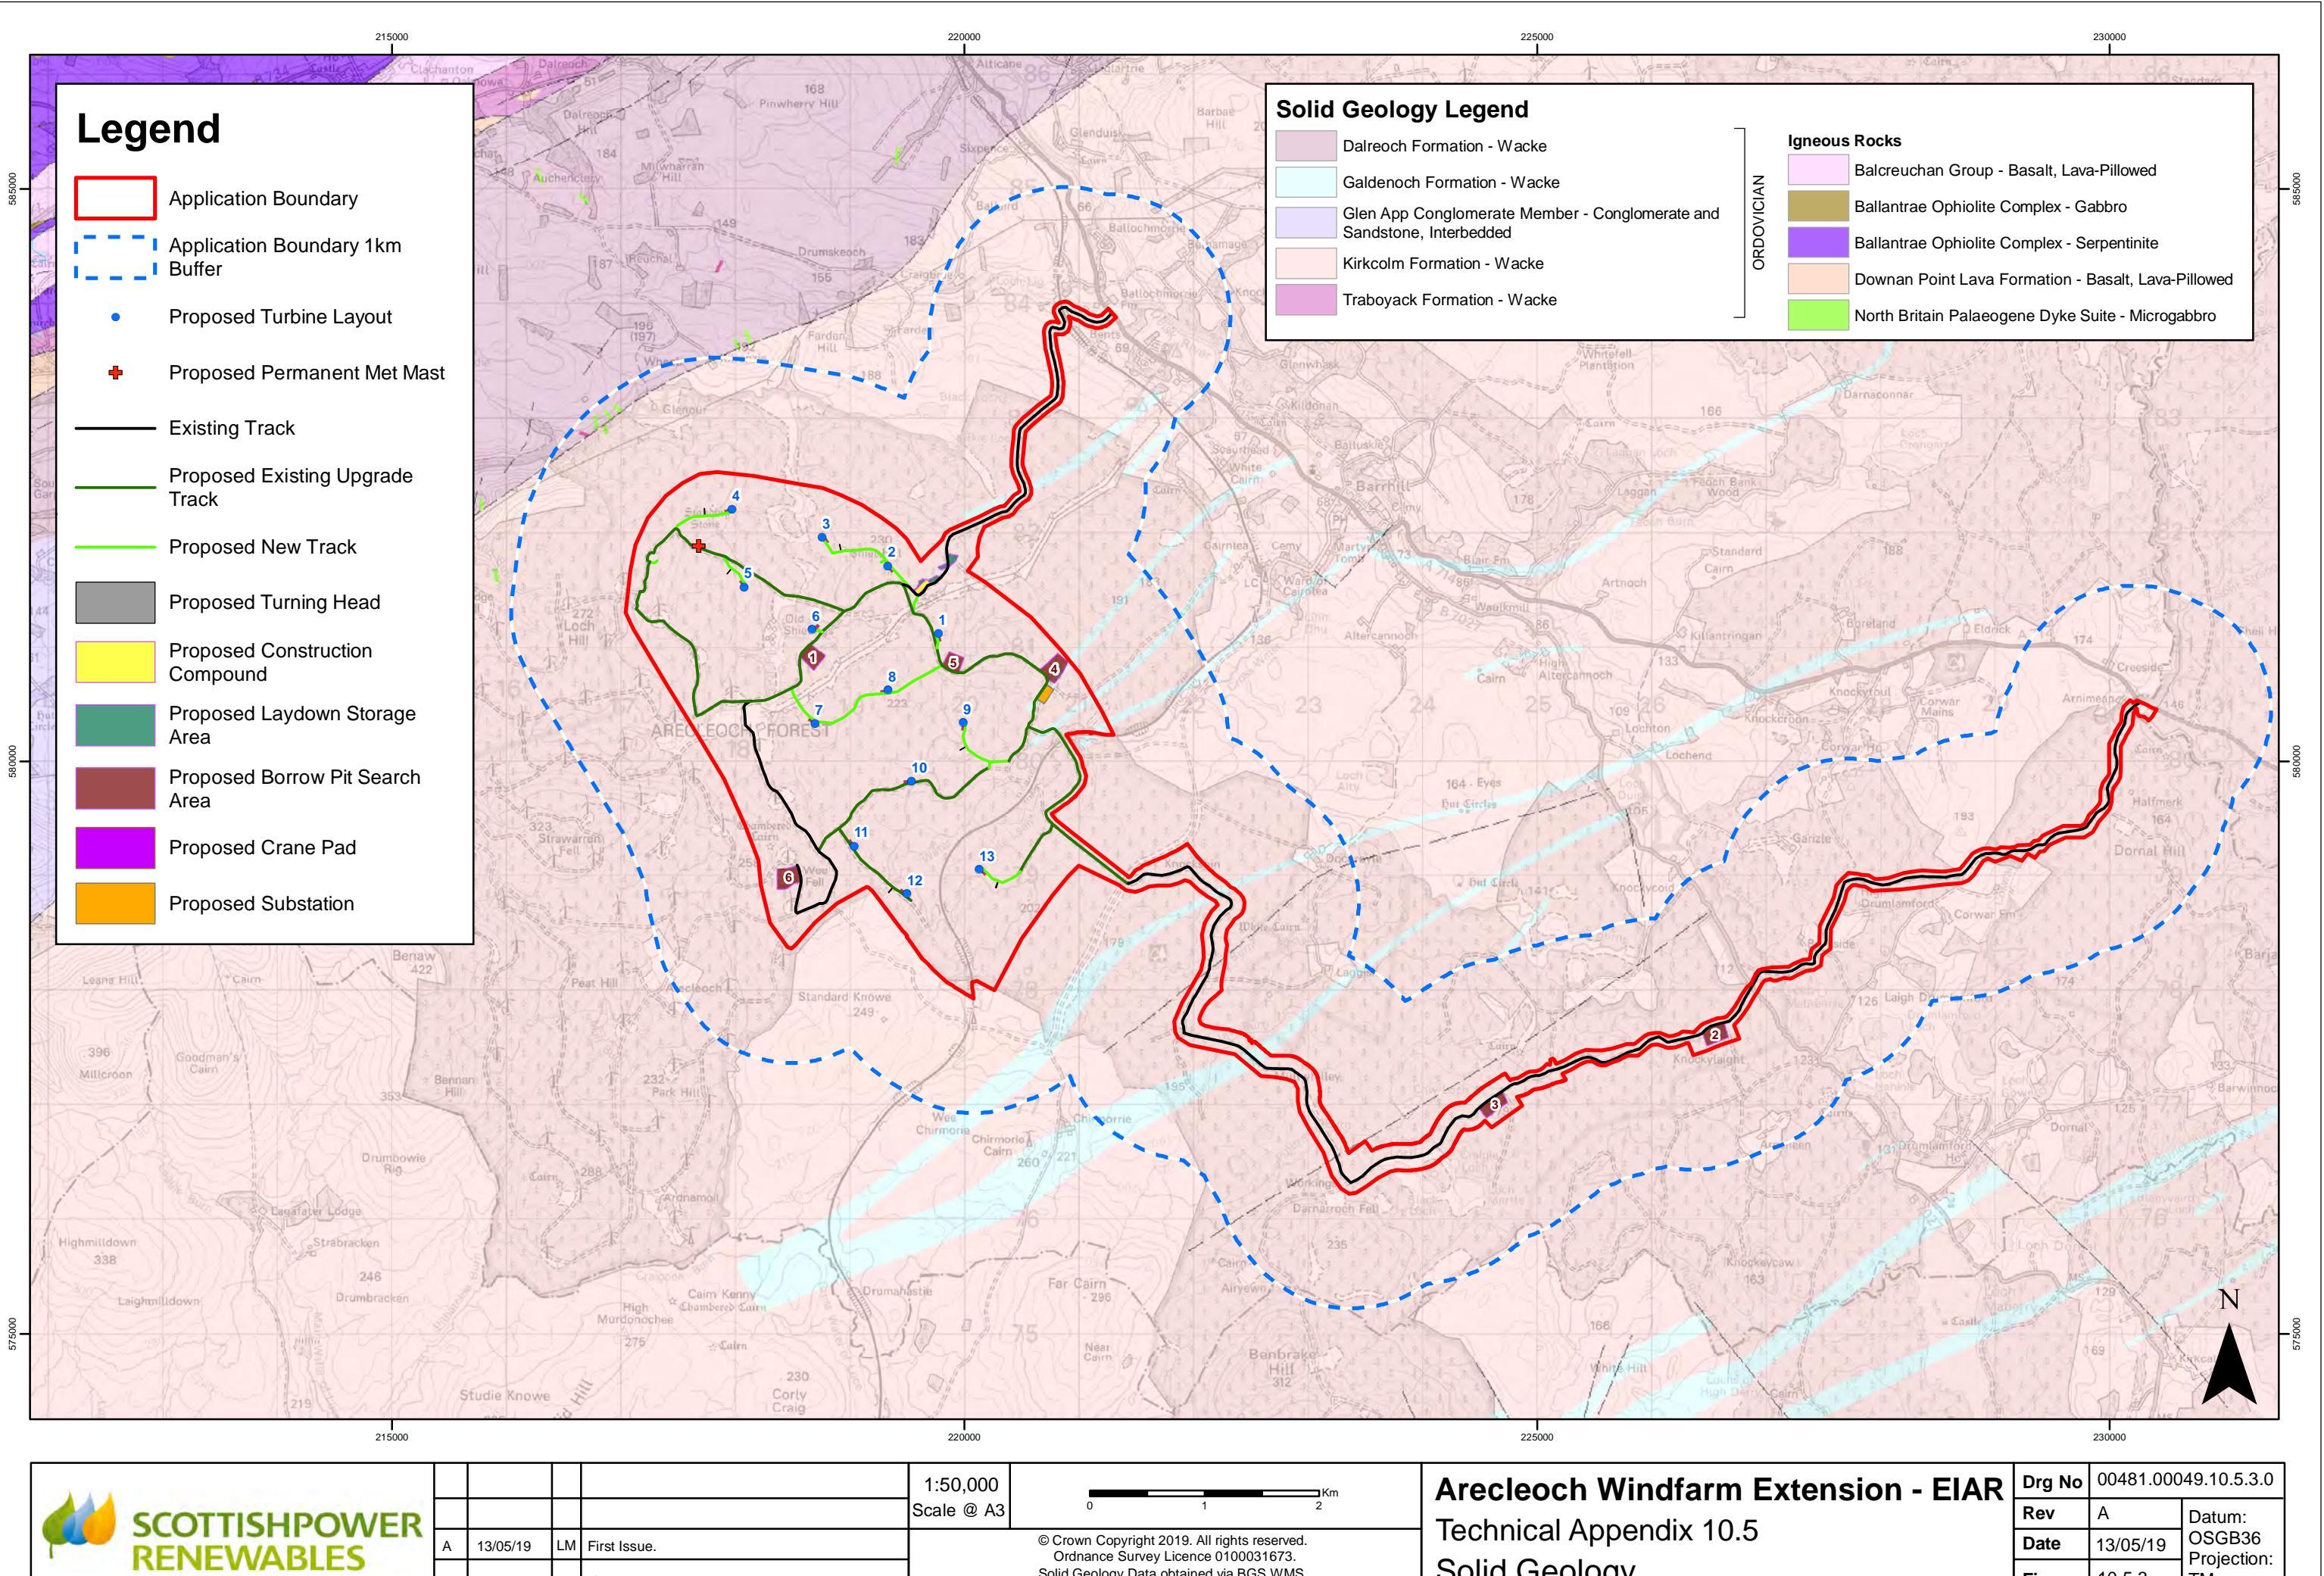
FIGURE 10.5.3: SOLID GEOLOGY

The geology of the Site comprises Ordovician age sedimentary rocks of the Barrhill Group.

The Site is almost entirely underlain by greywacke of the Kirkcolm Formation with narrow bands of the Galdenoch Formation. All of the proposed turbines are underlain by the Kirkcolm Formation. Faulting within the region is generally on a south west – north east trend. There are two minor faults mapped within the application site, cross-cutting the proposed access track, the Glen App Fault is present outside the application boundary, to the north west. The fault is defined by a change in lithology, to the younger Dalreoch Formation.

The solid geology of the Site is shown in Figure 3. Details of the geological units present onsite and immediately adjacent to Site are detailed in Table 1-1.
