# **East Anglia TWO Offshore Windfarm**

## **Appendix 20.3**

### **Geomorphological Baseline**

Preliminary Environmental Information

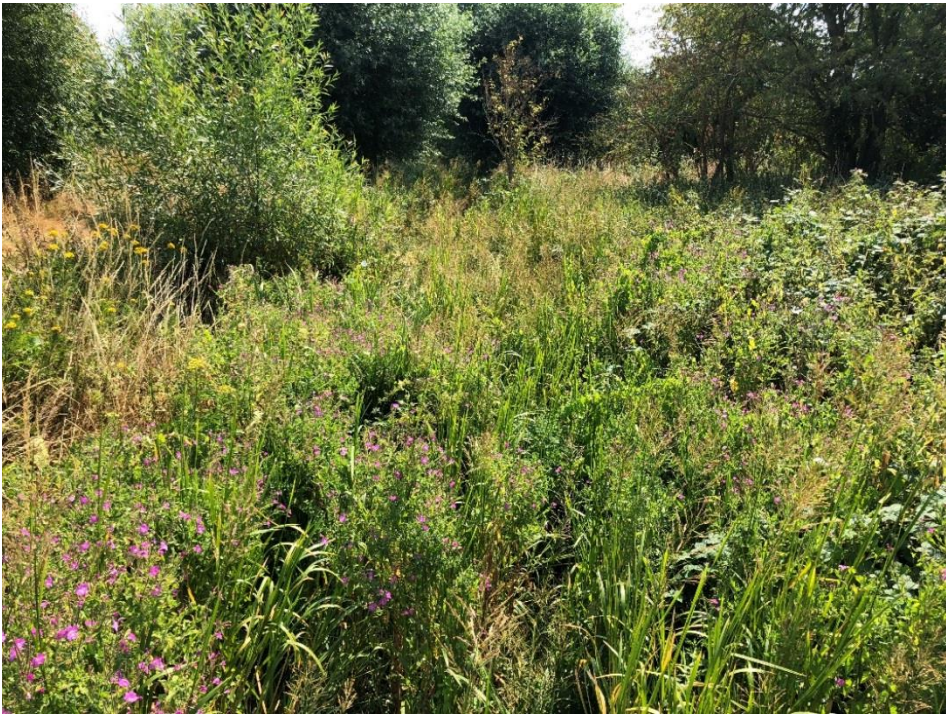
In-channel and riparian vegetation	The channel was dominated by extensive vegetation growth (including reeds) at the time of the survey ( <b>Plate A20.1</b> ).
Character photograph

<p><b>Plate A20.1 Extensive Vegetation Growth in Dry, Shallow Channel</b></p>

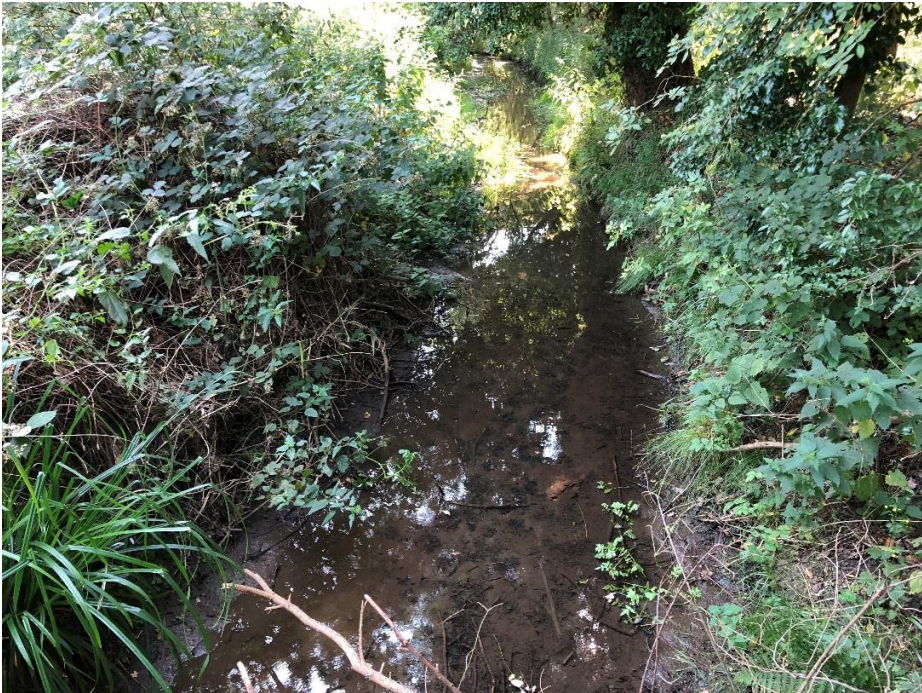
Floodplain characteristics	In the upstream part of the reach, the narrow floodplain is bounded by domestic gardens and grassland. The floodplain becomes wider and better connected to the floodplain further downstream, where it is bounded by woodland and arable fields.
In-channel and riparian vegetation	Very little vegetation was observed in the channel, although some emergent and marginal plants have colonised stable silt bars in the channel margins.
Character photograph

<p><b>Plate A20.2 Low-Energy Flows in Silt-Bed Channel</b></p>

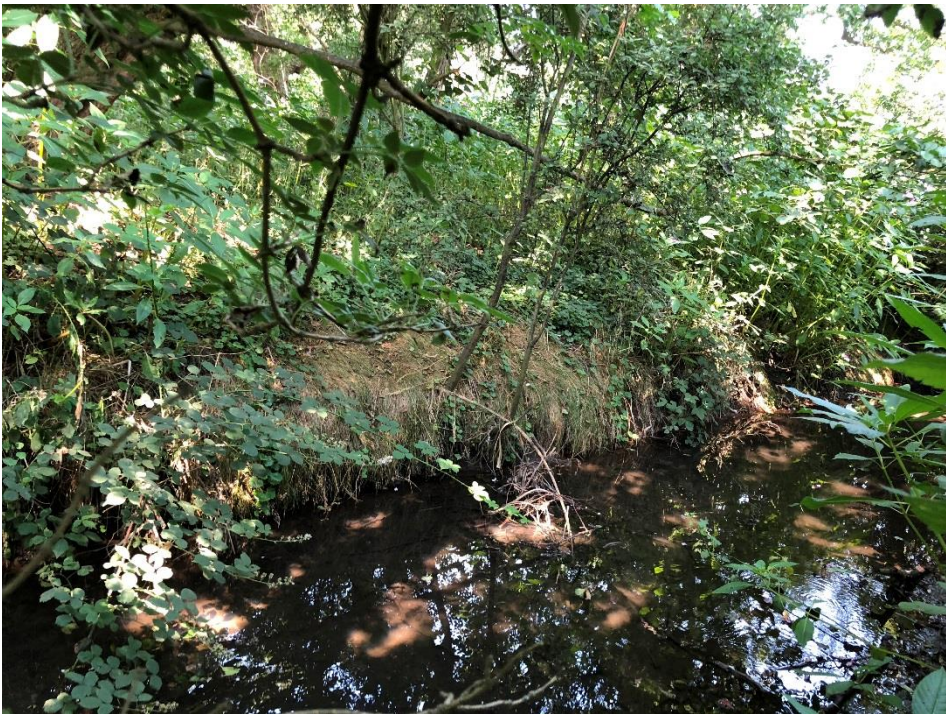
<p><b>Plate A20.3 Wide, Shallow Silt-Bed Channel with Low Energy Glide Flows</b></p>

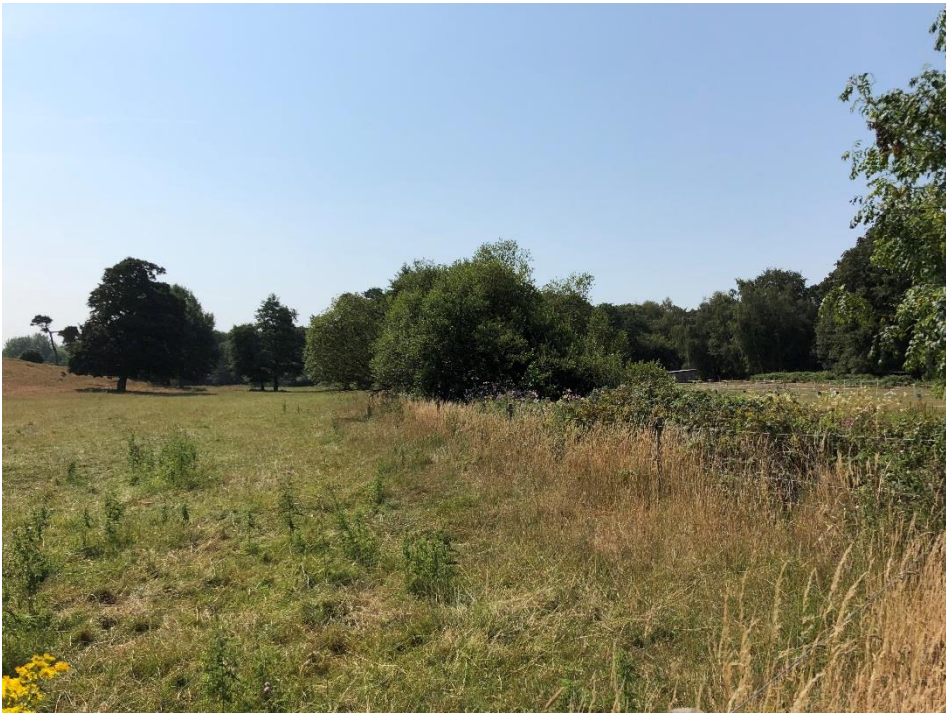
Floodplain characteristics	In the upstream end of the reach, the floodplain is wider than in upstream reaches, and dominated by grazing land and areas of woodland ( <b>Plate A20.4</b> ). The floodplain is drained by an extensive ditch system which is well connected with the main river channel. The floodplain becomes much wider at the downstream end of the reach, where the channel flows through floodplain wetlands (The Fens).
In-channel and riparian vegetation	Extensive areas of in-channel vegetation growth are interspersed with reaches with clear open water were observed during the survey ( <b>Plate A20.3</b> and <b>Plate A20.5</b> ). Considerable vegetation growth was apparent in the riparian zone, including Himalayan balsam ( <i>Impatiens glandulifera</i> ) at the upstream end of the reach, near the proposed crossing point.

<p><b>Plate A20.4 Locally Wide Floodplain with Dense Riparian Vegetation Growth</b></p>

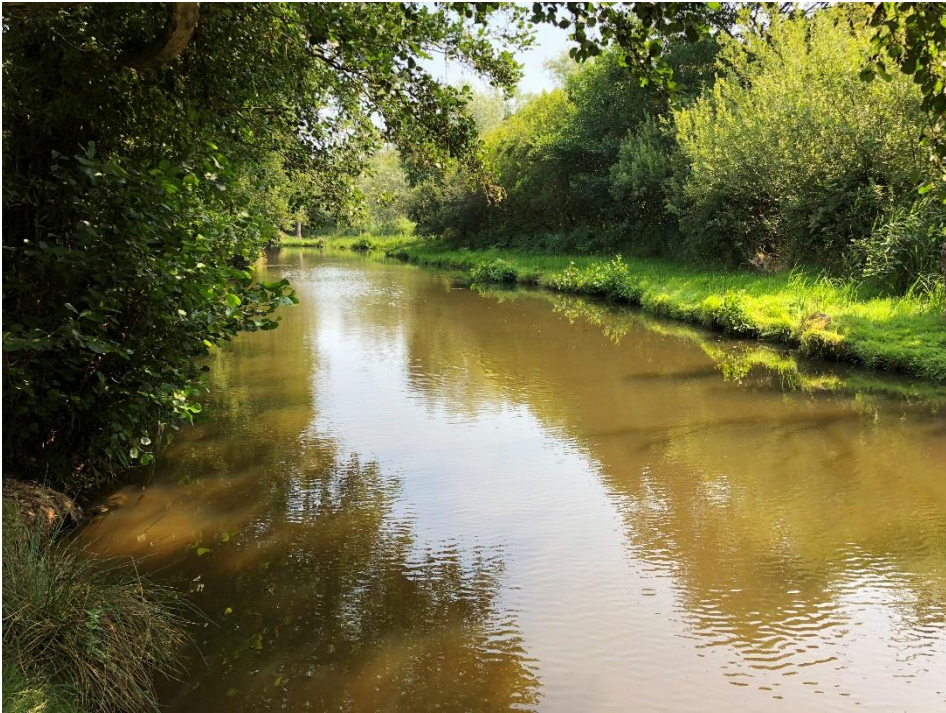
Flow conditions	Flow conditions were dominated by uniform, low energy glides ( <b>Plate A20.6</b> ). The reach upstream of the weir is impounded. The water was highly turbid at the time of the survey.

<p><b>Plate A20.6 Wide, Shallow Channel with Low Energy Glide Flows</b></p>
