Harestanes South Windfarm Extension

Environmental Impact Assessment Report Addendum

Appendix A1 – Consultation with SEPA

Watercourse Crossings Report

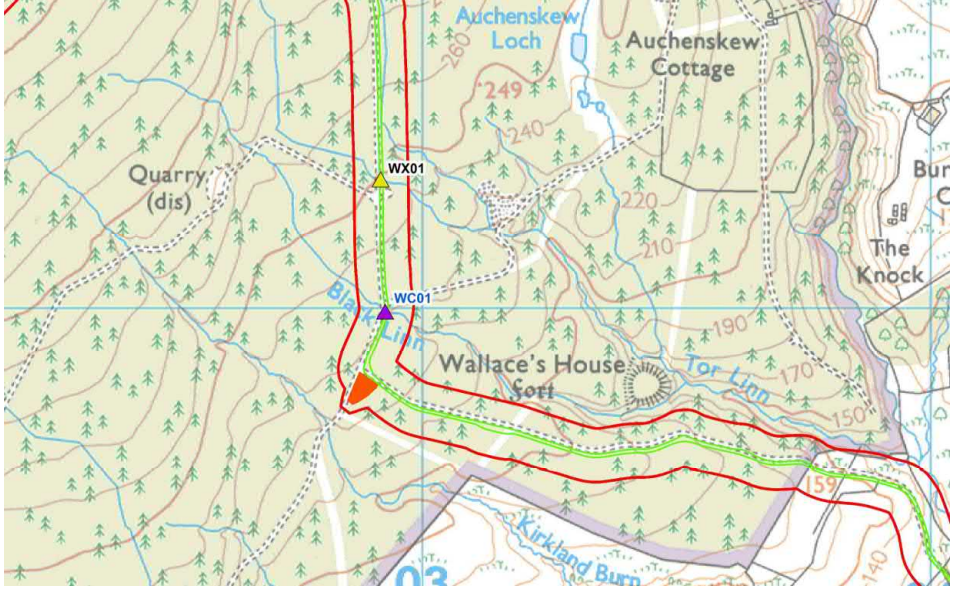
<p>Crossing ID: WC01</p> <p>Route: Crossing approximately 1.8km south of Turbine 5.</p> <p>Watercourse: Black Linn (Garrel Water tributary), Water of Ae Catchment.</p> <p>Description: Bed material consists of boulders, pebbles and cobbles. No bedrock visible at bed layer. Bank material is vegetation and soil. Small watercourse with rippled flow. The main channel is approximately 0.8m wide and 0.5m deep, with the valley 7.0m wide and 3.0m deep. The watercourse flows south east to the confluence with Garrel Water, approximately 1.2km downstream of this crossing.</p>	<p>NGR: NGR 302926, 590995</p>

<p>Catchment Area: Approximately 0.22km²</p> <p>Peak Flows (m³/s): Not available for this sub-catchment, WC08 values are considered representative.</p> <p>Mean Flow (m³/s): $Q_{\text{mean}} = 0.008\text{m}^3/\text{s}$</p> <p>Flood Risk: Identified on SEPA Flood Risk Map: Yes, surface water flooding upstream of the crossing.</p> <p>Ecology: Ecological surveys indicated that the burn has limited fish habitat suitability and was therefore scoped out for fish surveys. Signs of mammal protected species were noted along the Black Linn. However, the habitat suitability assessment considered that Black Linn provides moderate habitat for these species.</p> <p>Crossing Type: Existing culvert to be replaced by oversized circular culvert for this crossing.</p> <p>CAR Application: This would be anticipated to be require a CAR Registration and constructed following the relevant General Binding Rules.</p>

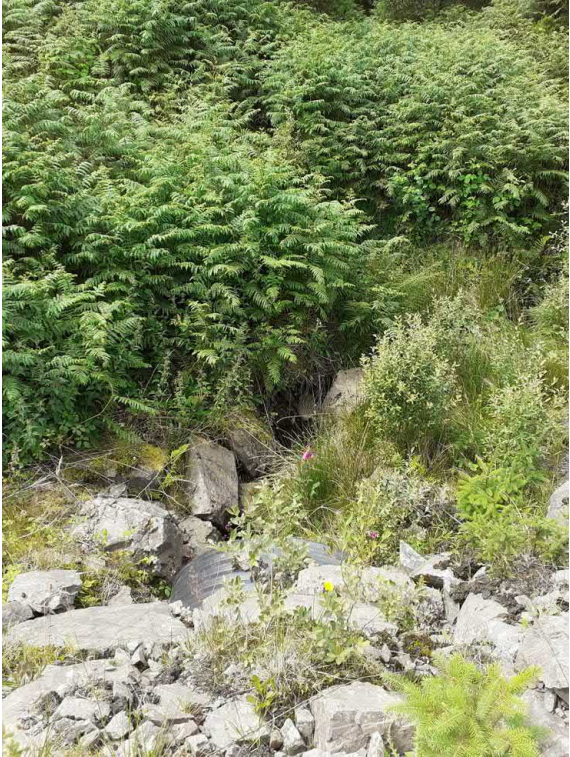
<p>Looking upstream from NGR 302926, 590995</p>

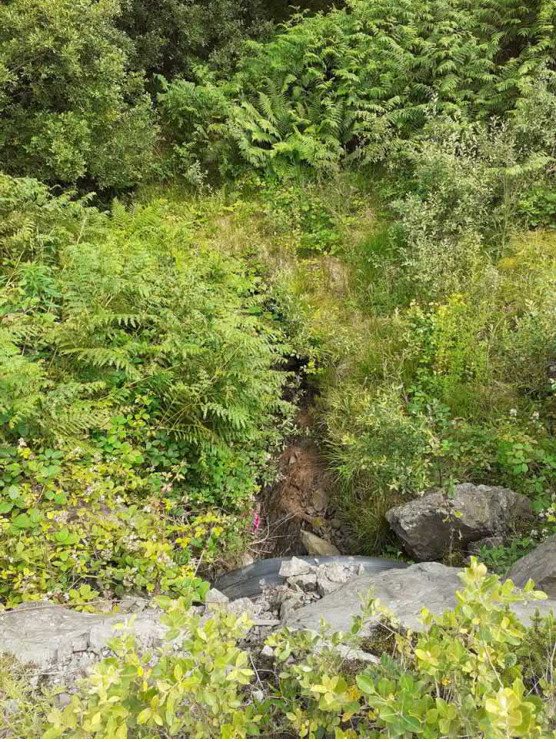
<p>Looking downstream from NGR 302926, 590995</p>

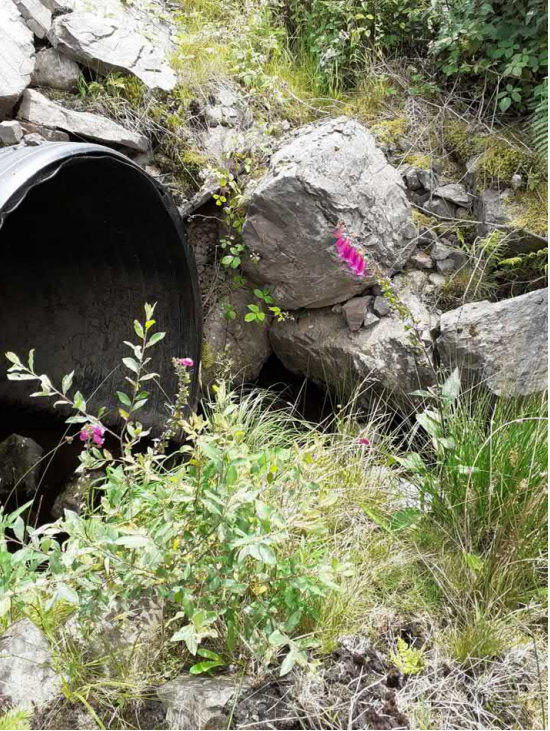
<p>View across channel from NGR 302926, 590995</p>

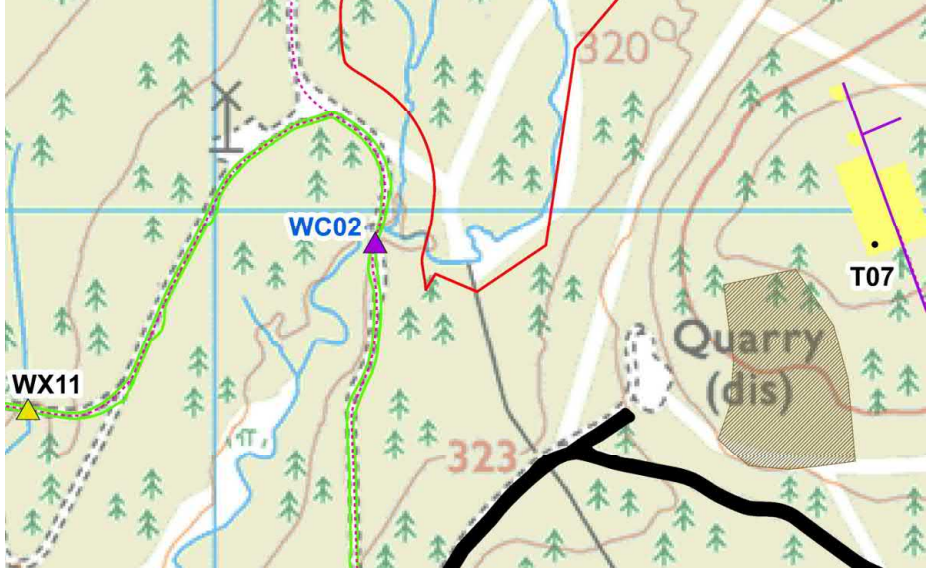
<p>Crossing ID: WC02</p> <p>Route: Crossing approximately 0.5km west of Turbine 7.</p> <p>Watercourse: Glenkiln Burn tributary, Water of Ae Catchment.</p> <p>Description: Bed material consists of boulders, pebbles, cobbles and gravel. No bedrock visible at bed layer. Bank material is vegetation and soil. The main channel is approximately 2.0m wide and 1.0m deep, with the valley 15.0m wide and 5.0m deep. The watercourse flows south west to the confluence with Glenkiln Burn, approximately 1.8km downstream of this crossing.</p>	<p>NGR: NGR 302162, 593969</p>

<p>Catchment Area: Approximately 3.3km²</p> <p>Peak Flows (m³/s): Q₅ = 4.98, Q_{25year} = 7.87, Q_{200year} = 12.92, Q_{200year + cc} = 15.50</p> <p>Mean Flow (m³/s): Q_{mean} = 0.12</p> <p>Flood Risk: Identified on SEPA Flood Risk Map: Yes, surface water flooding upstream of the crossing and river water flooding downstream of the crossing.</p> <p>Ecology: Ecological surveys indicated the burn has been identified with habitat suitability for both juvenile and adult salmonids. Surveys indicated good trout numbers present. Evidence of water vole was noted on the Glenkiln Burn upstream of the crossing. No signs of otters were noted.</p> <p>Crossing Type: Existing concrete clear span bridge to be replaced by a bridge crossing for this watercourse.</p> <p>CAR Application: This would be anticipated as requiring a Registration under CAR. Should bankside works extend to 20m or beyond, this would become a Simple Licence application.</p>

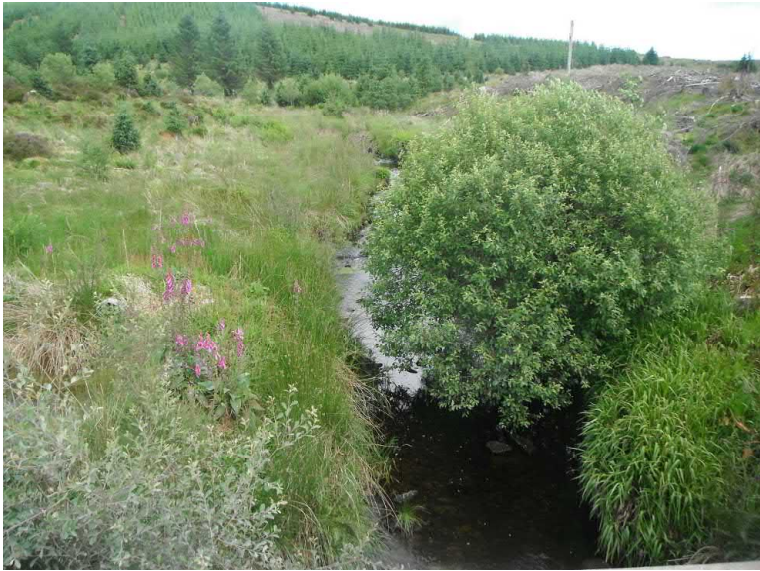
<p>Looking upstream from NGR 302162, 593969</p>

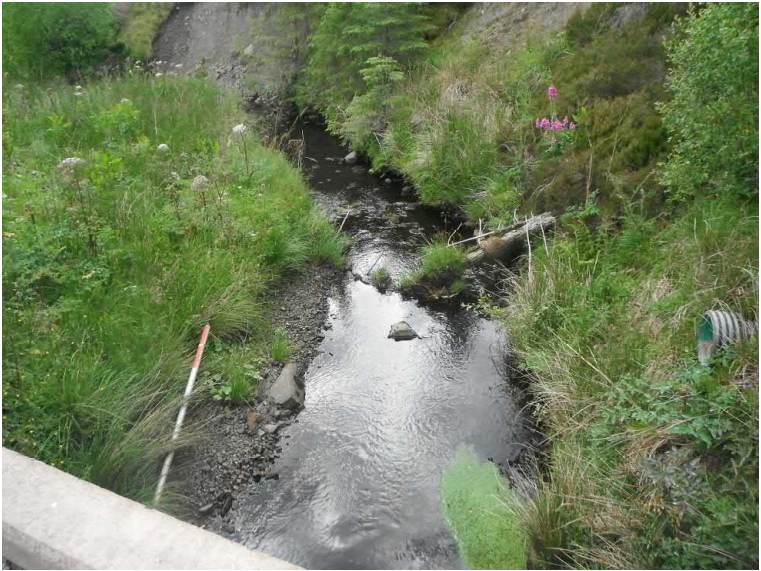
<p>Looking downstream from NGR 302162, 593969</p>

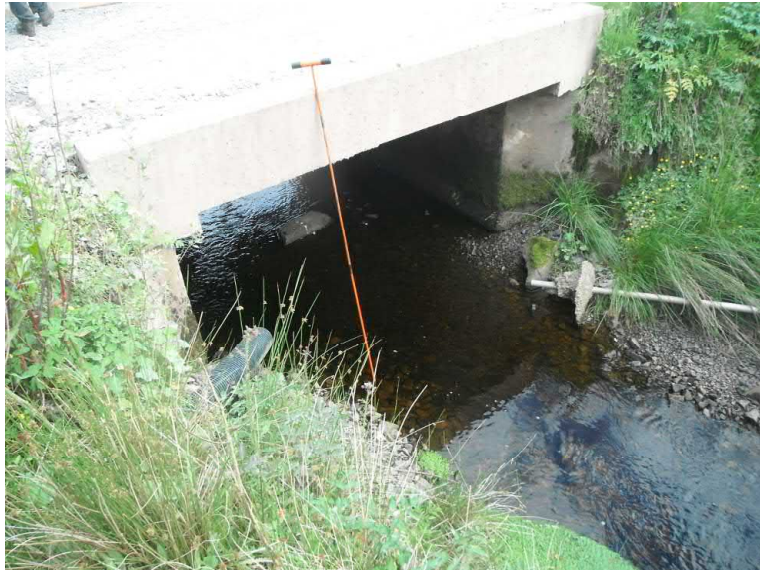
<p>View across channel from NGR 302162, 593969</p>

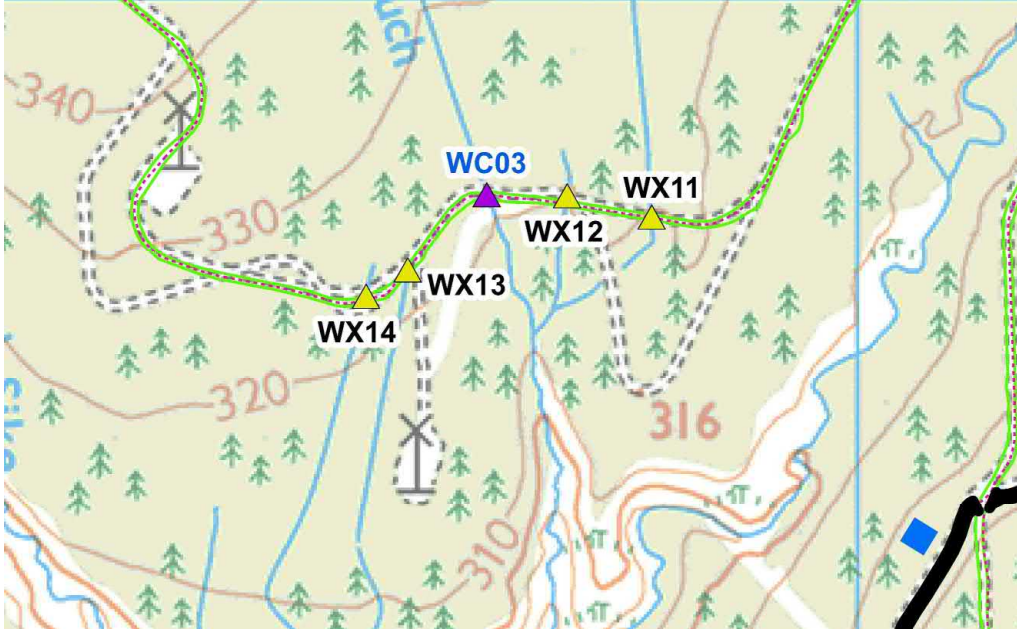
<p>Crossing ID: WC03</p> <p>Route: Crossing approximately 0.6km north of Turbine 4.</p> <p>Watercourse: Ox Cleuch (Glenkiln Burn tributary), Water of Ae Catchment.</p> <p>Description:</p>	<p>NGR: NGR 301660, 593821</p> <p>Bed material consists of cobbles, gravel and soil/clay. No bedrock visible at bed layer. Bank material is vegetation and soil. Small watercourse with rippled flow. The main channel is approximately 1.0m wide and 0.5m deep, with the valley 8.0m wide and 3.0m deep. The watercourse flows south to the confluence with Glenkiln Burn, approximately 1.3km downstream of this crossing.</p> <p>Downstream culvert is suspended above natural channel. The channel is incised with bank collapse evident downstream on the left bank. During the site visit, a deep pool below the culvert was noted.</p>

<p>Catchment Area: Approximately 0.35km²</p> <p>Peak Flows (m³/s): Not available for this sub-catchment, WC08 values are considered representative.</p> <p>Mean Flow (m³/s): Q_{mean} = 0.011m³/s</p> <p>Flood Risk: Identified on SEPA Flood Risk Map: No.</p> <p>Ecology: No evidence of fish present within this burn; however, the ecological surveys indicated the Glenkiln Burn has been identified with habitat suitability for both juvenile and adult salmonids. Surveys indicated good trout numbers present. No evidence of water vole or otters were recorded during the surveys around the Ox Cleuch crossing.</p> <p>Crossing Type: Existing culvert to be replaced by oversized circular culvert for this crossing.</p> <p>CAR Application: This would be anticipated to be require a CAR Registration and constructed following the relevant General Binding Rules. However, due to the bank erosion noted during the site visit, a Simple Licence might be required.</p>

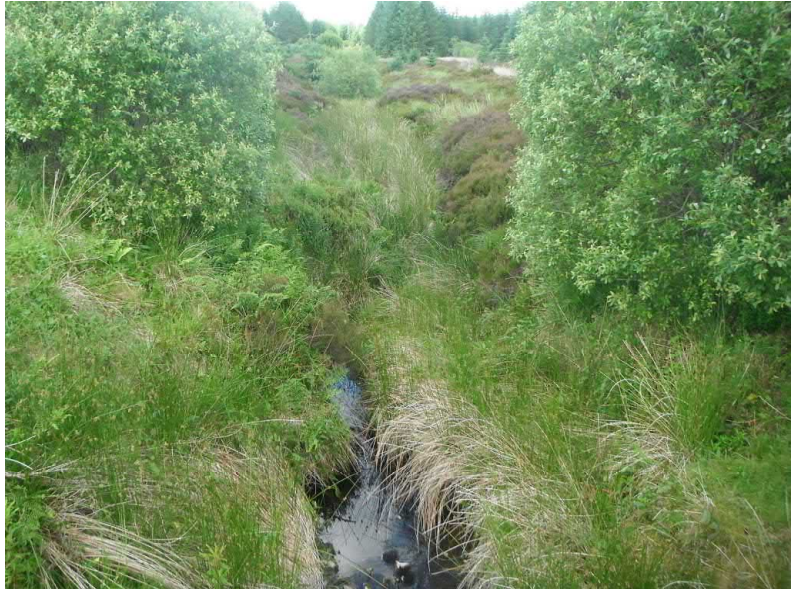
<p>Looking upstream from NGR 301660, 593821</p>

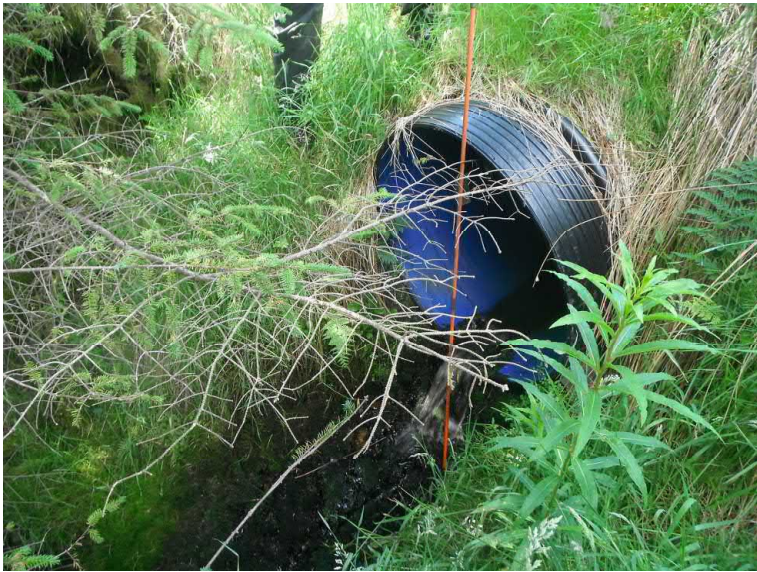
<p>Looking downstream from NGR 301660, 593821</p>

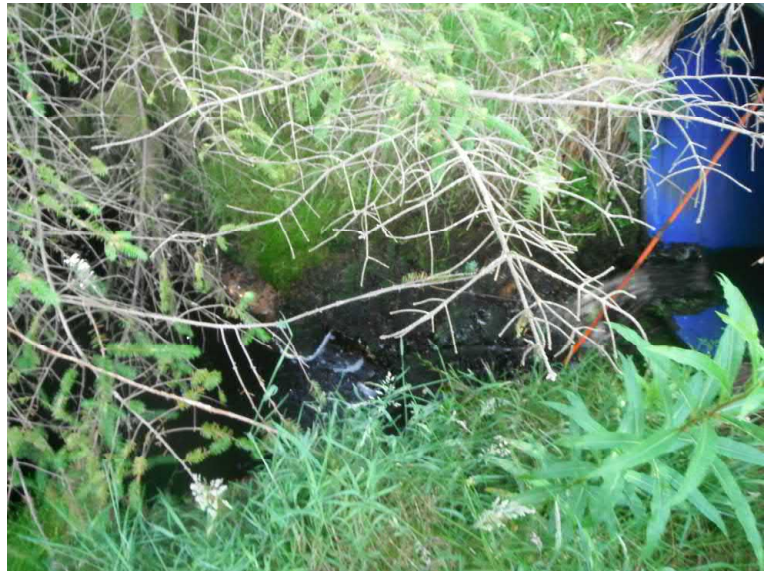
<p>View across channel from NGR 301660, 593821</p>

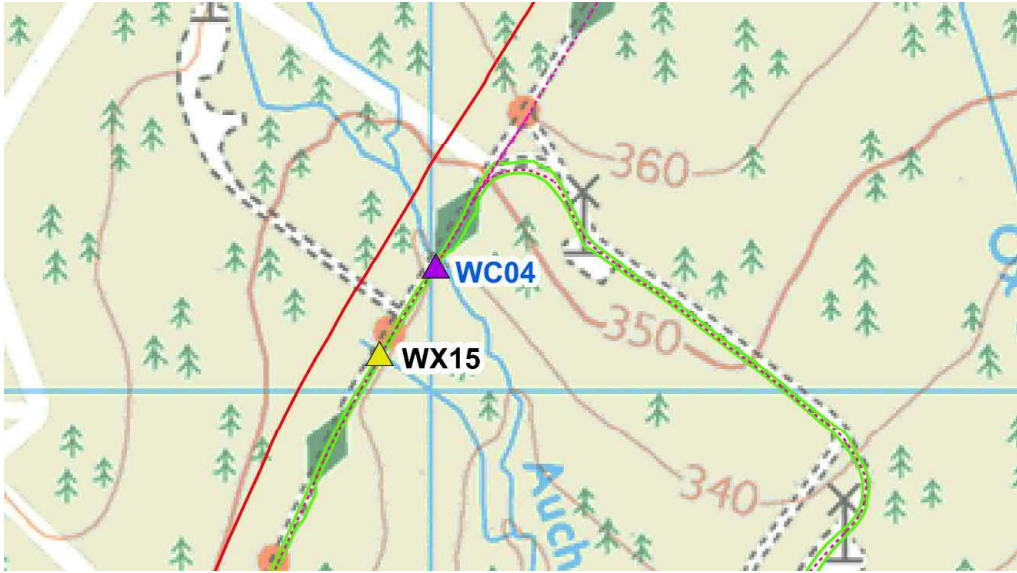
<p>Crossing ID: WC04</p> <p>Route: Crossing approximately 1.2km west of Turbine 7</p> <p>Watercourse: Auchendowal Sike (Glenkiln Burn tributary), Water of Ae Catchment</p> <p>Description: Bed material consists of cobbles and gravel. Bank material is boulders, vegetation and soil. The main channel is approximately 1.0m wide and 0.5m deep, with the valley 30m wide. The watercourse flows south to the confluence with Glenkiln Burn, approximately 1.5km downstream of this crossing.</p>	<p>NGR: NGR 301004, 594116</p>

<p>Catchment Area: Approximately 0.34km²</p> <p>Peak Flows (m³/s): Not available for this sub-catchment, WC08 values are considered representative.</p> <p>Mean Flow (m³/s): $Q_{mean} = 0.011m^3/s$</p> <p>Flood Risk: Identified on SEPA Flood Risk Map: No.</p> <p>Ecology: Ecological surveys indicated that there is limited habitat suitability for fish and there is no evidence of fish present within the Auchendowal Sike. However, ecological surveys indicated the Glenkiln burn has been identified with habitat suitability for both juvenile and adult salmonids. No evidence of water vole or otters were recorded during the surveys around the Auchendowal Sike crossing.</p> <p>Crossing Type: Existing culvert to be replaced by oversized circular culvert for this crossing.</p> <p>CAR Application: This would be anticipated to require a CAR Registration and constructed following the relevant General Binding Rules.</p>

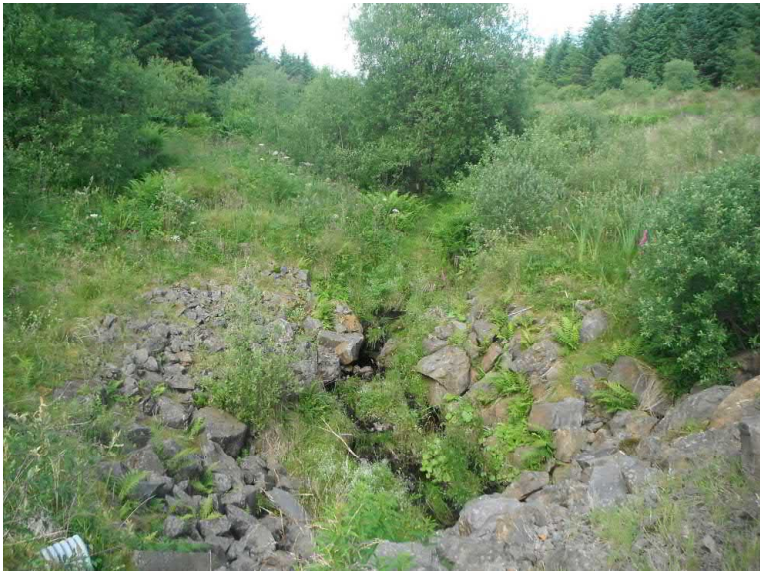
<p>Looking upstream from NGR 301004, 594116</p>

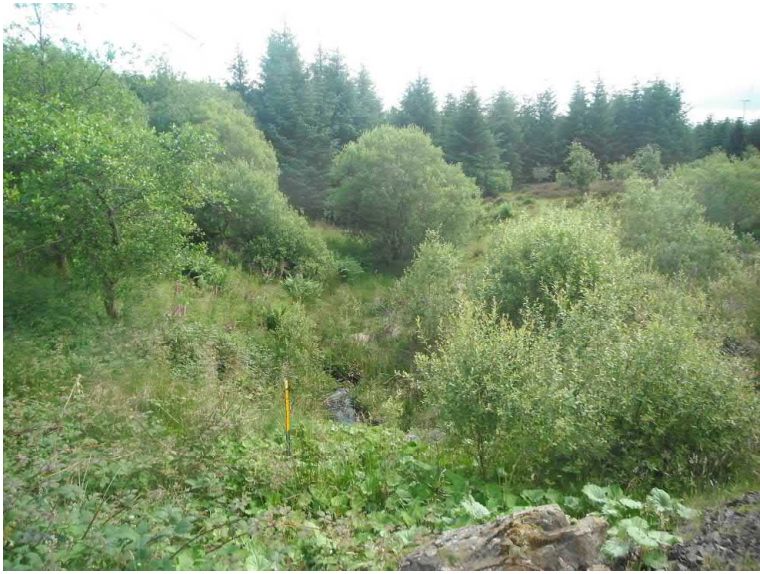
<p>Looking downstream from NGR 301004, 594116</p>

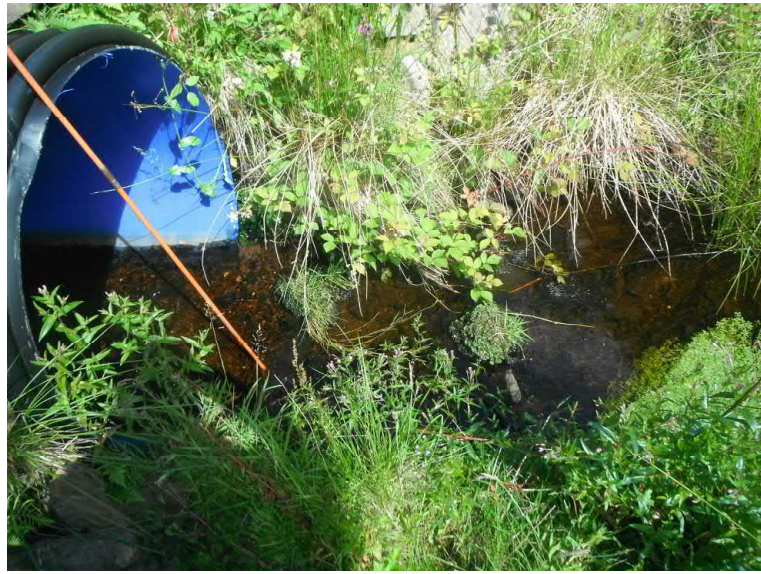
<p>View across channel from NGR 301004, 594116</p>

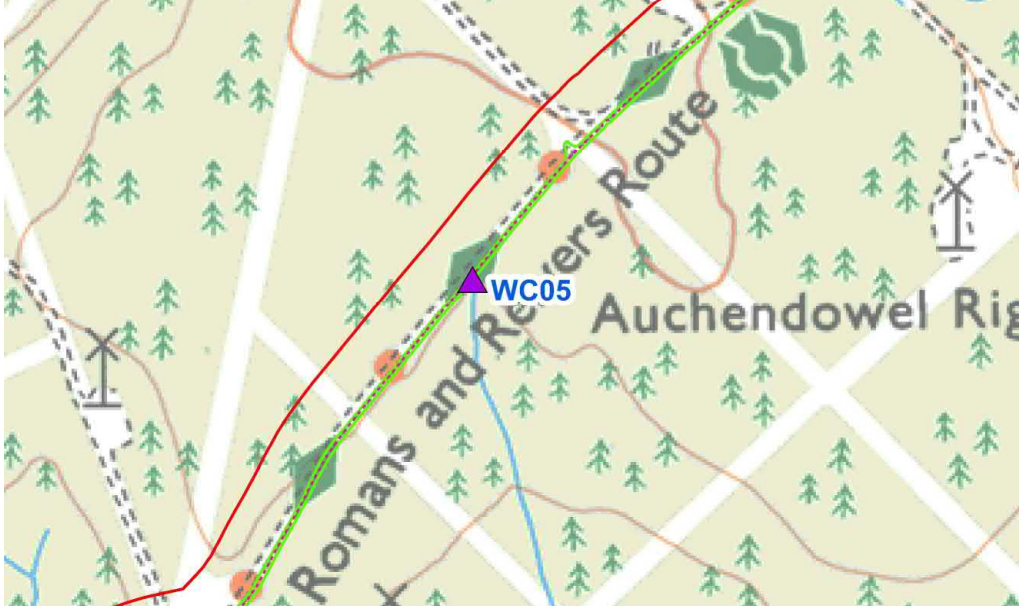
<p>Crossing ID: WC05</p> <p>Route: Crossing approximately 0.9km north of Turbine 2</p> <p>Watercourse: Rough Cleuch (Glenkiln Burn tributary), Water of Ae Catchment.</p> <p>Description: This is a small drain with little visible flow at the time of the survey. Bank material is vegetation and peat. No bedrock visible at this layer. Bed material was not visible due to overgrown vegetation. The main channel is approximately 1.0m wide and 0.2m deep, with no apparent valley. The watercourse flows south east to the confluence with Glenkiln Burn, approximately 1.2km downstream of this crossing.</p> <p>The watercourse is currently culverted via a 0.5m pipe. Further downstream the watercourse drains into a ditch, which is then culverted via a second 0.5m pipe.</p>	<p>NGR: NGR 300481, 593384</p>

<p>Catchment Area: Approximately 0.08km²</p> <p>Peak Flows (m³/s): Not available for this sub-catchment, WC08 values are considered representative.</p> <p>Mean Flow (m³/s): Q_{mean} = 0.003m³/s</p> <p>Flood Risk: Identified on SEPA Flood Risk Map: No.</p> <p>Ecology: Ecological surveys indicated that this watercourse offers suitable fish habitat. Further surveys indicated good trout numbers are present. No evidence of water vole or otters were recorded during the surveys around the Rough Cleuch crossing.</p> <p>Crossing Type: Existing culvert to be replaced by oversized circular culvert for this crossing.</p> <p>CAR Application: This would be anticipated to be require a CAR Registration and constructed following the relevant General Binding Rules.</p>

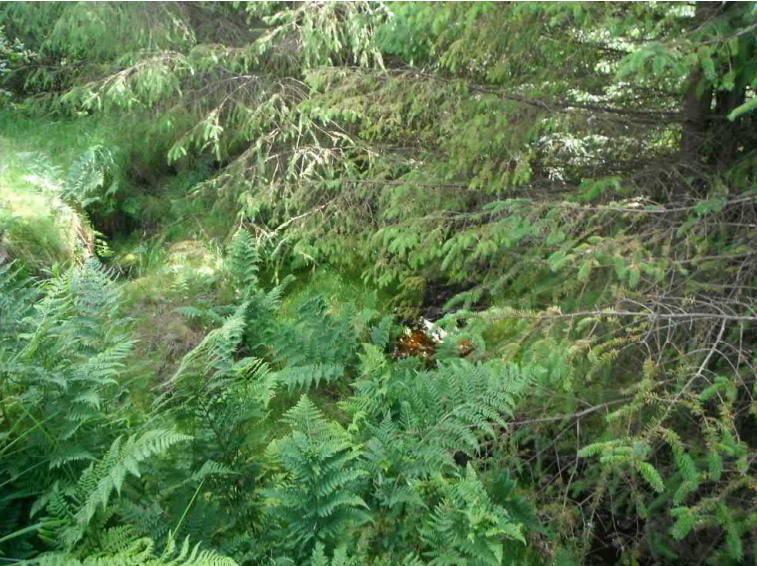
<p>Looking upstream from NGR 300481, 593384</p>

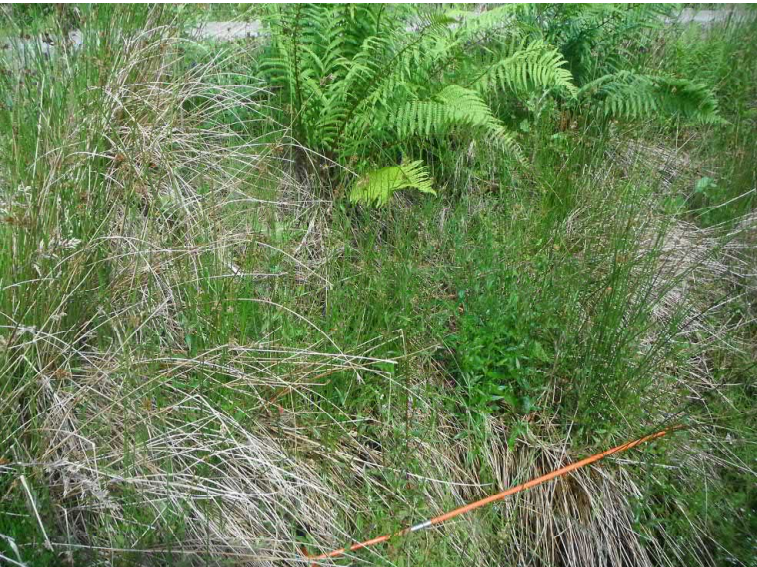
<p>Looking downstream from NGR 300481, 593384</p>

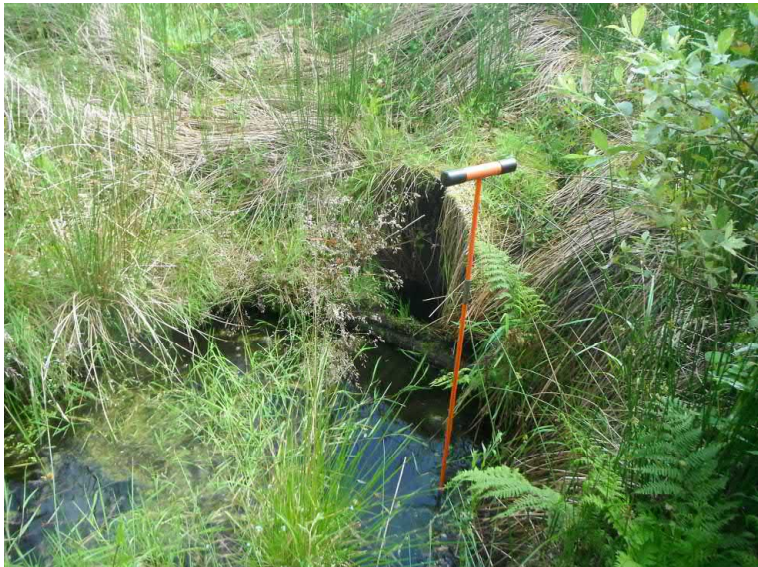
<p>View downstream from the second culvert from NGR 300481, 593384</p>

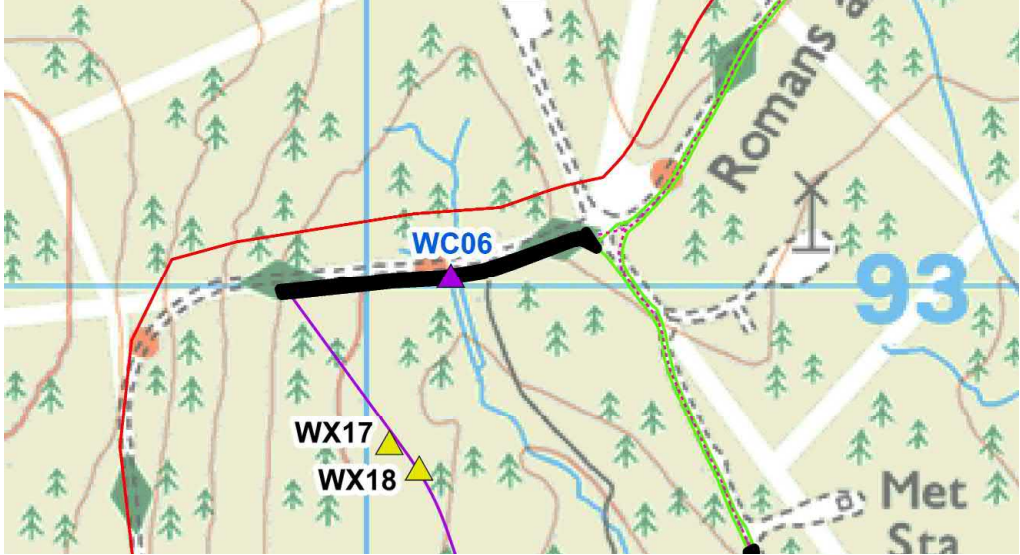
<p>Crossing ID: WC06</p> <p>Route: Crossing approximately 0.5km north of Turbine 1</p> <p>Watercourse: Clachanbirnie Burn (Glenkiln Burn tributary), Water of Ae Catchment</p> <p>Description: Bed material consists of pebbles, cobbles, gravel and fine sediment. No bedrock visible at bed layer. Bank material is vegetation and peat. The watercourse had rippled flow at the time of the survey. The main channel is approximately 1.0m wide and 0.5m deep, with no apparent valley. The watercourse flows south, then east to the confluence with Glenkiln Burn, approximately 2.0km downstream of this crossing.</p>	<p>NGR: NGR 300076, 593011</p>

<p>Catchment Area: Approximately 0.17km²</p> <p>Peak Flows (m³/s): Not available for this sub-catchment, WC08 values are considered representative.</p> <p>Mean Flow (m³/s): Q_{mean} = 0.006m³/s</p> <p>Flood Risk: Identified on SEPA Flood Risk Map: No.</p> <p>Ecology: Ecological surveys indicated the burn offers suitable habitat for juvenile fish. No fish were recorded during surveys for Clachanbirnie Burn. No evidence of water vole or otters were recorded during the surveys around the Clachanbirnie Burn crossing. However, the watercourse was assessed as offering moderate habitat suitability.</p> <p>Crossing Type: Existing culvert to be replaced by oversized circular culvert for this crossing.</p> <p>CAR Application: This would be anticipated to be require a CAR Registration and constructed following the relevant General Binding Rules.</p>

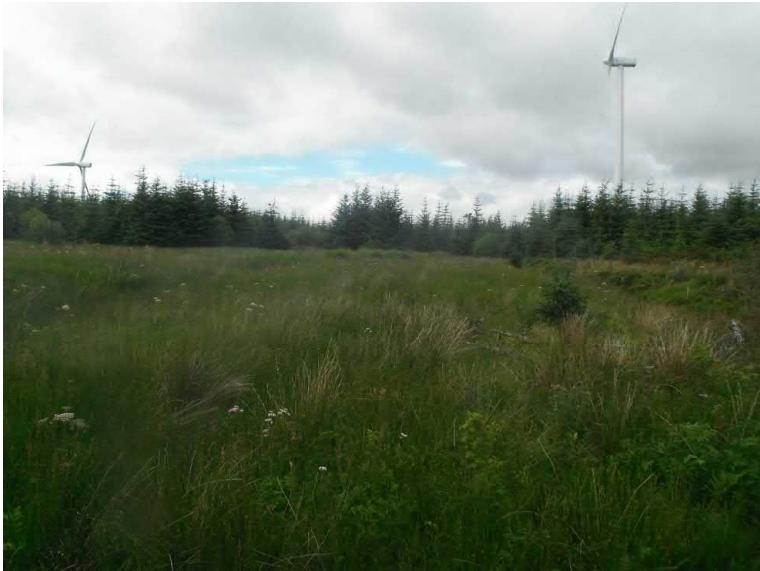
<p>Looking upstream from NGR 300076, 593011</p>

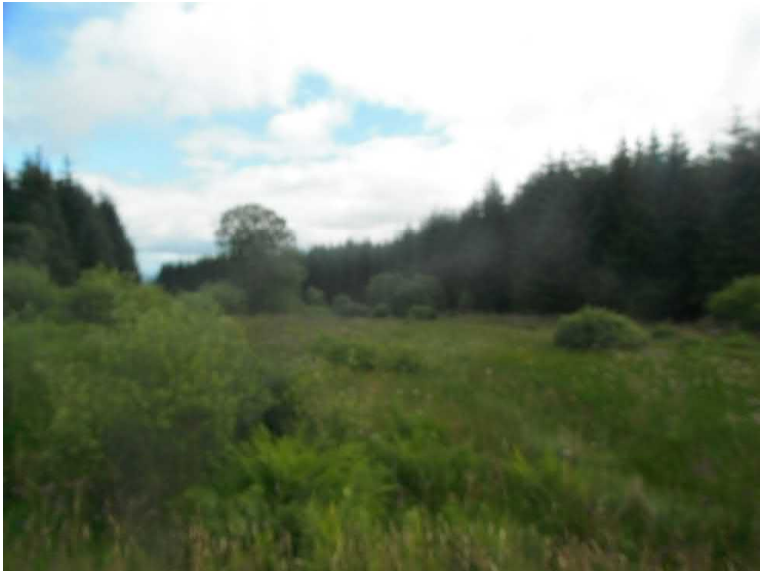
<p>Looking downstream from NGR 300076, 593011</p>

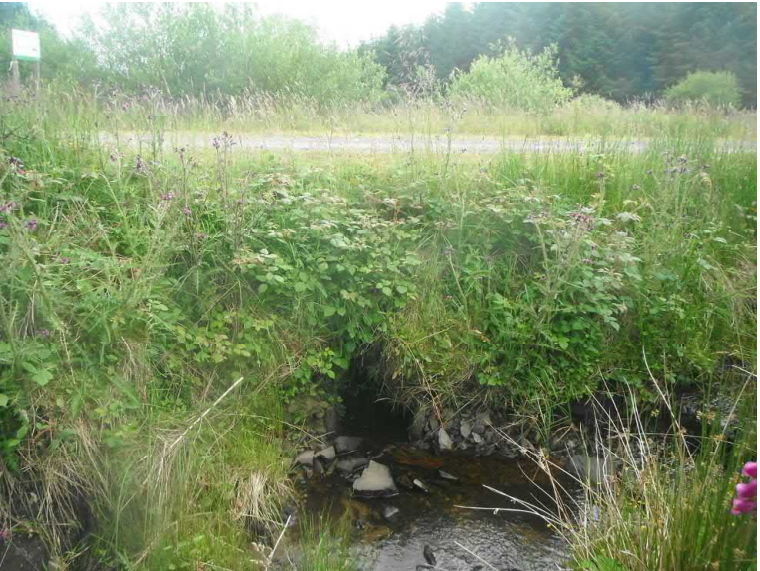
<p>View across channel from NGR 300076, 593011</p>

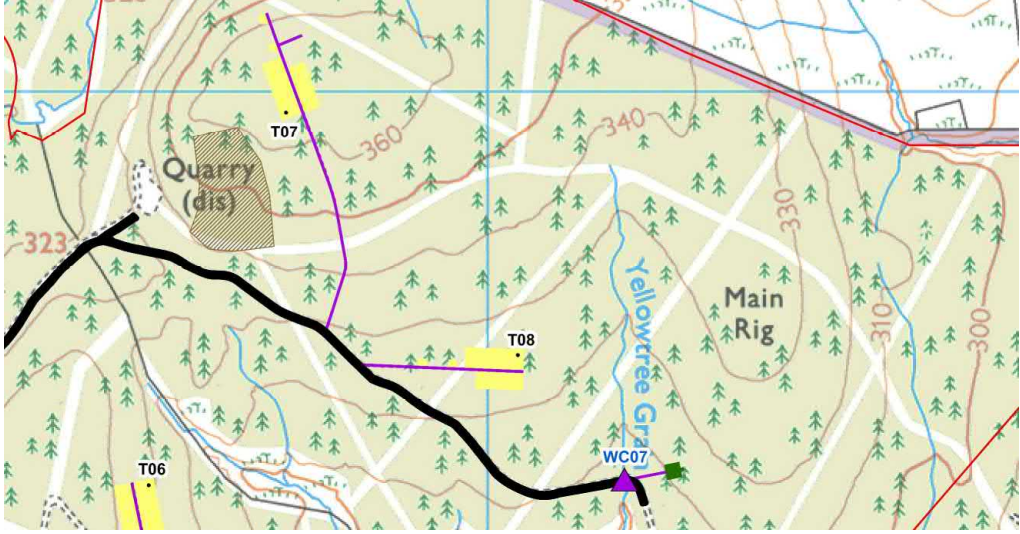
<p>Crossing ID: WC07</p> <p>Route: Crossing approximately 70m west of Met Mast</p> <p>Watercourse: Yellowtree Grain (Garrel Water tributary), Water of Ae Catchment.</p> <p>Description: Bed material consists of pebbles, cobbles and gravel. Bank material is pebbles, cobbles, vegetation and peat. The watercourse had rippled flow at the time of the survey. The main channel is approximately 1.5m wide and 0.5m deep, with the valley 5.0m wide and 2.5m deep. The watercourse flows south to the confluence with Garrel Water, approximately 0.7km downstream of this crossing.</p>	<p>NGR: NGR 303225, 593362</p>

<p>Catchment Area: Approximately 0.27km²</p> <p>Peak Flows (m³/s): Not available for this sub-catchment, WC08 values are considered representative.</p> <p>Mean Flow (m³/s): Q_{mean} = 0.009m³/s</p> <p>Flood Risk: Identified on SEPA Flood Risk Map: No.</p> <p>Ecology: Ecological surveys indicated the burn is considered suitable habitat for fish. Fish surveys undertaken on Yellowtree Grain indicate no presence of fish. Signs of otters were noted upstream of the crossing. No signs of water vole were noted.</p> <p>Crossing Type: Existing culvert to be replaced by oversized circular culvert for this crossing.</p> <p>CAR Application: This would be anticipated to be require a CAR Registration and constructed following the relevant General Binding Rules.</p>

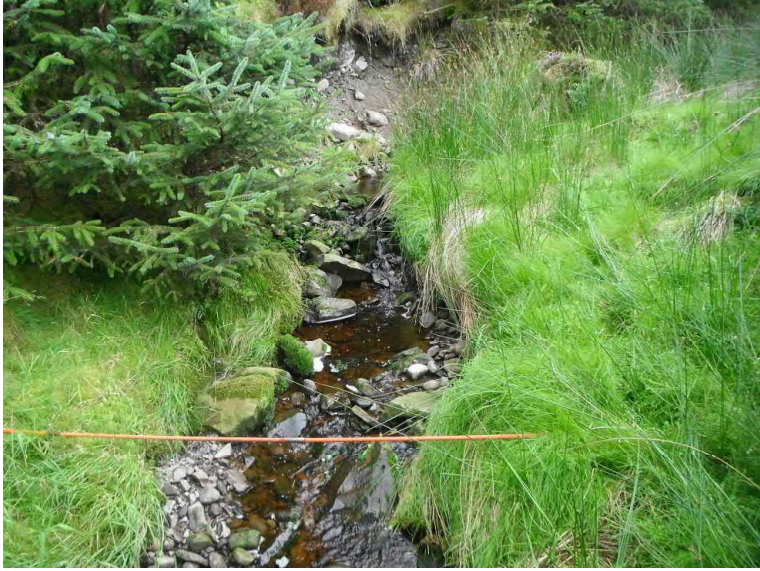
<p>Looking upstream from NGR 303225, 593362</p>

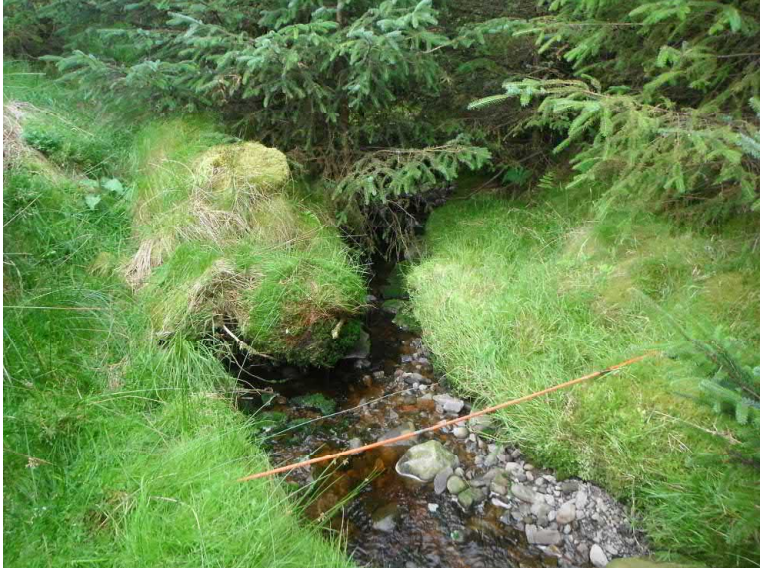
<p>Looking downstream from NGR 303225, 593362</p>

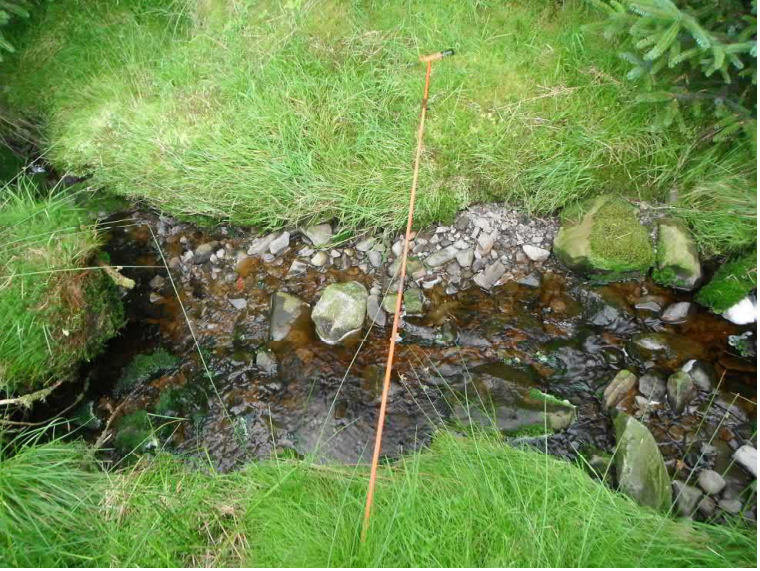
<p>View across channel from NGR 303225, 593362</p>

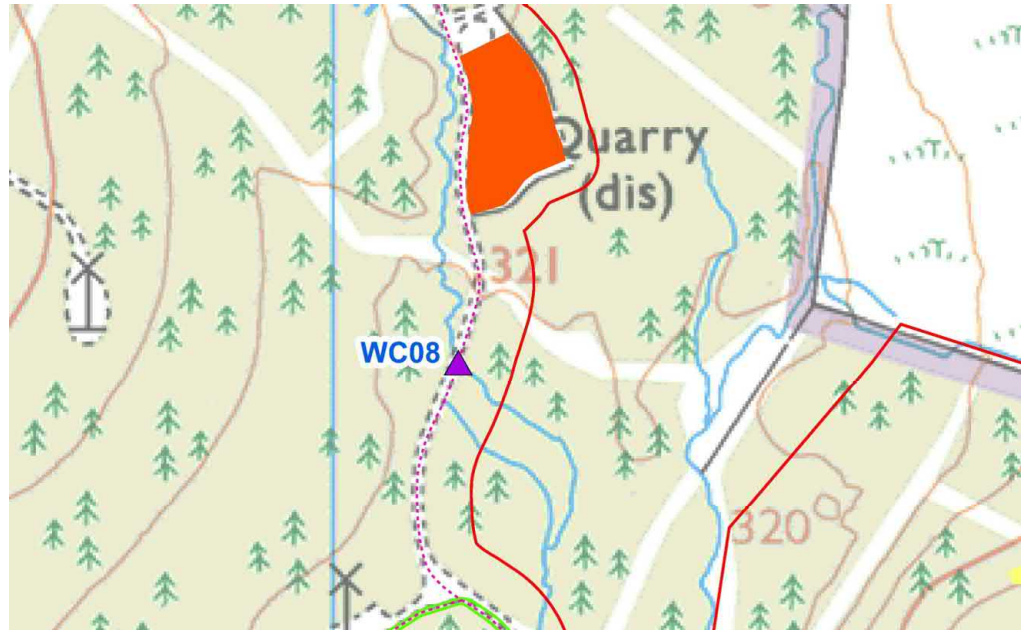
<p>Crossing ID: WC08</p> <p>Route: Crossing approximately 0.7km north west of turbine 14.</p> <p>Watercourse: Auchencaigroch Burn, (Tributary of Glenkiln Burn) Water of Ae Catchment.</p> <p>Description: Bed material consists of pebbles, cobbles and gravel. Bank material is pebbles, cobbles, vegetation and peat. The watercourse had rippled flow at the time of the survey. The main channel is approximately 1.0m wide and 0.5m deep. The watercourse flows south to the confluence with Glenkiln Burn, approximately 1.5km downstream of this crossing. This watercourse is currently culverted.</p>	<p>NGR: NGR 302114, 594318</p>

<p>Catchment Area: Approximately 0.85km²</p> <p>Peak Flows (m³/s): Q₅ = 1.55, Q_{25year} = 2.45, Q_{200year} = 4.09, Q_{200year + cc} = 4.90</p> <p>Mean Flow (m³/s): Q_{mean} = 0.03</p> <p>Flood Risk: Identified on SEPA Flood Risk Map: Yes, small areas of surface water flooding throughout the burn.</p> <p>Ecology: Ecological surveys indicated the burn is considered to have limited suitability for habitat for fish. The watercourse is considered to provide moderate habitat for otters. Evidence of water vole was noted on Auchencaigroch Burn.</p> <p>Crossing Type: Existing circular pipe to be upgraded, which will involve extending the pipe and run the cable in a trench adjacent to the road.</p> <p>CAR Application: This would be anticipated to be require a CAR Registration and constructed following the relevant General Binding Rules.</p>

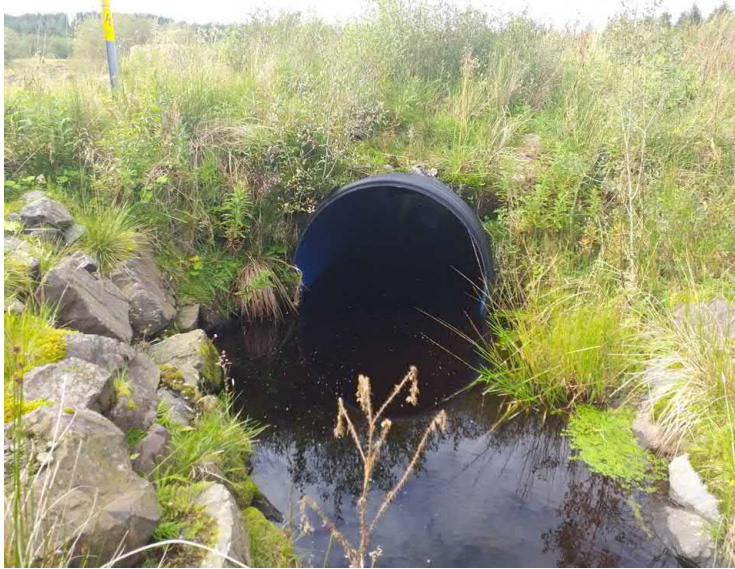
<p>Looking upstream from NGR 302114, 594318</p>

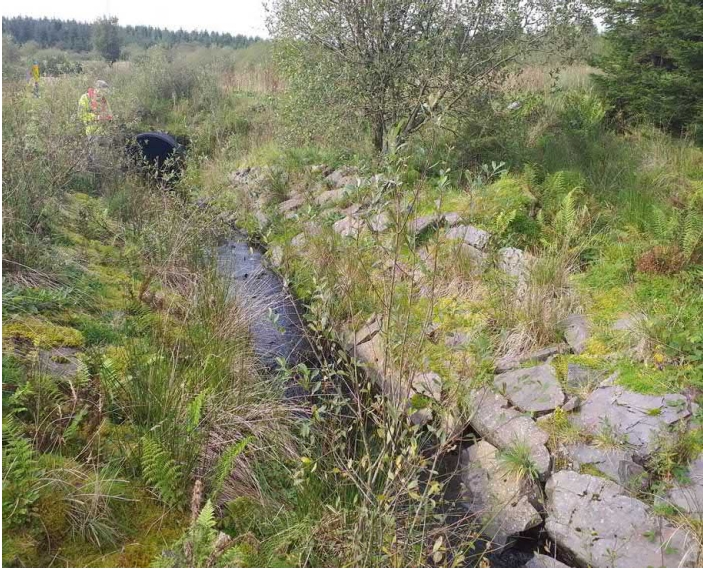
<p>Looking downstream from NGR 302114, 594318</p>

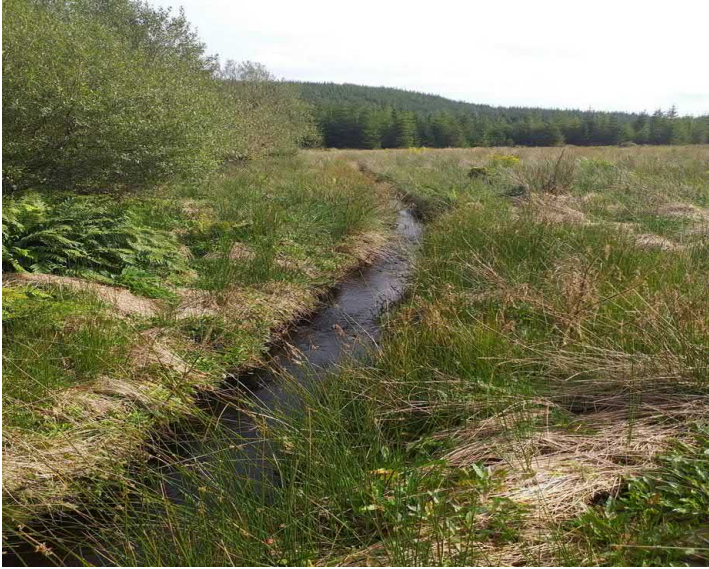
<p>View across channel from NGR 302114, 594318</p>

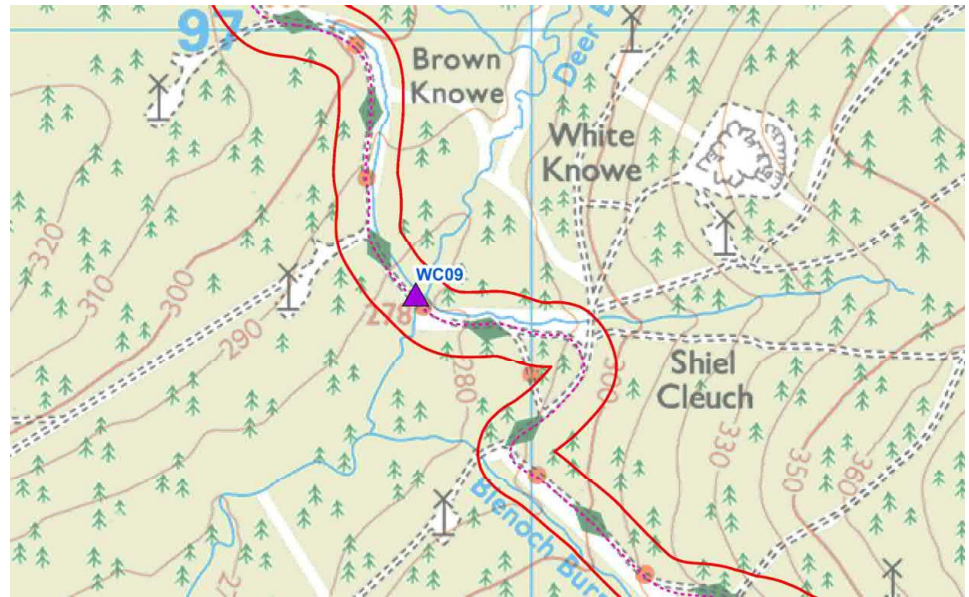
<p>Crossing ID:</p> <p>Route:</p> <p>Watercourse:</p> <p>Description:</p>	<p>WC09</p> <p>NGR: NGR 300825, 596580</p> <p>Crossing approximately 1.07km south of the substation.</p> <p>Deer Burn, Tributary of the Water of Ae Catchment.</p> <p>Bed material consists of pebbles, cobbles and gravel. Bank material is largely vegetation. The watercourse had rippled flow at the time of the survey. The main channel is approximately 1.8m wide and 1.0m deep, with the valley 3.0m wide and 1.5m deep. The watercourse flows south west to the confluence with Water of Ae, approximately 3.30km downstream of this crossing.</p> <p>This watercourse crossing currently consists of two clear span structures at crossing point (one housing cables, the other supporting forestry track).</p>

<p>Catchment Area:</p> <p>Peak Flows (m³/s):</p> <p>Mean Flow (m³/s):</p> <p>Flood Risk:</p> <p>Ecology:</p> <p>Crossing Type:</p> <p>CAR Application:</p>	<p>Approximately 2.81km²</p> <p>$Q_5 = 4.75$, $Q_{25\text{year}} = 7.57$, $Q_{200\text{year}} = 12.45$, $Q_{200\text{year} + \text{cc}} = 14.94$</p> <p>$Q_{\text{mean}} = 0.11$</p> <p>Identified on SEPA Flood Risk Map: Yes, small areas of surface water flooding throughout the burn upstream and high river flood risk downstream.</p> <p>Ecological surveys indicated the burn is considered to provide suitable habitat for fish. Further surveys confirmed the presence of trout. Potential otter couch habitat was recorded under the cable and track bridges. No signs of water vole were noted.</p> <p>Existing steel cable bridge to be upgraded with the inclusion of cable suspending to bridge.</p> <p>This would be anticipated to be require a CAR Registration and constructed following the relevant General Binding Rules.</p>

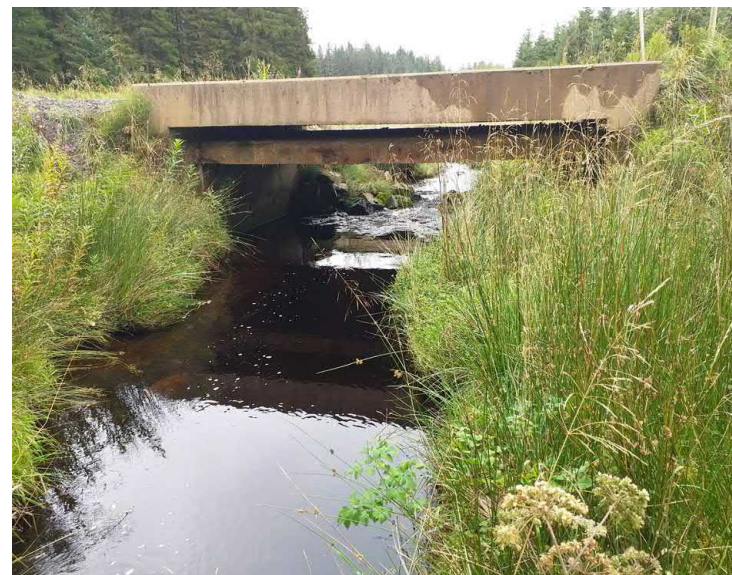
Looking upstream from NGR 300825, 596580

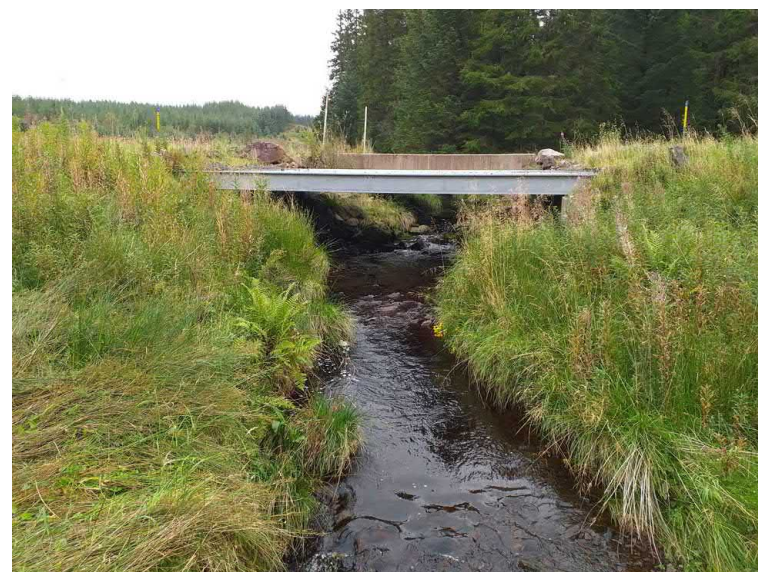
Looking downstream from NGR 300825, 596580

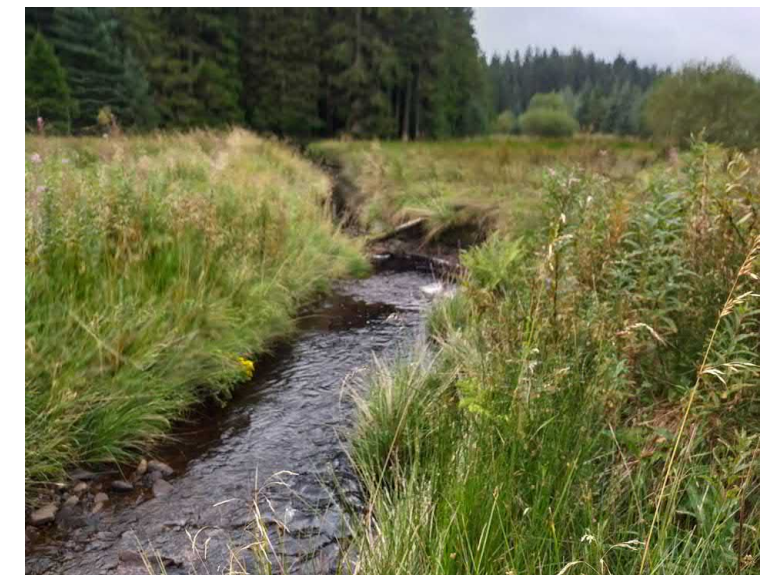
View across channel from NGR 300825, 596580

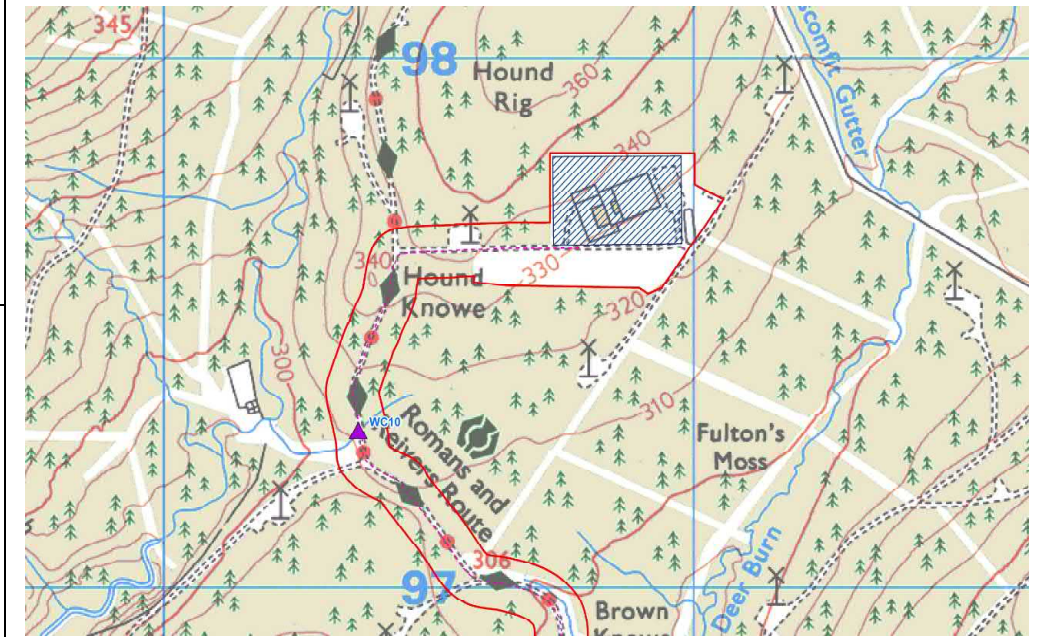
Crossing ID:	WC10	NGR: NGR 3003374, 597302
Route:	Crossing approximately 0.55km south west of the substation.	
Watercourse:	Unnamed Tributary of the Water of Ae	
Description:	Bed material consists of pebbles, cobbles and gravel. Bank material is pebbles, cobbles, vegetation and peat. The watercourse had rippled flow at the time of the survey. The main channel is approximately 0.25m wide and 0.50m deep, with the valley 8.0m wide and 4.0m deep. The watercourse flows south to the confluence with Water of Ae approximately 0.32km downstream of this crossing.	
Catchment Area:	Approximately 2.86km ²	
Peak Flows (m³/s):	Not available for this sub-catchment, WC09 values are considered representative.	
Mean Flow (m³/s):	Q _{mean} = 0.003	
Flood Risk:	Identified on SEPA Flood Risk Map: No. Areas of flood risk from rivers downstream of the tributary on the Water of Ae.	
Ecology:	Ecological surveys indicated the watercourse is considered to have limited suitability for fish habitat. Otters were noted in the valleys of Water of Ae. No signs of water vole were noted.

Crossing Type:	Existing circular pipe to be upgraded, which will involve extending the pipe and run the cable in a trench adjacent to the road.	
CAR Application:	This would be anticipated to require a CAR Registration and constructed following the relevant General Binding Rules.

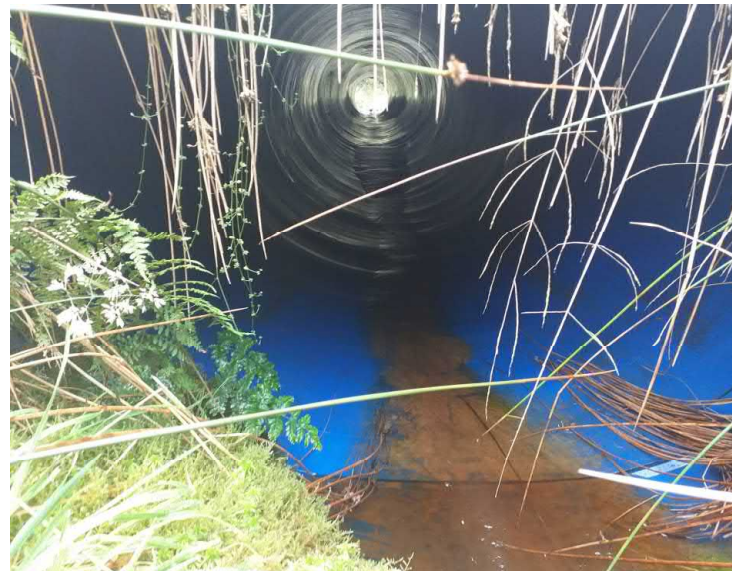
Looking upstream from NGR 3003374, 597302
