Harestanes South Windfarm Extension

Environmental Impact Assessment Report Addendum

Appendix A1 – Consultation with SEPA

Watercourse Crossings Report

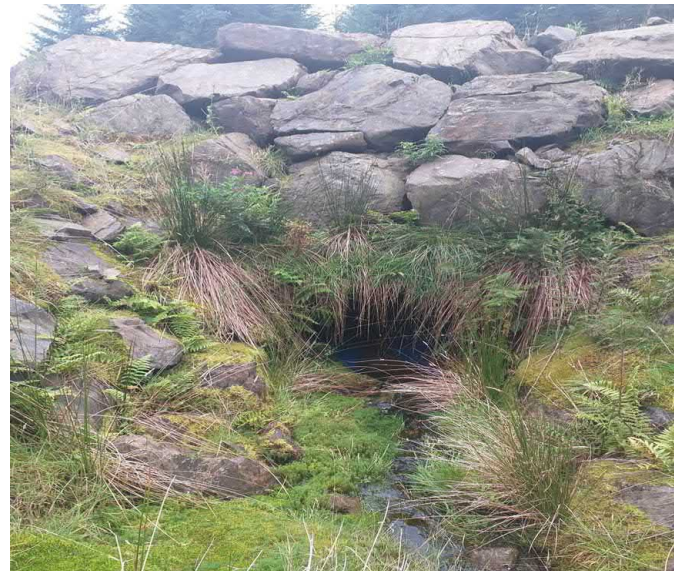
Looking downstream from NGR 3003374, 597302

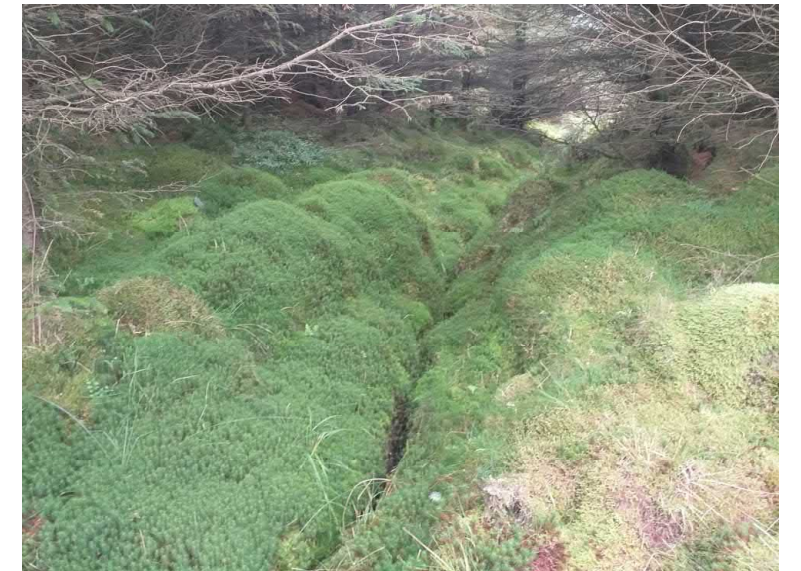
Looking upstream from NGR 3003374, 597302
