Cable Route Environmental Information

Project: Sound of Islay Demonstration Tidal Array
Date: May 2013

**SCOTTISHPOWER
RENEWABLES**

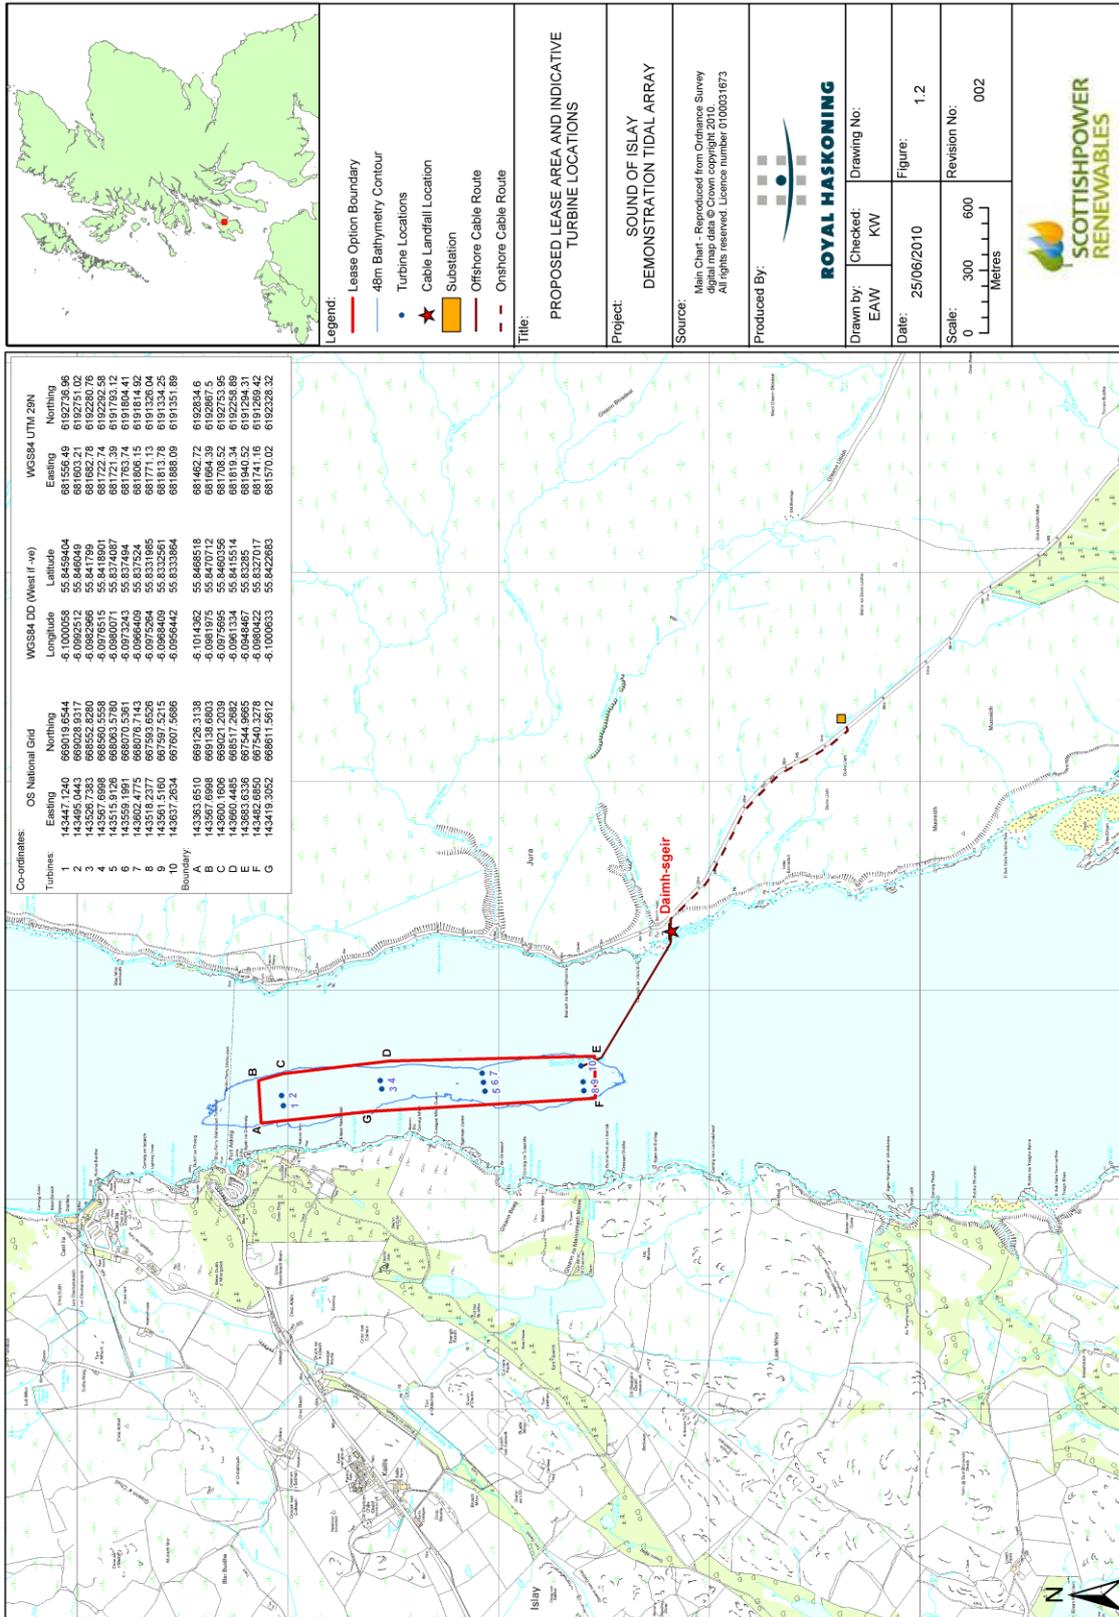
Figure 1.1: Development site showing turbine locations, cable route and onshore infrastructure as consented in 2011.

SPR currently holds consent to construct, install and operate a demonstration tidal power array within the Sound of Islay (Figure 1.1). The Development will utilise the tidal flow running through the Sound to power tidal turbines during the flood and ebb tidal flows and generate electricity throughout these flow periods.

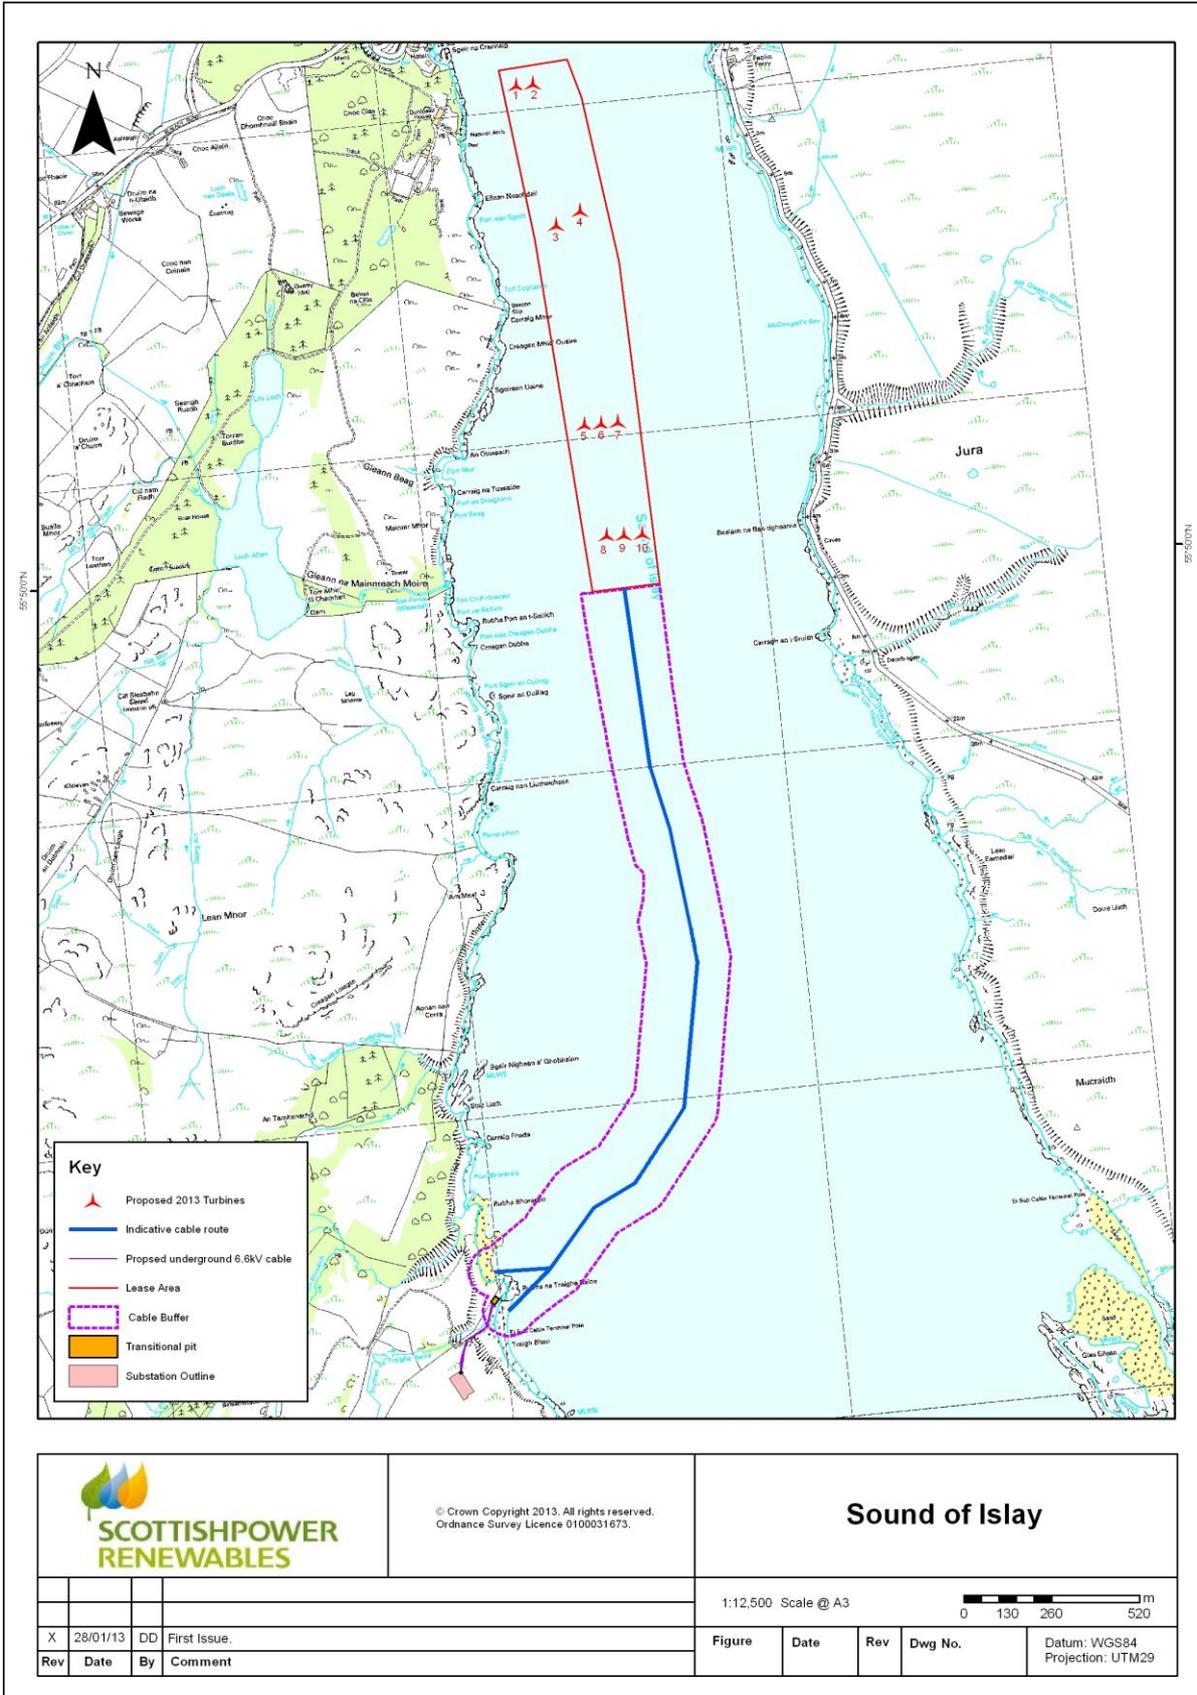
Figure 1.2: Development site showing turbine locations, cable route (incl. buffer) and onshore infrastructure as proposed in 2013.

Post-consent discussions were held with the regulator and, as a result of these discussions related to the interpretation of planning legislation, a number of amendments have been made to the Development. The principal change in relation to this Marine Licence application relates to a new cable route to shore, which is now planned to make landfall on Islay instead of Jura as previously consented (Figure 1.2).

Two potential cable landfall locations have been identified (Figure 1.2). The northern landfall site is deemed to be the most appropriate as it allows for bend radius parameters to be fully considered when laying the cables and maintains an appropriate working distance from the already present SSE cable that connects Islay and Jura. The southerly landfall location would mean that the bend radius of the cable would be tight and potentially lead to a greater need for future maintenance or replacement operations.

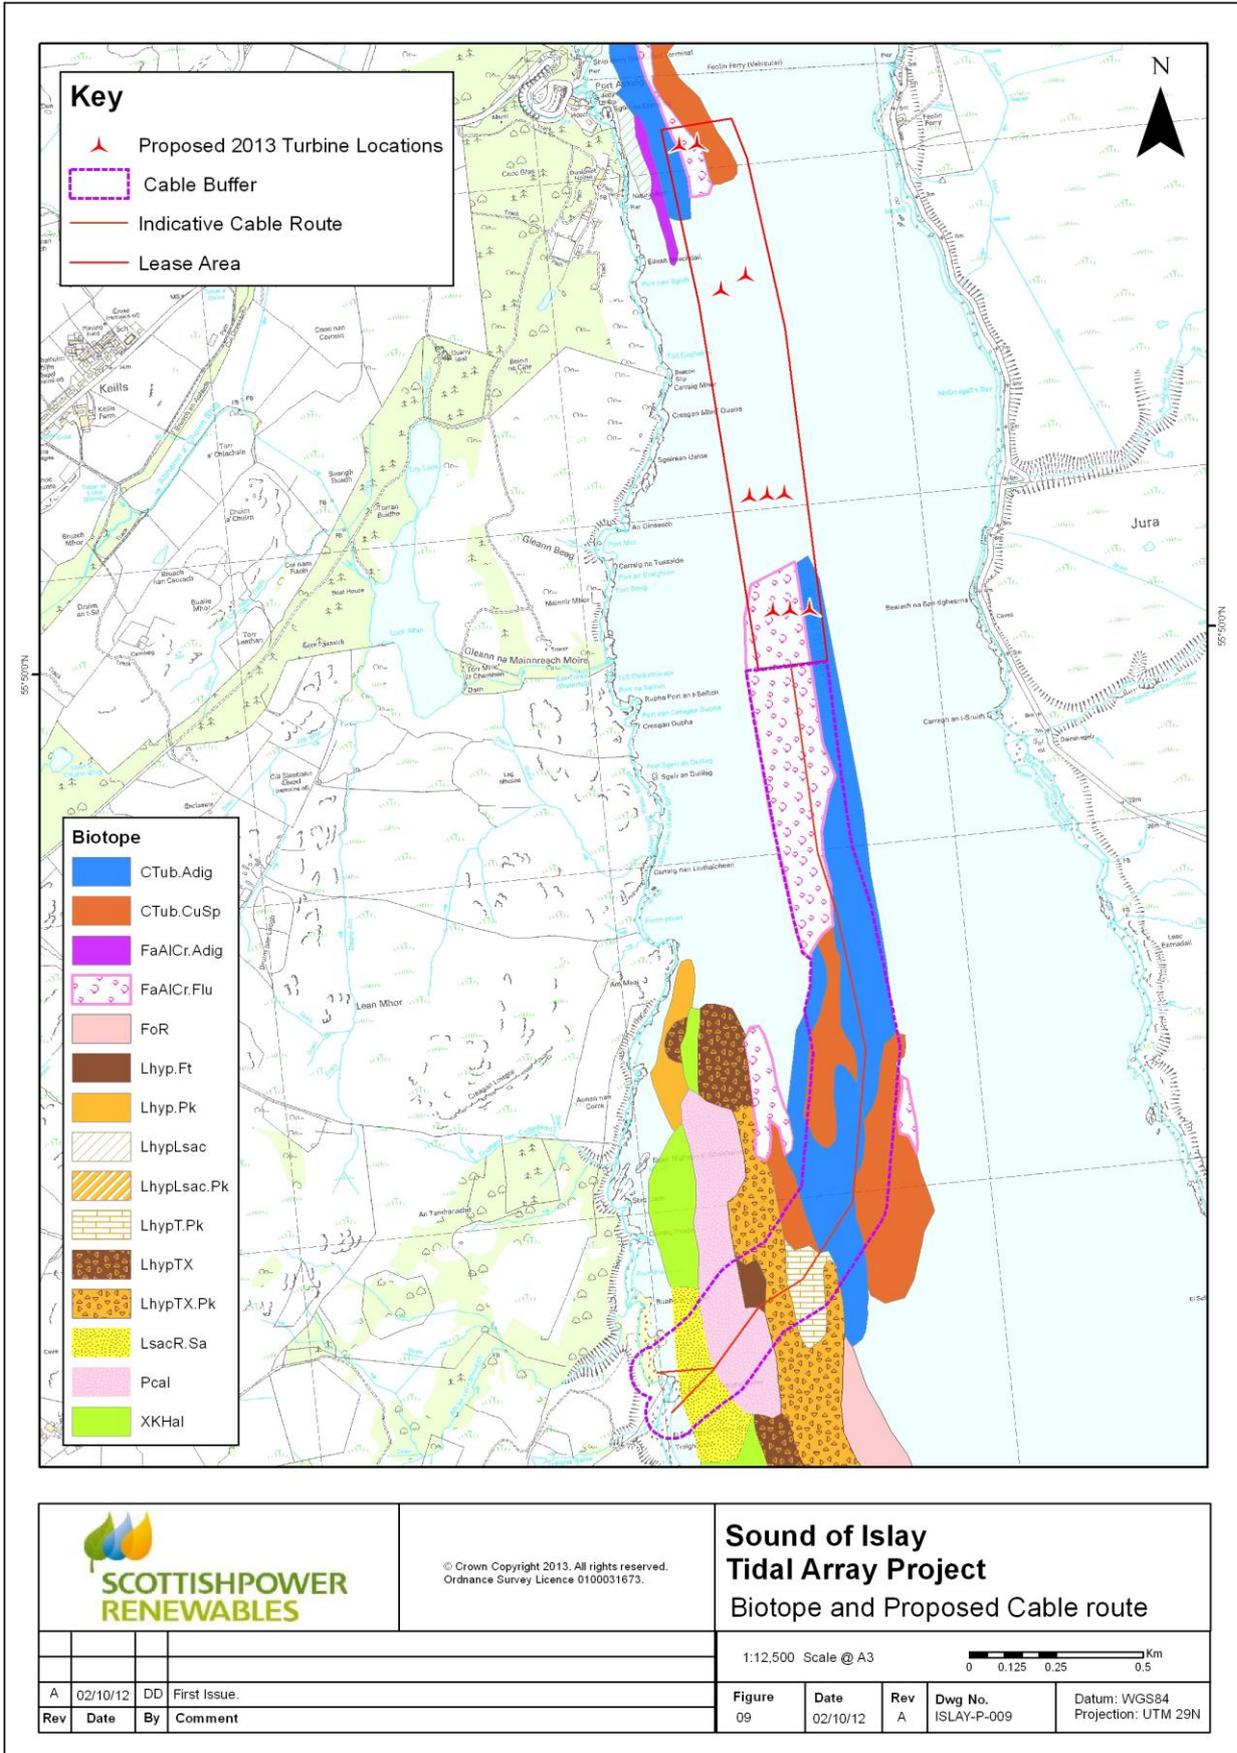
Figure 3.1: Biotopes in relation to newly proposed cable route.

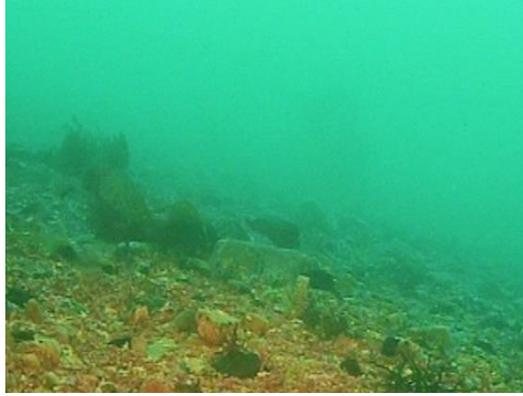
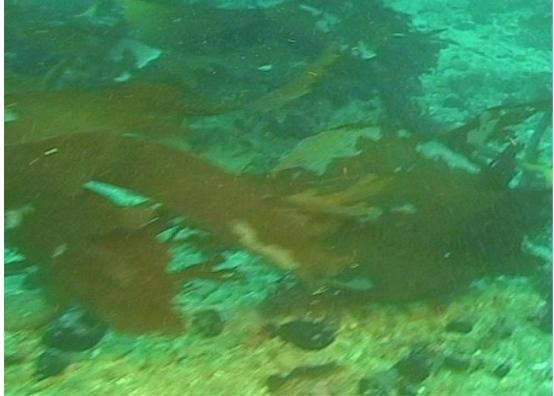
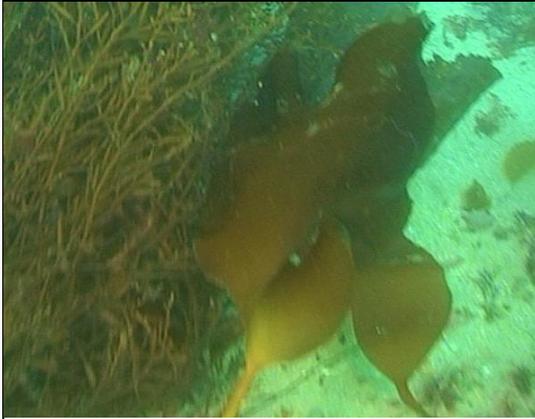
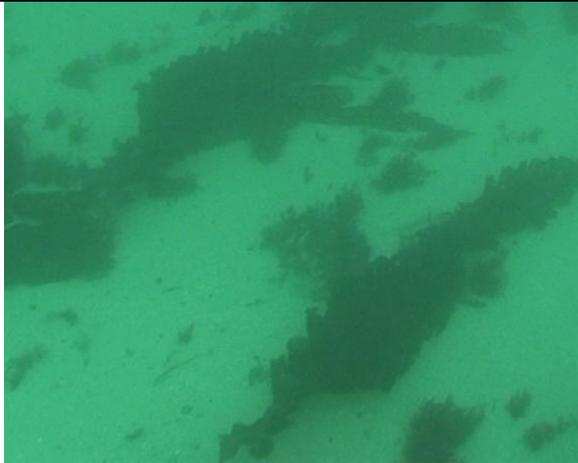
Plate 3.1: Drop down images in relation to the four PMFs identified during the newly proposed cable route survey (see Appendix 1). Biotope codes according to Connor *et al.* (2004)

Biotope SS.SMp.Mrl.Pcal	Biotope IR.MIR.KR.LhypTX

Biotope IR.HIR.KSed.XKHal	Biotope SS.SMp.KSwSS.LsacR.Sa
